PROPOSED LOWER NORTH ELEVATION

## TYPICAL WINDOW - OUTWARD OPENING (based on Ideal Combi FUTURA+)

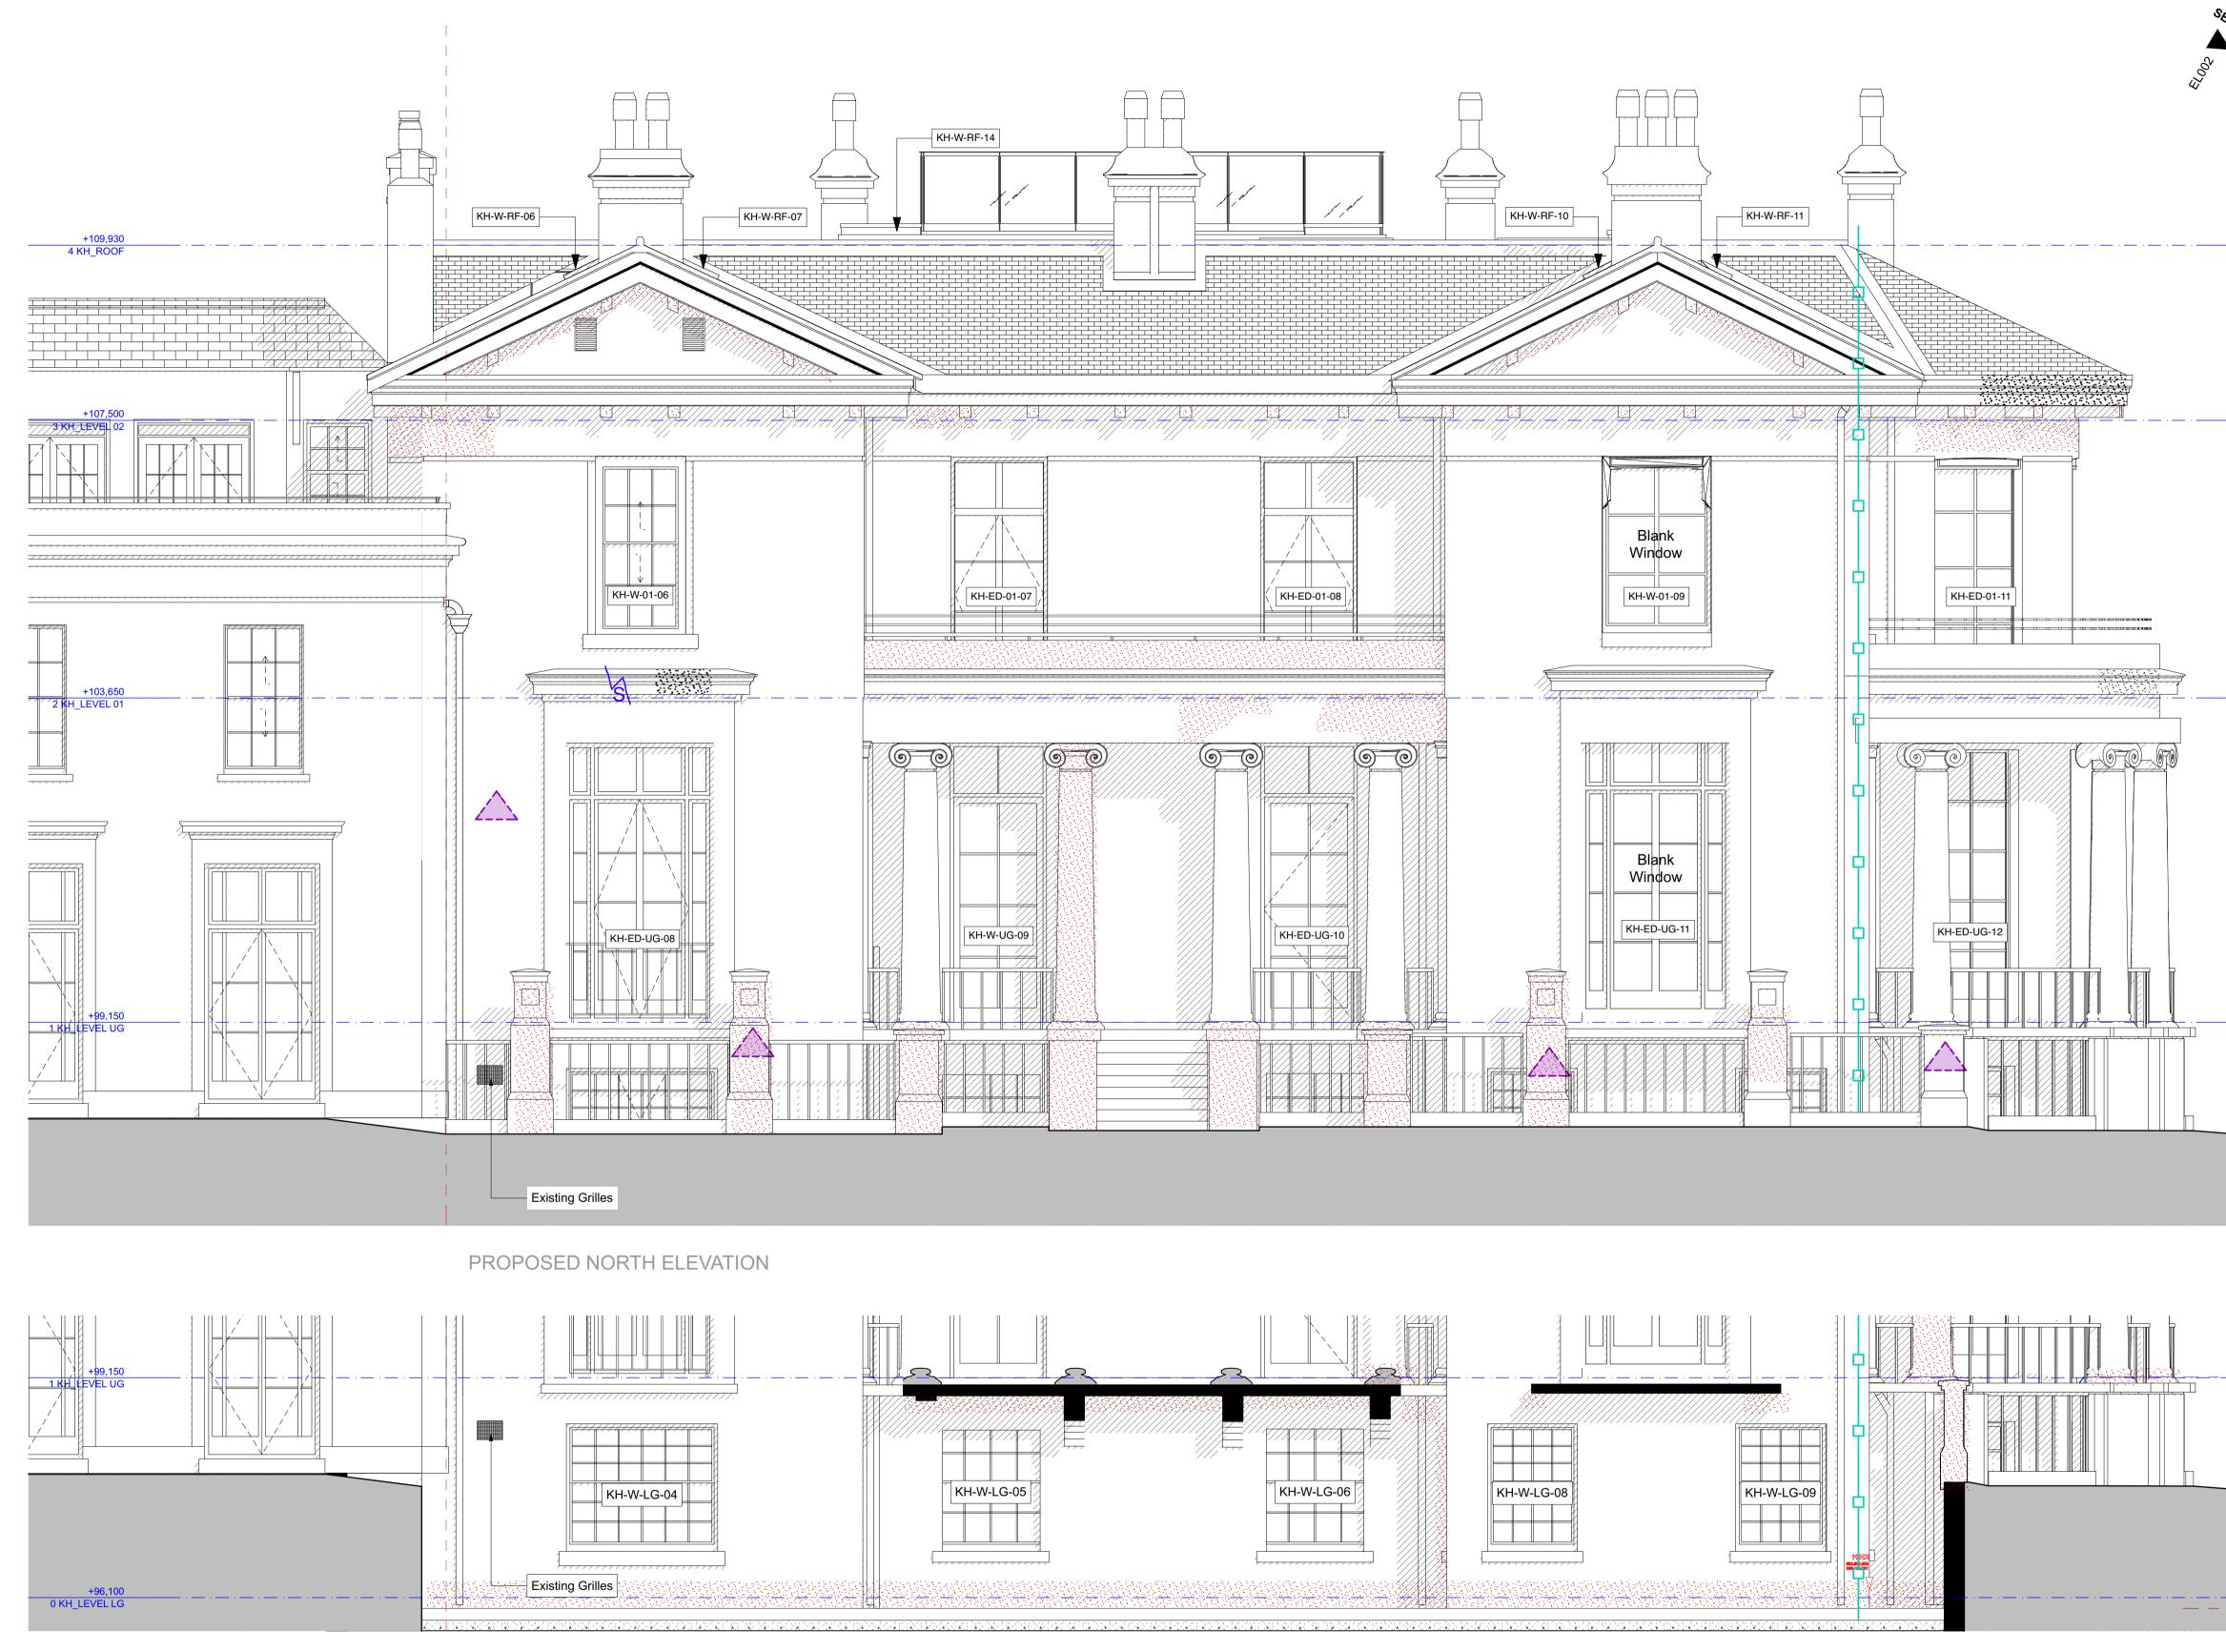
## REPAIR WORK KEY

Stonework - Repair

Brickwork - Repair.

Repointing - Rake out and repoint to match existing.

Stained area to be cleaned.

Any type of fitting to be removed and brickwork made good.

Render - Repair

Cornice - Repair
