BASEMENT IMPACT ASSESSMENT

40 FROGNAL LANE

LONDON NW3 6PP

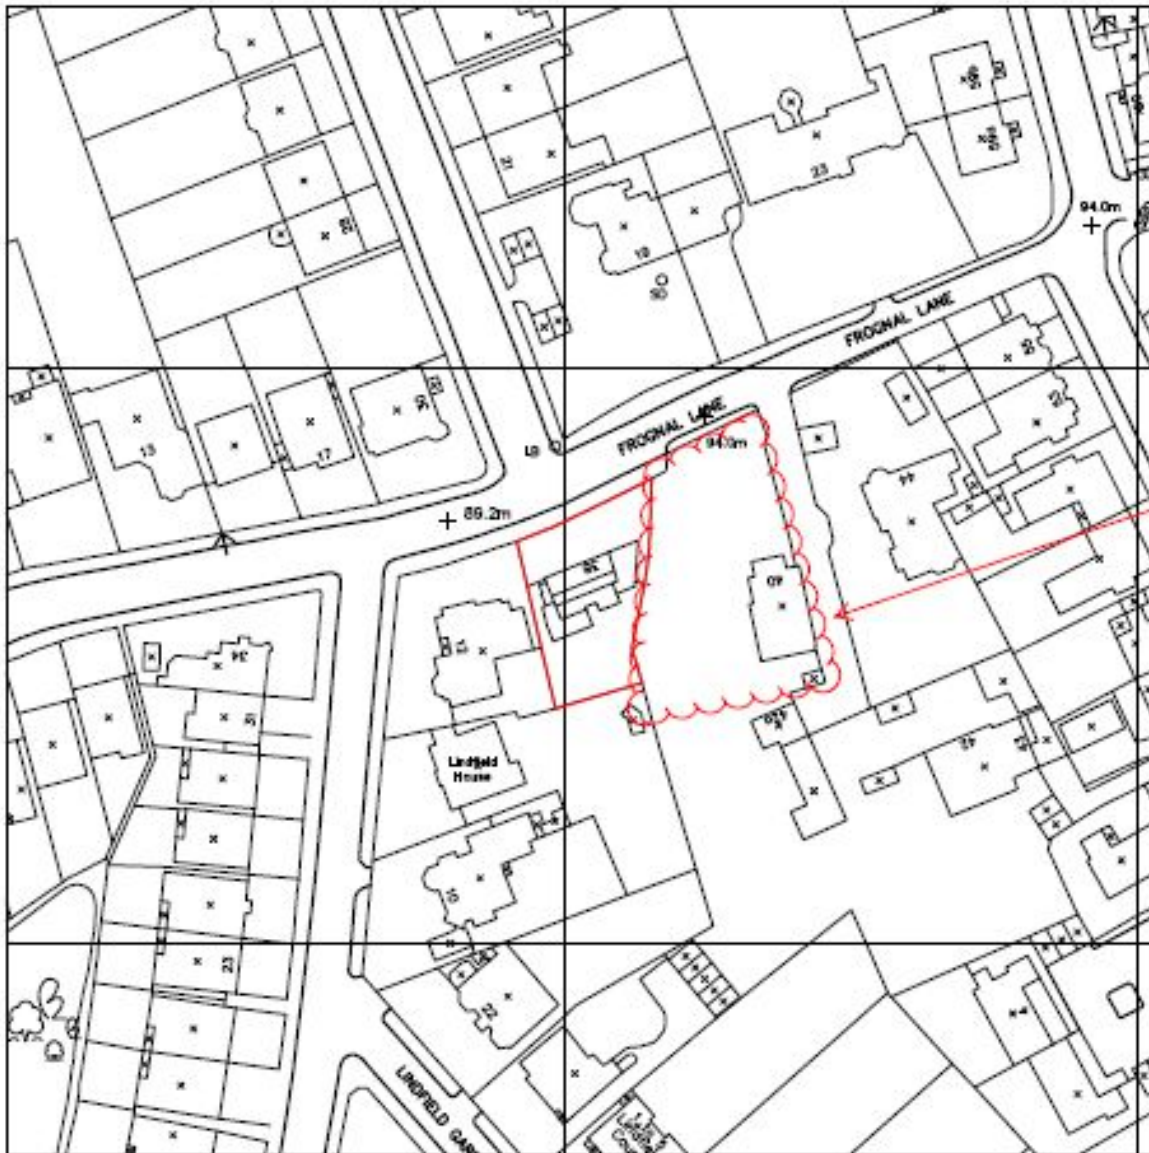
40 Frognal Lane

OS Extract
Scale 1:1250

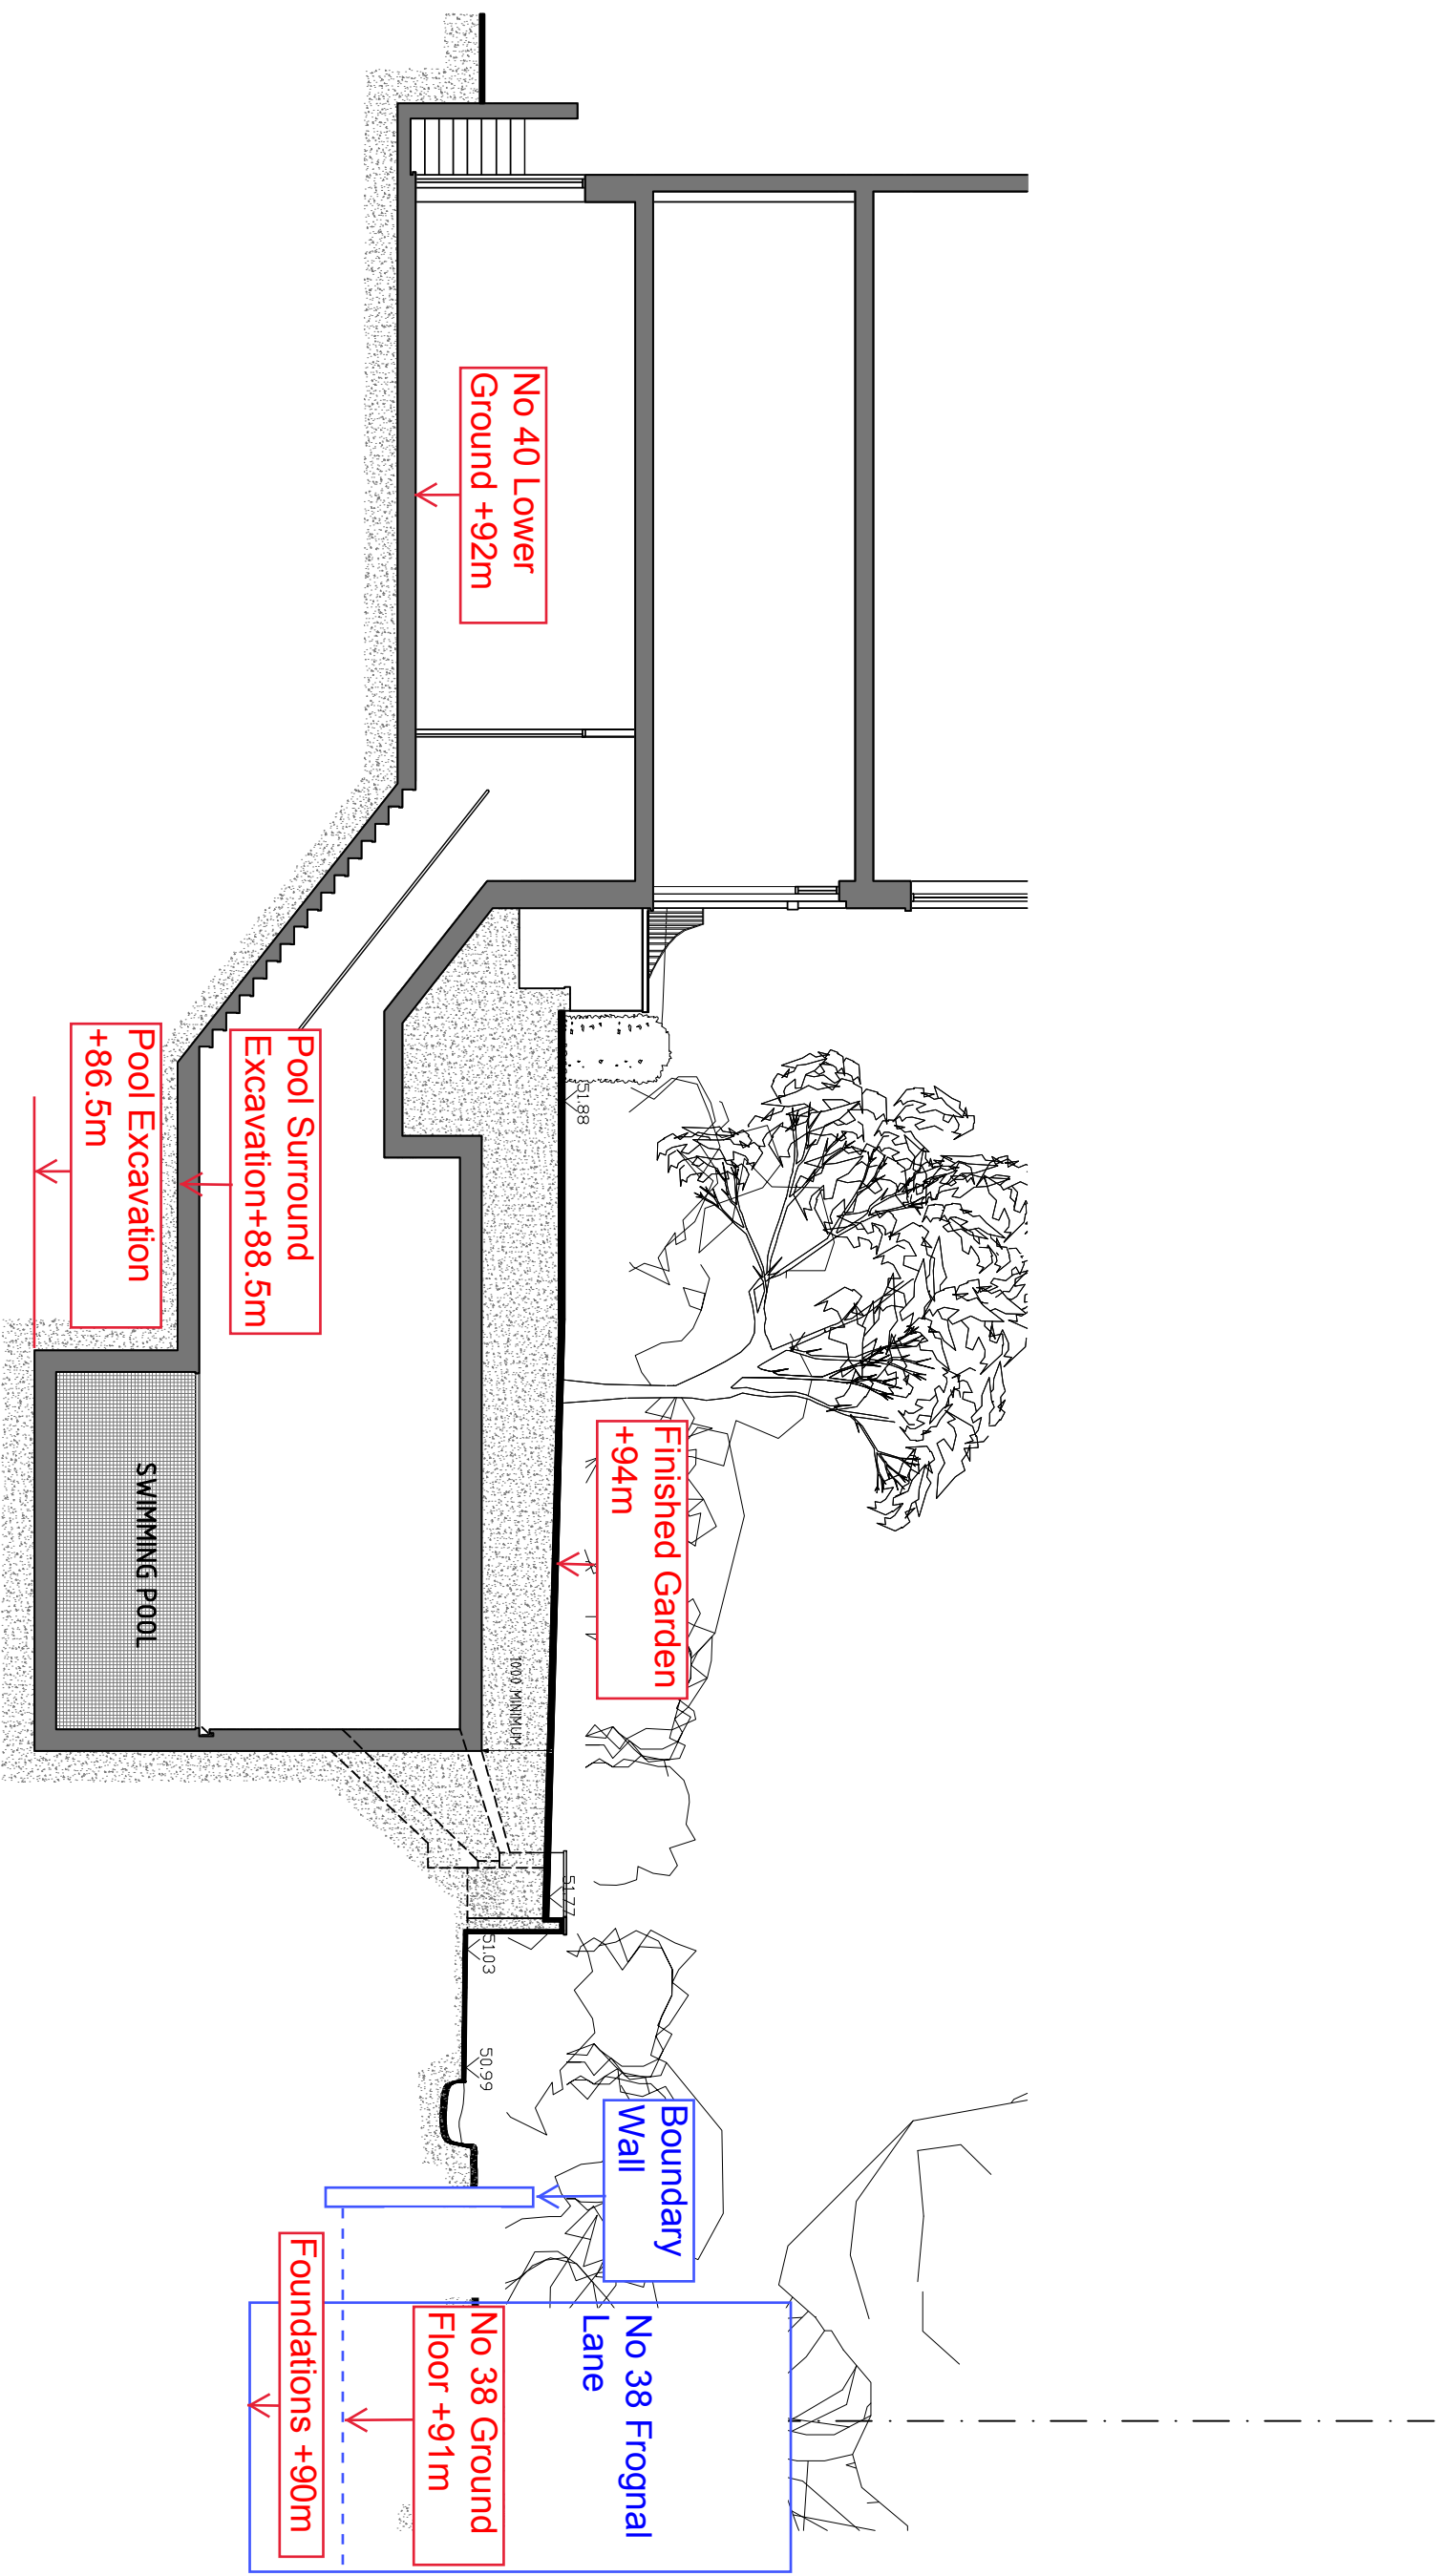
Drawing 10998/CS01

Schematic Cross Section and Levels

1.2.2 The house has a lower ground floor which is +92m; the foundations are likely to be +91.5m. This means the pool surround excavation is 3m below the foundations and the deep end is 5m below

1.2.3 No 38 is at +91m and its foundations are at +90m. Taking an average depth to the excavation of the pool and surround of 87m, this means the pool itself is 3m below No 38.
