This design and access statement has been prepared to accompany the Planning and Listed Building Consent application for proposed works at Number 40 Great James Street, London.

This document sets out the rationale of the collective proposals for the property, a grade II\* listed eighteenth century townhouse. Currently the building is vacant, unable to be put into beneficial use associated with its mixed land use class whilst there are structural issues and a lack of modern servicing. The document will discuss how proposals have been carefully considered such that further removal of historic building fabric is avoided whilst the structure is repaired and modern services are installed.

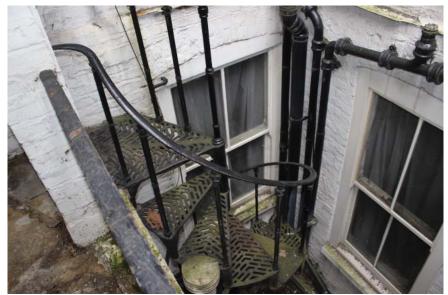
Spiral staircase to basement at the rear

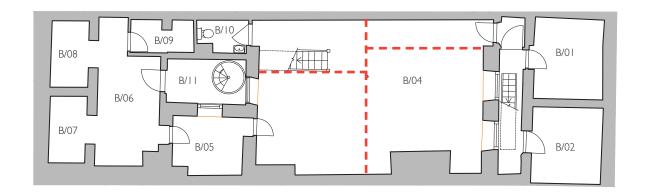
## **BASEMENT**

The basement would originally have been occupied by service spaces, such as the kitchen, storage and servant accommodation. Goods would have been lowered down into the front area, often via a crane arm set within the railings. No evidence of this survives, although the gate to the stair is modern, indicating that there was no stair present originally.

The area beneath the main house has been converted into a large open plan space - it is thought that the partitions were removed in the early 20th century. Support is now provided by central single cast iron column. The stair up to ground is modern and there is timber overboarding to the ceiling which dates from the open plan intervention. There is a large fireplace to the former front room which would have contained the original range. This has a rendered surround.

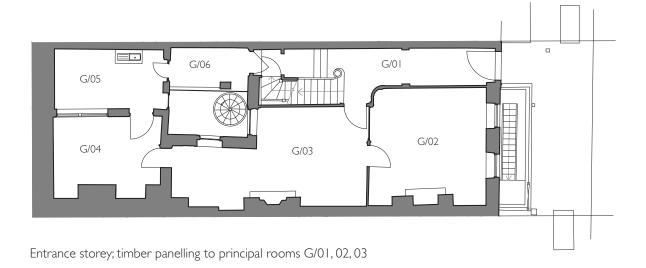
## **GROUND FLOOR**

The building is accessed at this level. The timber panelling to the principal rooms G/01, G/02, G/03 is raised and fielded with a carved timber dado rail and cornicing.

The stair up to first floor is original with elaborate carved timber strings and newels with a Corinthian motif and candy twist balusters. The stair up from the basement is enclosed with timber boards abutting the balustrade in this location and is of late twentieth century construction.

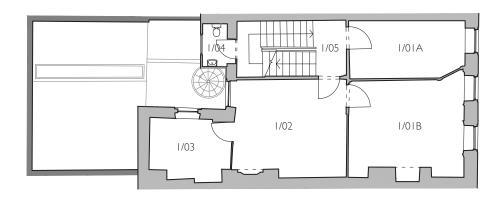
## **FIRST FLOOR**

This would have been the most important floor in the original hierarchy of spaces of the house, known as the piano nobile. The stair to this level and above is original and has decorative carved timber strings, newels and balusters. A WC closet is accessed at the half landing of the stair 1/04. This is a later addition as can be determined from the interruption to the original panelling layout. The closet is constructed from a variety of materials; masonry, timber and corrugated boards.

In the front room I/01A & B a non-original timber partition has been inserted within, evidenced by the cut marks in the original decorative plaster cornice and unusual geometry. Original shutters to the front windows remain operational although in need of refurbishment. The partition between I/02 and I/03 is a later insertion, possible dating from the early 20th century as evidenced by the timber construction with glazed

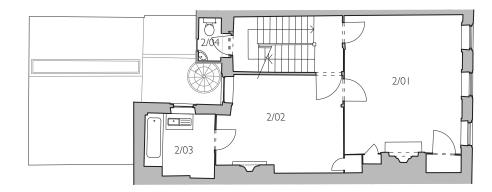
## SECOND FLOOR

This level would have originally been occupied by the master bedrooms. The stair to this level is original and has decorative carved timber strings, newels and balusters. The WC closet is accessed at the half landing 2/04.

The front room is as per the original layout with later nineteenth century cupboards either side of the fire place. Original shutters to the front windows remain operational although in need of refurbishment.

The rear closet has original panelling and timber cornicing although the previous use as bathroom / kitchen has left some parts damaged.

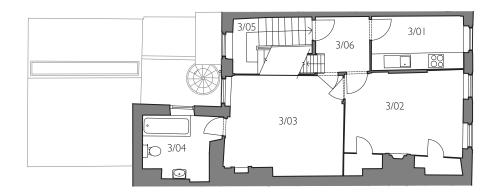
## THIRD FLOOR

This level would have originally been occupied by lower-status functions, such as childrens and servants bedrooms. Signifying this, the stair to this level is original but is more utilitarian, lacking the same level of decorative timber carving as found on the lower levels. The original window to the half-landing is still present at this level, the WC closet terminating at 2nd floor level.

The layout of rooms to this level is thought to be original, with two smaller rooms to the front and a larger room to the rear through which the rear closet wing is accessed. A modern kitchen has been inserted into room 3/01.

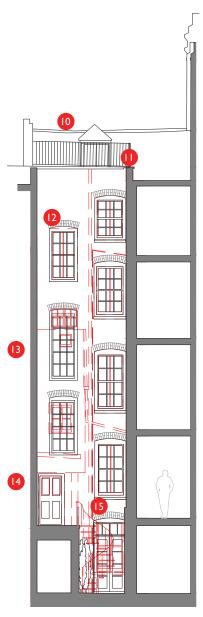
PROPOSED REAR ELEVATION & SECTION

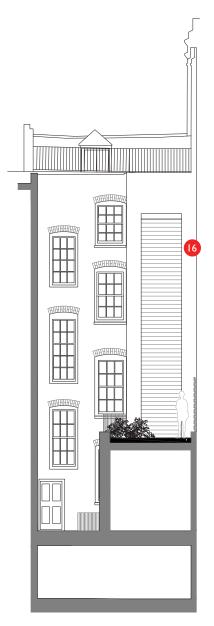
PROPOSED REAR ELEVATION

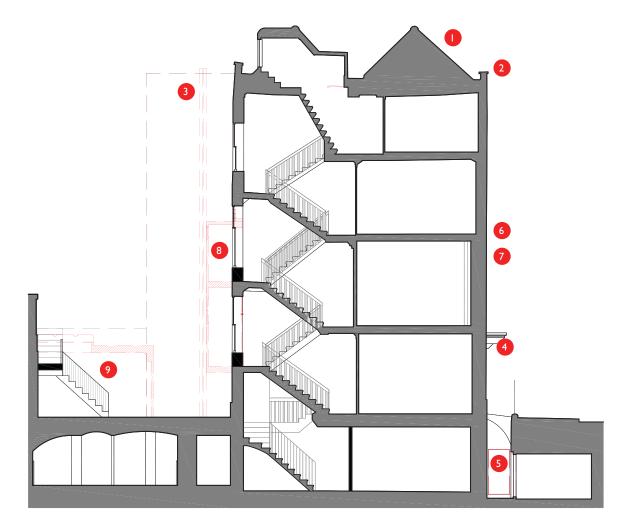
PROPOSED SECTION A-A

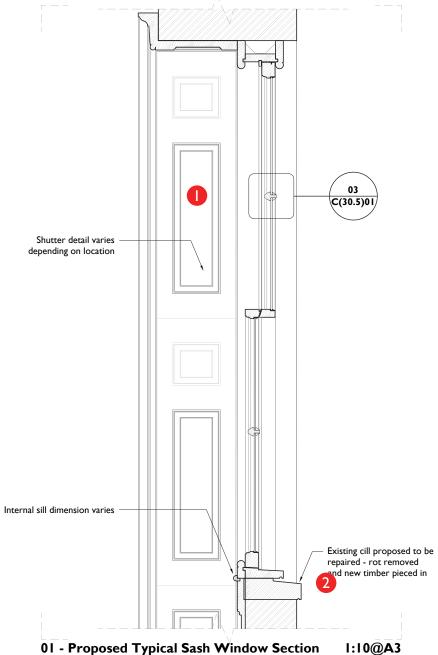
#### 3.1.12 PROPOSED WINDOW DETAILS

- Where historic existing ironmongery is proposed to be removed, overhauled and refixed to the existing shutters.
- Repairs to rotten cills are proposed
- The proposed glazing bar dimensions is appropriate to the era of the building. The detail has also been taken from a previously completed building on the street that has set a precedent for acceptable dimensions.

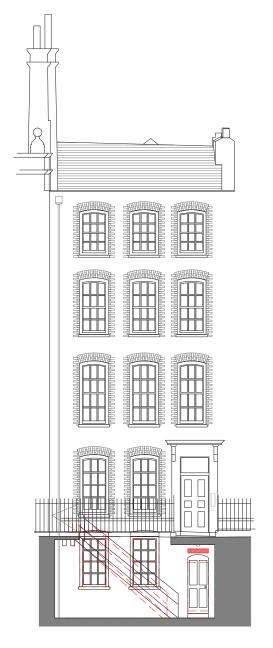
PROPOSED FRONT ELEVATION - ALL WINDOWS PROPOSED TO BE REPLACED WITH 6 OVER 6 TIMBER SASHES

- New 6 over 6 timber sash windows proposed to the entire façade. Where possible sash boxes are proposed to be retained and repaired.
- 8 Existing closet extension proposed to be removed. Windows proposed to original locations within existing structural openings.

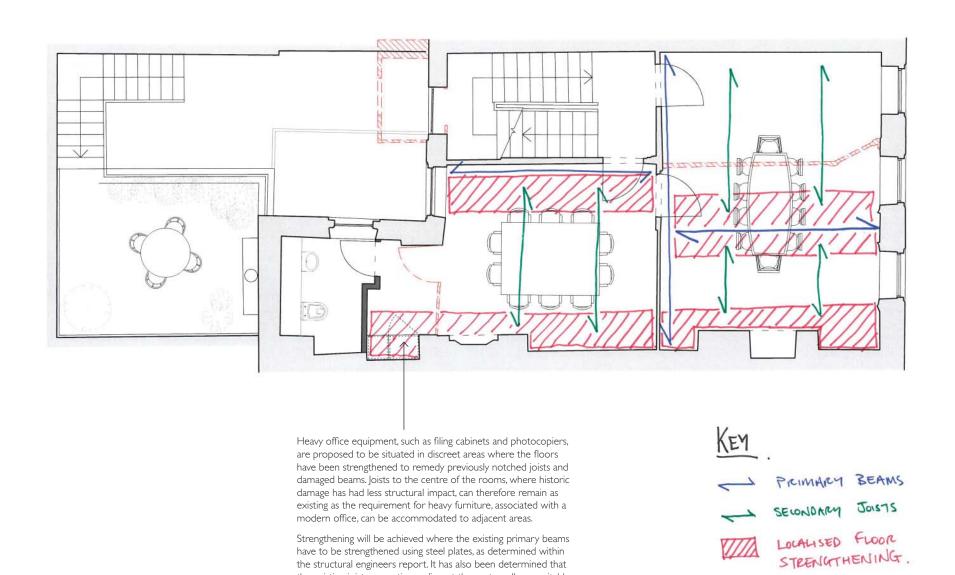
### PROPOSED STRUCTURAL STRATEGY

Strengthening will be achieved where the existing primary beams have to be strengthened using steel plates, as determined within the structural engineers report. It has also been determined that the existing joist connections adjacent the party walls are suitable

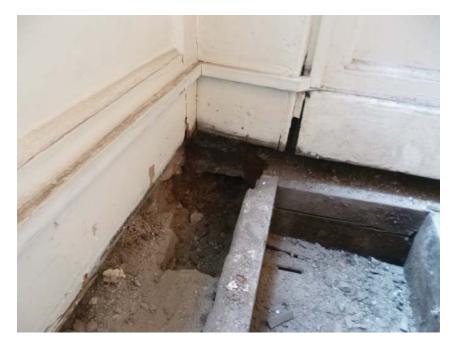
Rotten wall plate and beam end

Rotten (missing) structural wall plate and beam end to first floor rear room

The rotten beam to the first floor rear room needs to remedied with a low impact solution. The drawing opposite indicates the strategy and method statement for how to deal with installing new steel strengthening to prevent further damage to the remainder of the property whilst minimising disruption to original panelling and ceiling constructions.

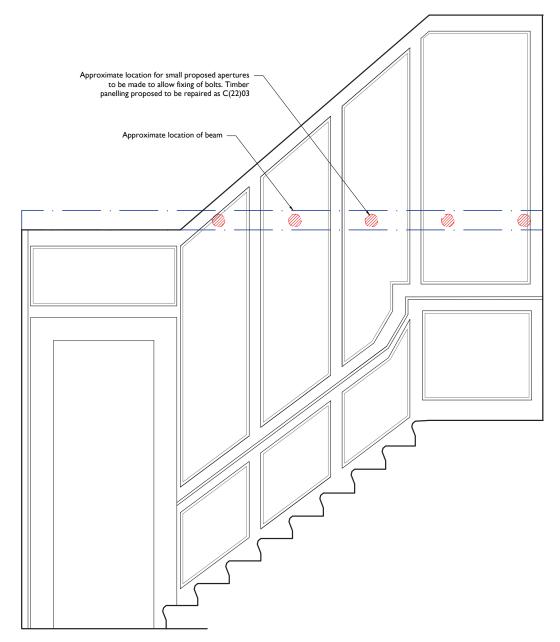
Proposed Elevation from Stair

#### **METHOD STATEMENT**

- Remove floorboards adjacent to panelling.
- 2 Cut back joists as required to allow fitting of new timber beam alongside existing.
- Renew wall plate.
- 4 New beam bolted to existing beam. Existing joists refixed to new beam via joist hangers or similar.
- Refix joists.
- 6 Re-fit floorboards..

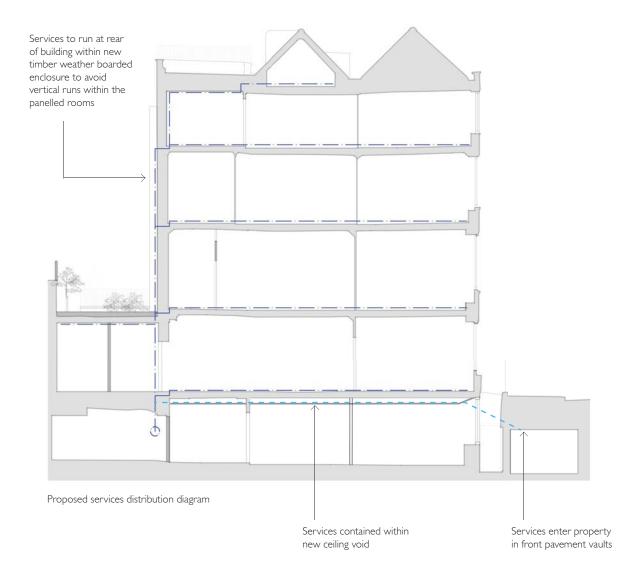
As shown in the adjacent diagram, services for the building are proposed to be routed from the front pavement vault to the rear of the property, concealed within a replacement dropped ceiling in the basement storage room. At the rear of the property, an external timber weather boarded enclosure is proposed such that the main services can rise vertically to each floor, allowing the removal of the existing surface mounted conduit internally in the building which clashes with the panelling where it is present.

At each storey all services are proposed to run within the existing floor voids using existing notches in joists where possible. The building currently does not have a central heating system installed. Heating will be achieved using a conventional wet radiator system, as endorsed by Historic England and London Borough of Camden, with radiators installed in each habitable room.

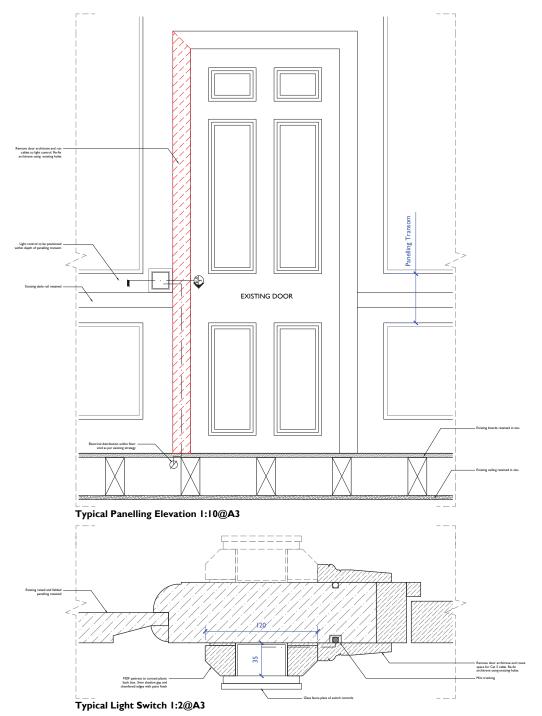
The proposed routing of cabling for items such as light switches is proposed as per the following detail drawing. Existing crude surface mounted electrical conduits are proposed to be removed where possible and the existing timber panelling made good. The proposed treatment is to minimise the amount of surface mounted trunking required with installing modern services. It is proposed that electrical services are routed within the existing floor voids and, where possible, utilise existing notches within the joists. To route cables to items such as light switches, it is proposed to locate these behind existing door architraves that are proposed to be carefully lifted, notched, and re-fixed. In this manner the integrity of the panelled rooms can be re-established whilst the proposals discretely install the necessary services within the rooms.

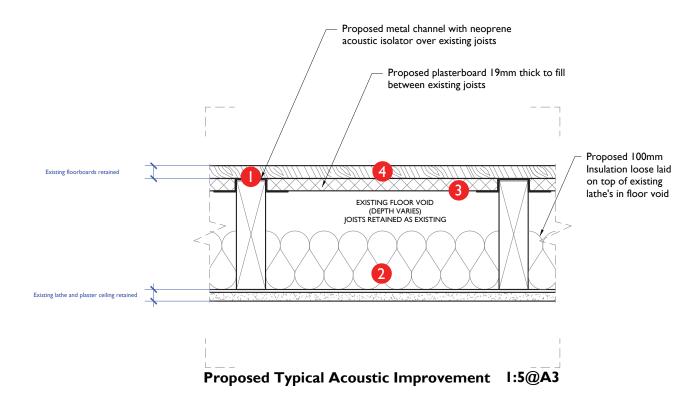
Whilst the existing floorboards are lifted to allow works access during the construction, it is proposed to take advantage of this opportunity to improve the acoustic isolation between the existing second and third floor residential units. This will be achieved using a proprietary system as shown to the right.

- A bracket with resilient layer is fixed to the existing timber joists.
- 2 Loose laid insulation is inserted into the floor void, ensuring that the existing lathe and plaster ceiling is retained.
- Fire resistant plasterboard is fixed between adjacent joists on the brackets installed in point I
- The retained existing floor boards are re-fixed on top of the existing joists to their original locations.
