**TUC CONGRESS HOUSE  
LOWER GROUND FLOOR AND SIXTH FLOOR REFURBISHMENT**

**DESIGN AND ACCESS STATEMENT  
INCORPORATING HERITAGE IMPACT ASSESSMENT**

**HUGH BROUGHTON ARCHITECTS  
APRIL 2017**

Structural Engineer's RIBA Stage 2 Report

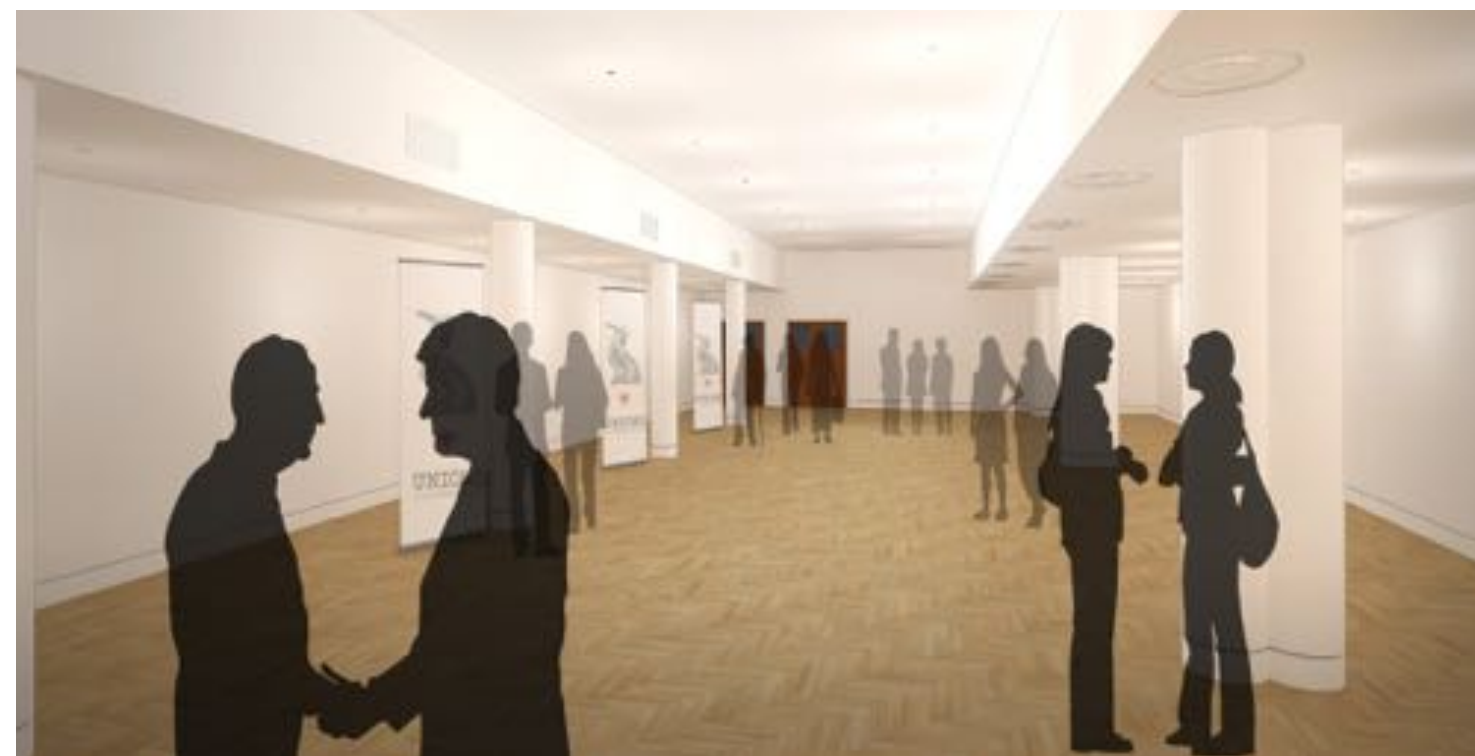
*New Conference Centre break out area with new lighting, refurbished diffuser outlets, refurbished herringbone timber floor and redecorated.*

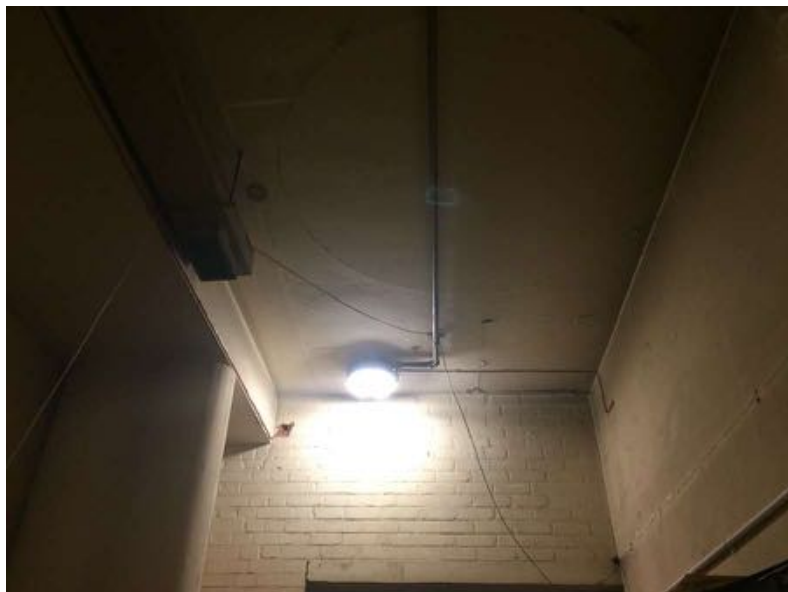
The image below is taken at sub-basement level looking at the soffit of the circular and square knock-out panels, whose edges are discernible.

The eastern opening appears to be in its original condition (infilled with a knock-out floor panel). This may be retained.

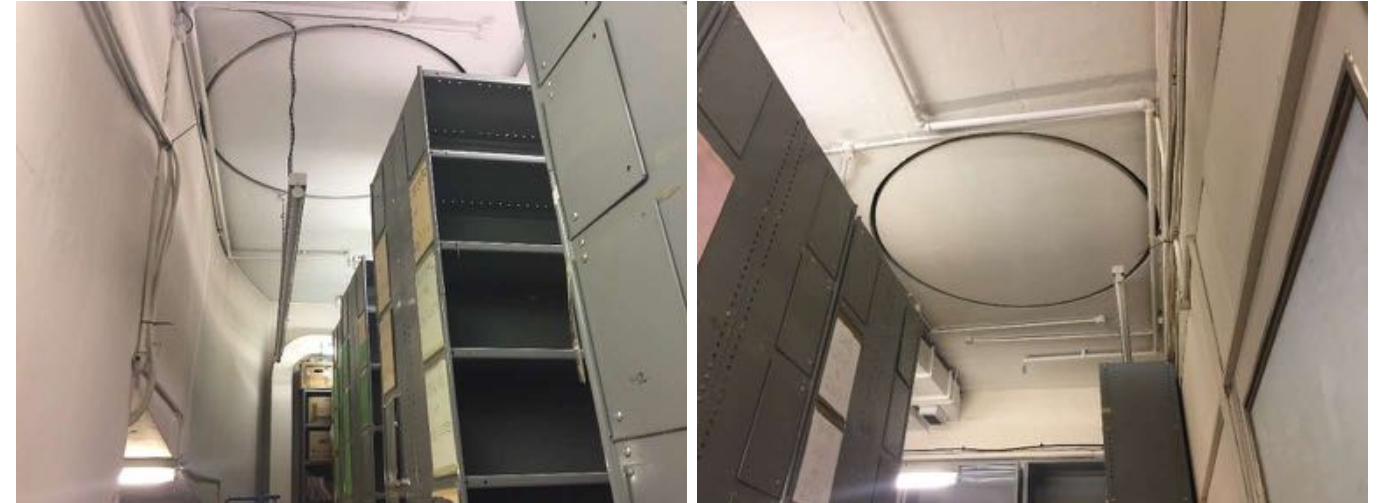
The images below show the central (right) and western (left) openings as viewed from sub-basement. A lightweight infill panel has been installed in each location. The square knock-out panels were not visible.

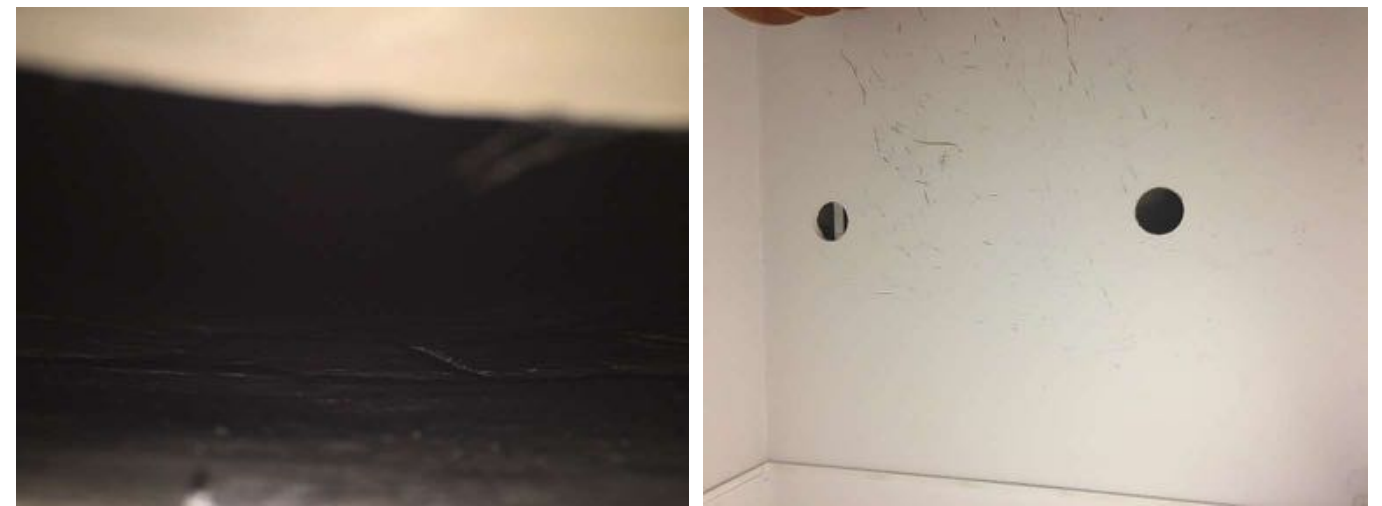
The image below right shows a view looking up at the edge of the central circular infill panel, where brickwork is visible. A profiled metal deck was also visible spanning north-south which appears to have been used to infill the circular opening at ground floor level.

The image below right shows openings in a partition wall built outboard of the masonry surrounding the circular openings, viewed at basement level. Brickwork was visible through these small openings.

The masonry brickwork surrounding the central and western stair openings from basement to ground floor does not appear to be structural. The brickwork may be removed with no requirement for new structural members.

The central and western circular openings at ground floor level appear to have been infilled at some point in the past. The construction of the infills are not known, although a profiled metal deck soffit was observed in the central location. This could be part of a composite steel/concrete decking, or just a lightweight deck. Either way, the existing structure may be retained. Fire protection is recommended to the underside of the openings, in the form of plasterboard finishes.
