## **UCL- 20 Bedford Way-Phase 1**

## Structural Report-Outlining significant alterations

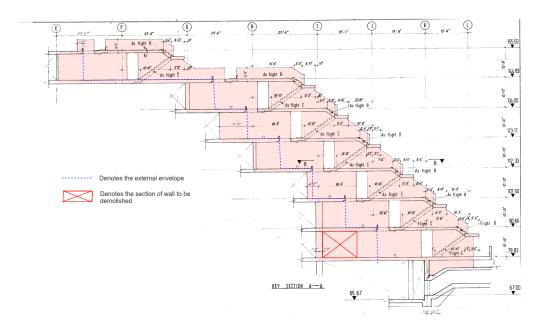
The section of wall that is proposed to be demolished is on grid line 118 at Level 3, the wall itself spans from level 3 up to level 9. The justification for the removal of this section of wall is that the load path will not be significantly altered by the introduction of this opening. This has been proved by finite element modelling this section of the building. From review of the reinforced concrete record drawings it can be seen that the floor plate of both the Level 3 slab and the Level 4 slabs are detailed as if the support provided by this wall was not there, presumably to keep the detailing consistent. Therefore the removal of this section of the wall should not have a detrimental effect to the slabs. However before this work can take place the reinforcement to both Level 3 and Level 4 slabs will have to be determined to verify it as per the record drawings.

Image taken from 1972 record drawing 2550 01/WD17.1 C

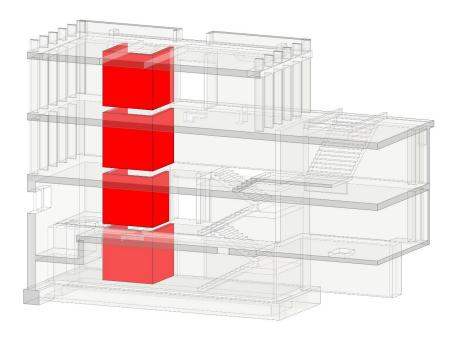
A lift is required to serve Level 2 to Level 4; this will require the formation of a new shaft and the local demolition of the Level 2, 3 & 4 slabs. The positioning of this lift in relation to the column/wall layout is such that the new openings do not require significant strengthening. However this will be provided by the blockwork that will form the shaft wall. Once again from reviewing the reinforced record drawings, it is not deemed providing this shaft is an issue but it has been advised that this reinforcement is verified on site.

Image taken from AECOM Revit model
