Ref: 15/23908-2

**15 LYNDHURST TERRACE,
LONDON NW3 5QA**

BASEMENT IMPACT ASSESSMENT

Revised Submission: March 2017

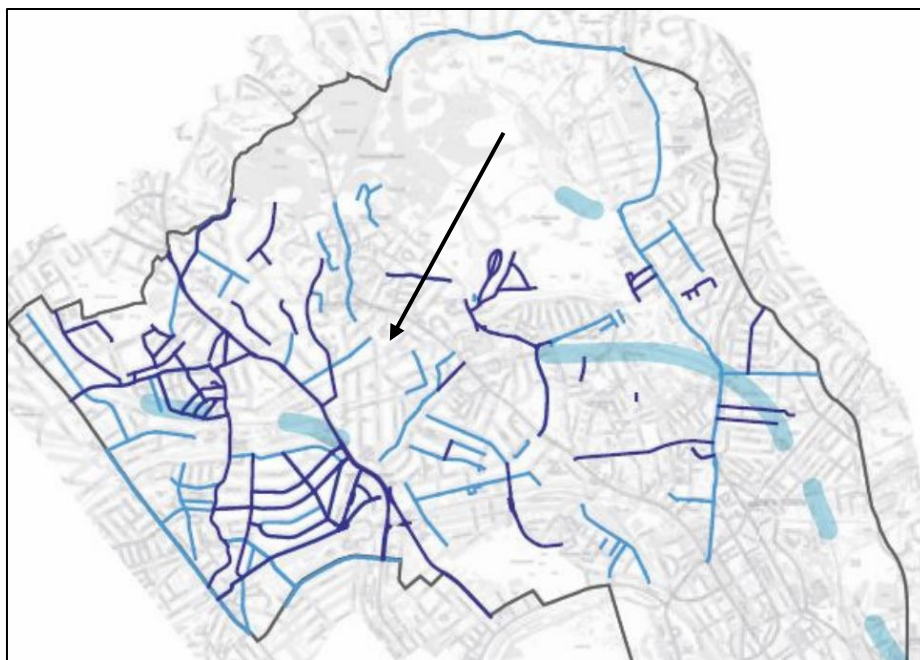
Figure 9. Extract from Figure 15 of the Camden CPG4 showing roads which flooded in 1975 (light blue), in 2002 (dark blue) and 'areas with potential to be at risk from surface water flooding' (wide light blue bands)

Figure 9 shows that Lyndhurst Road did not flood during either the 1975 or the 2002 flood events. The closest road to the property which flooded in either of these events is Arkwright Road located 130m to the north-west which flooded in 1975 and 2002.

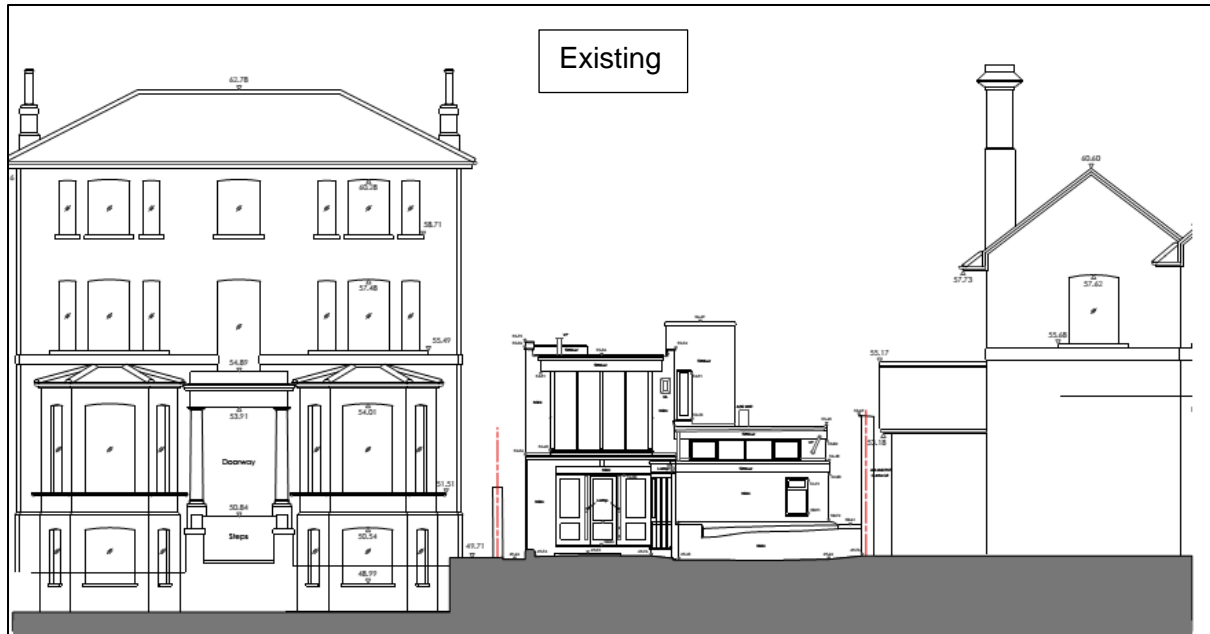
It is proposed to demolish the existing property at the site and construct a new three to four-storey residential property including a single storey basement to 3.00m maximum depth (46.50mSD). Sections showing the existing and proposed layouts are detailed in Figure 10 below.
