project 53 Fitzroy Park

drawing status. project no. 2160751 Preliminary originator. zone. level. role. drg no. revision EW 00 SEC S 3103

APPENDIX B DETERMINATION OF HORIZONTAL TENSILE STRAINS AND DEFLECTION RATIOS

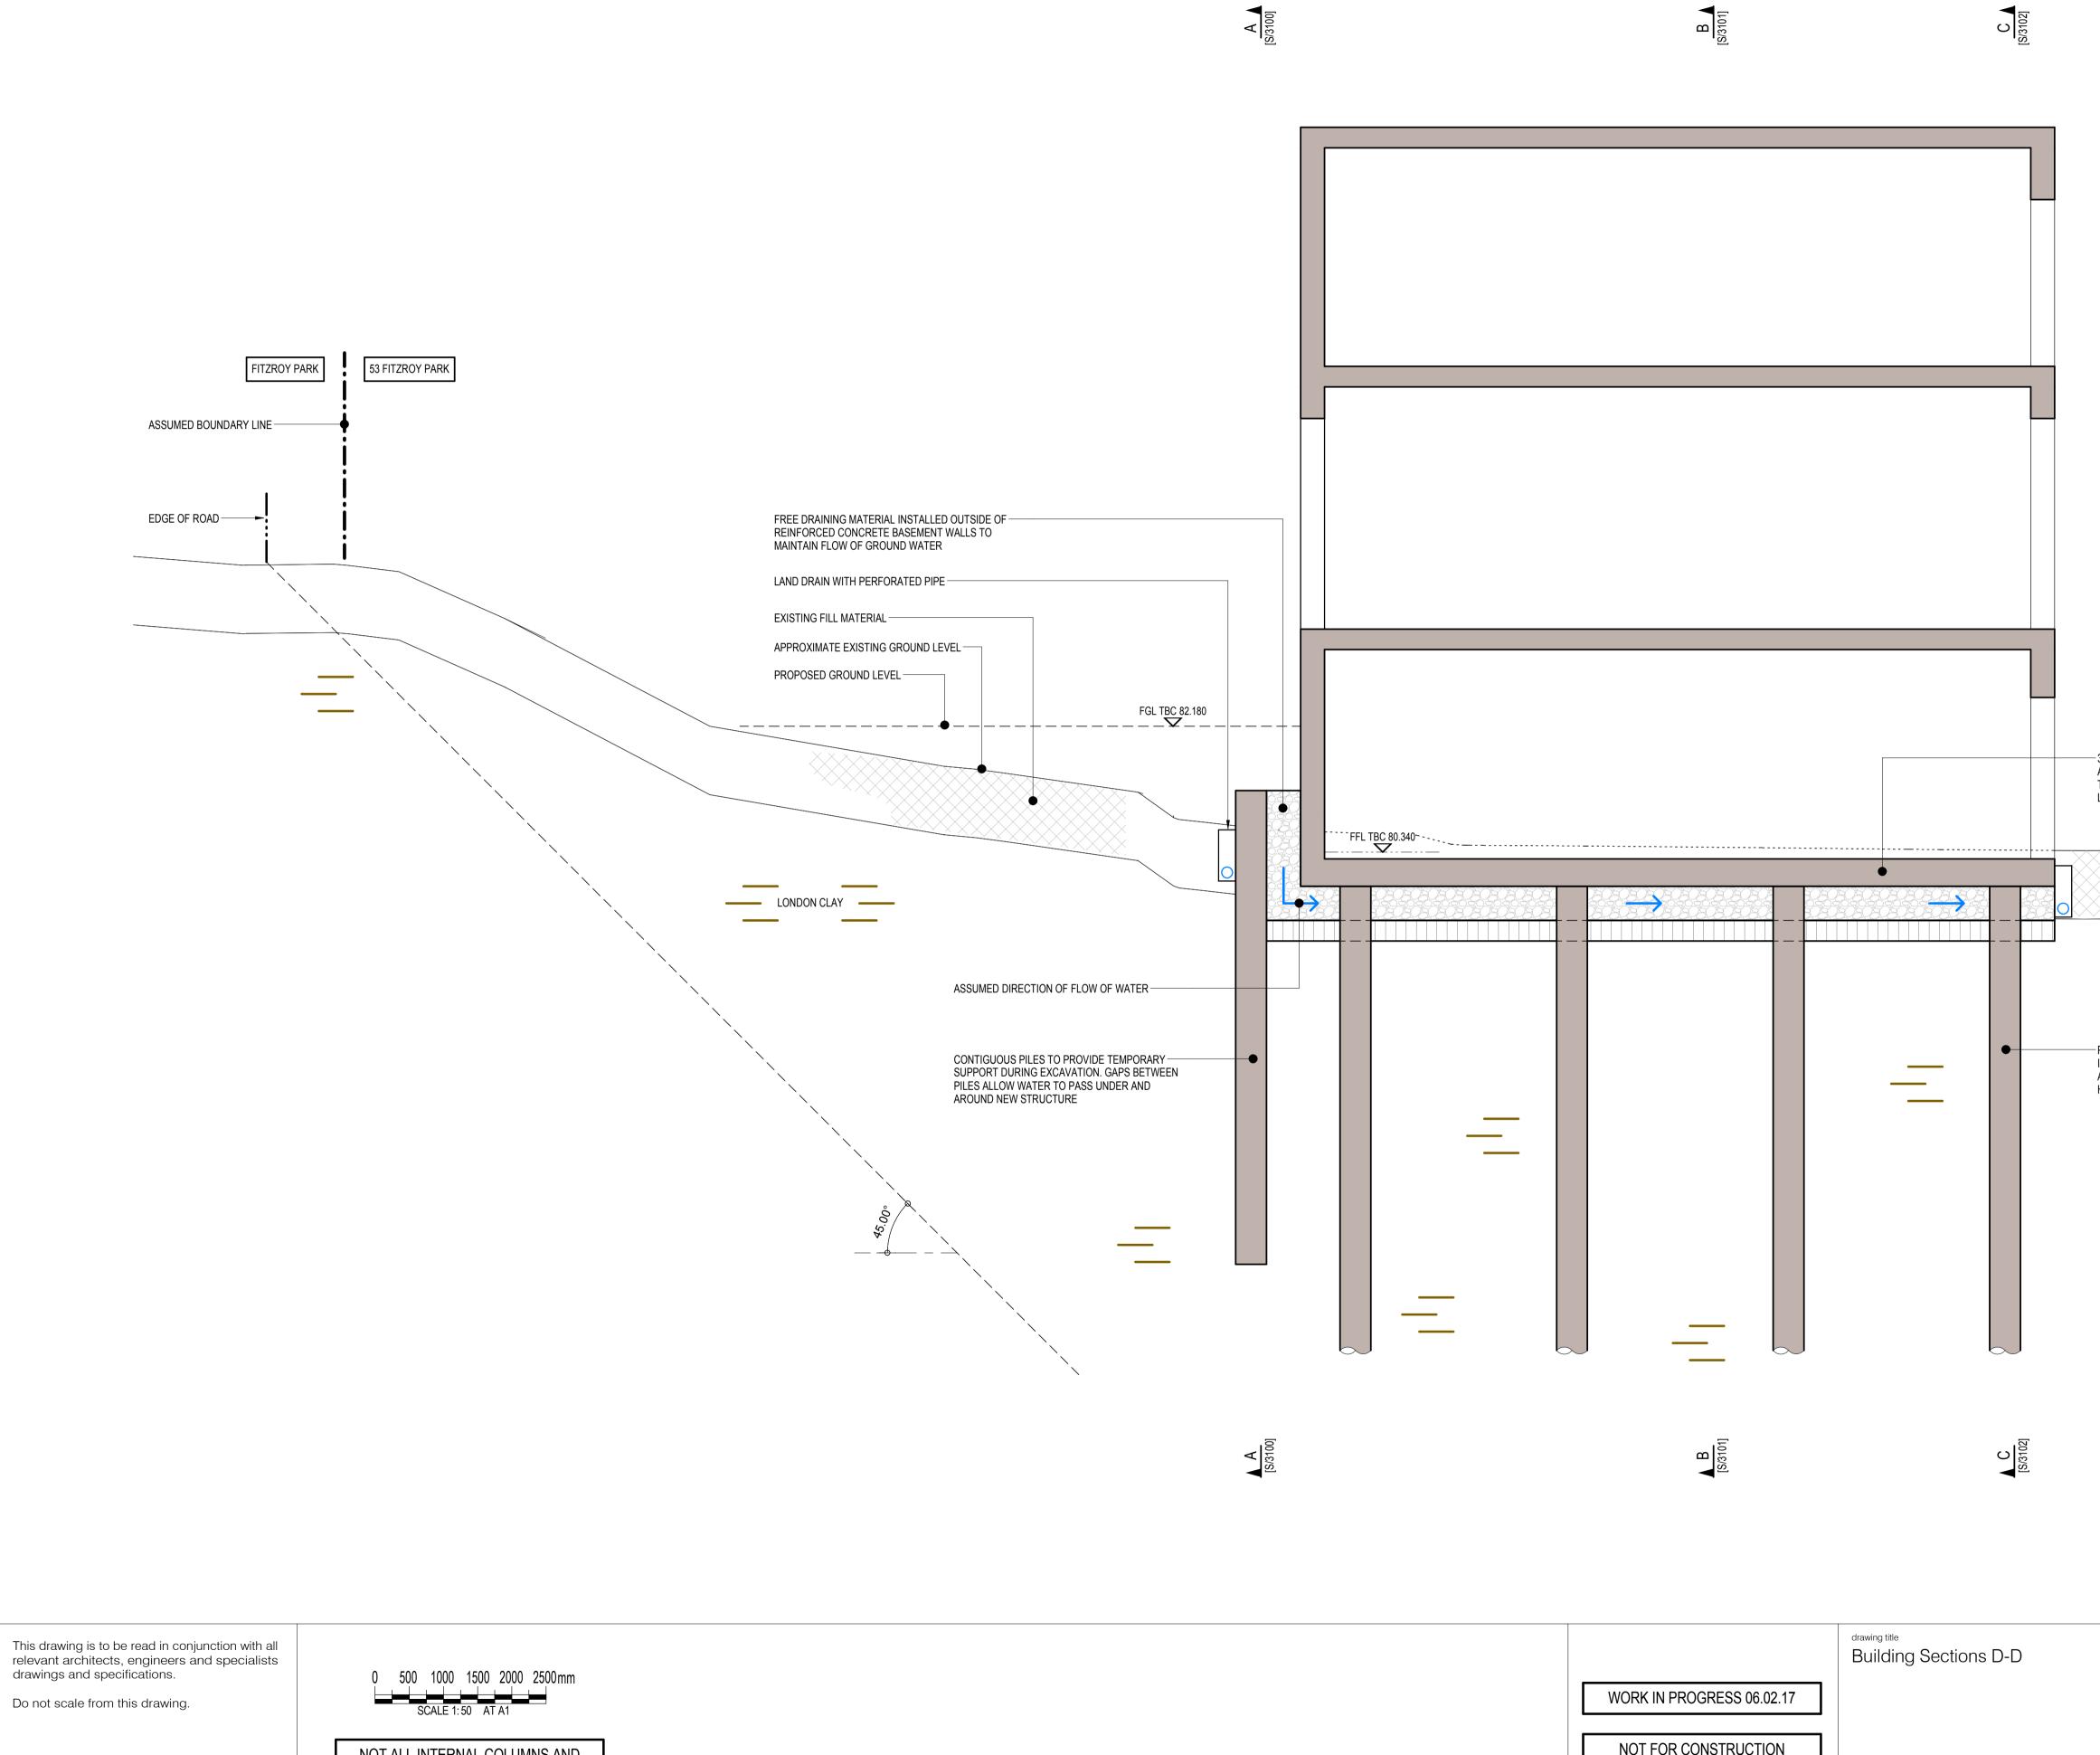
drawing title Building Sec	ctions D-D	
	WORK IN PROGRESS 06.02.17			
	NOT FOR CONSTRUCTION			
		scale (s)	date	drawn
rev	date by chk description	1:50@A1; 1:100@A3	Oct 2014	BMC
		1

NOT ALL INTERNAL COLUMNS AND WALLS SHOWN FOR CLARITY

300mm THICK REINFORCED CONCRETE SLAB ON APPROX 500mm THICK FREE DRAINING MATERIAL TO MAINTAIN GROUND WATER FLOW. CELLCORE LAYER TO DEAL WITH EXPANSIVE SOILS/HEAVE

— PILES TRANSFER VERTICAL BUILDING LOADS INTO GROUND (LONDON CLAY) AND RESIST ANY UPLIFT FORCES ON SLAB DUE TO HYDROSTATIC HEAD OR HEAVE PRESSURE

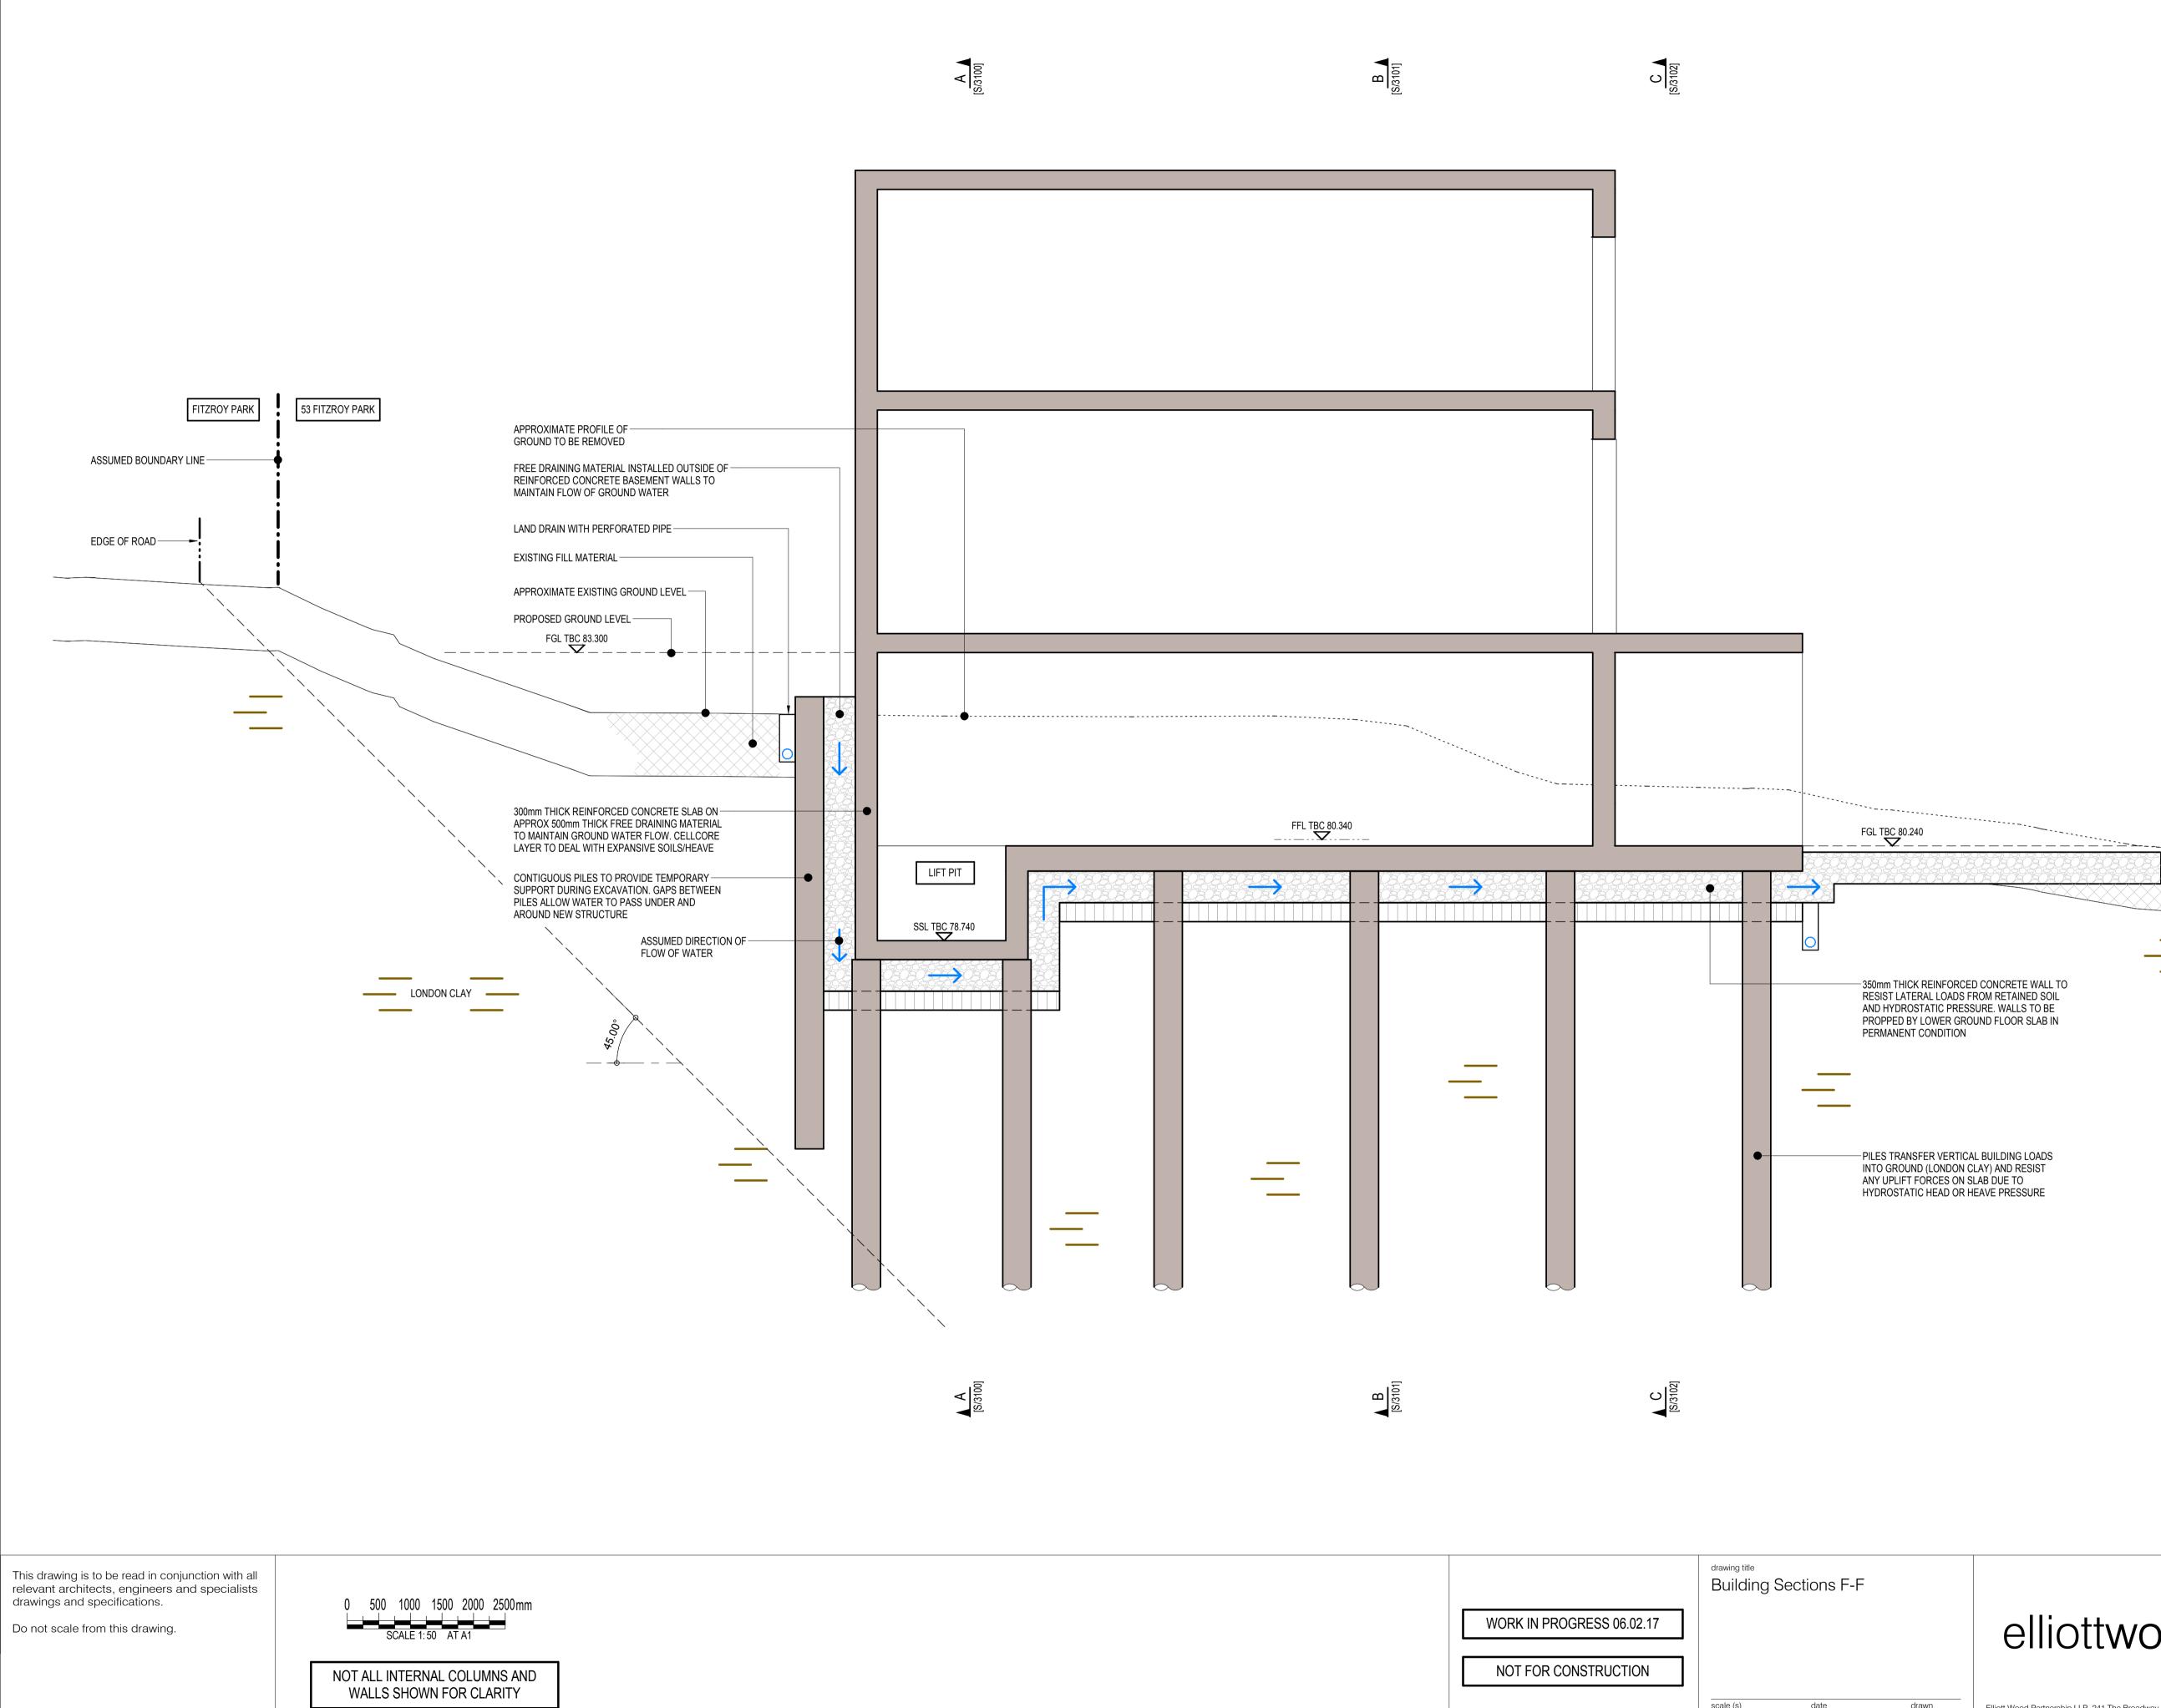
drawing title Building Sec	tions F-F	
WOF	RK IN	PRO	GRESS 06.02.17			
NC	T FOI	R CC	ONSTRUCTION			
ev date	by	chk	description	scale (s) 1:50@A1; 1:100@A3	date Oct 2014	drawn BMC

- 350mm THICK REINFORCED CONCRETE WALL TO RESIST LATERAL LOADS FROM RETAINED SOIL AND HYDROSTATIC PRESSURE. WALLS TO BE PROPPED BY LOWER GROUND FLOOR SLAB IN PERMANENT CONDITION

- PILES TRANSFER VERTICAL BUILDING LOADS INTO GROUND (LONDON CLAY) AND RESIST HYDROSTATIC HEAD OR HEAVE PRESSURE

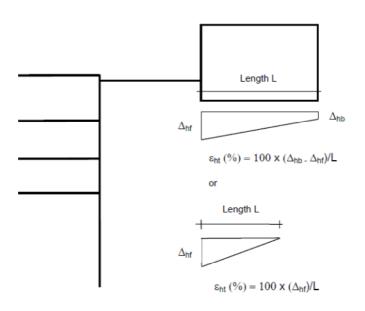
Horizontal Tensile Strain Eht

To determine the resulting horizontal tensile strain that will develop in the adjacent properties, the lateral displacement to the rear of the property (Δ_{hb}) is subtracted from the lateral displacement at the front of the property (Δ_{hf}). The resulting differential lateral displacement is then divided by the length of the property perpendicular to the basement wall to determine the horizontal tensile strain. Where the lateral displacement is zero at the rear of the property the lateral displacement at the front of the property is divided by the distance from the front of the property to the point of zero lateral displacement to determine the lateral strain. This approach is illustrated below and has been adopted for both the lateral displacements caused by wall installation and excavation.

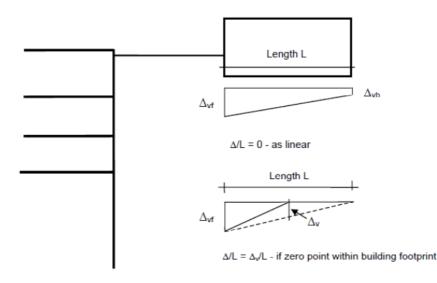
In the case of properties adjacent to a basement excavation the deflection ratio will depend on the distribution of vertical ground movement across its footprint. Reference to Figure 2.8 of CIRIA 580 in fact indicates a linear distribution of settlement due to wall installation with distance from the wall. As such the Deflection Ratio will be zero unless the point at which settlement ceases is within the footprint of the building as illustrated below.
