Project	The Hall School, 23 Crossfield Road NW3 4NU	Project Ref	G1701
Subject	Planning Application 2016/6319/P	Date	08/02/17

1 Introduction and summary of conclusions

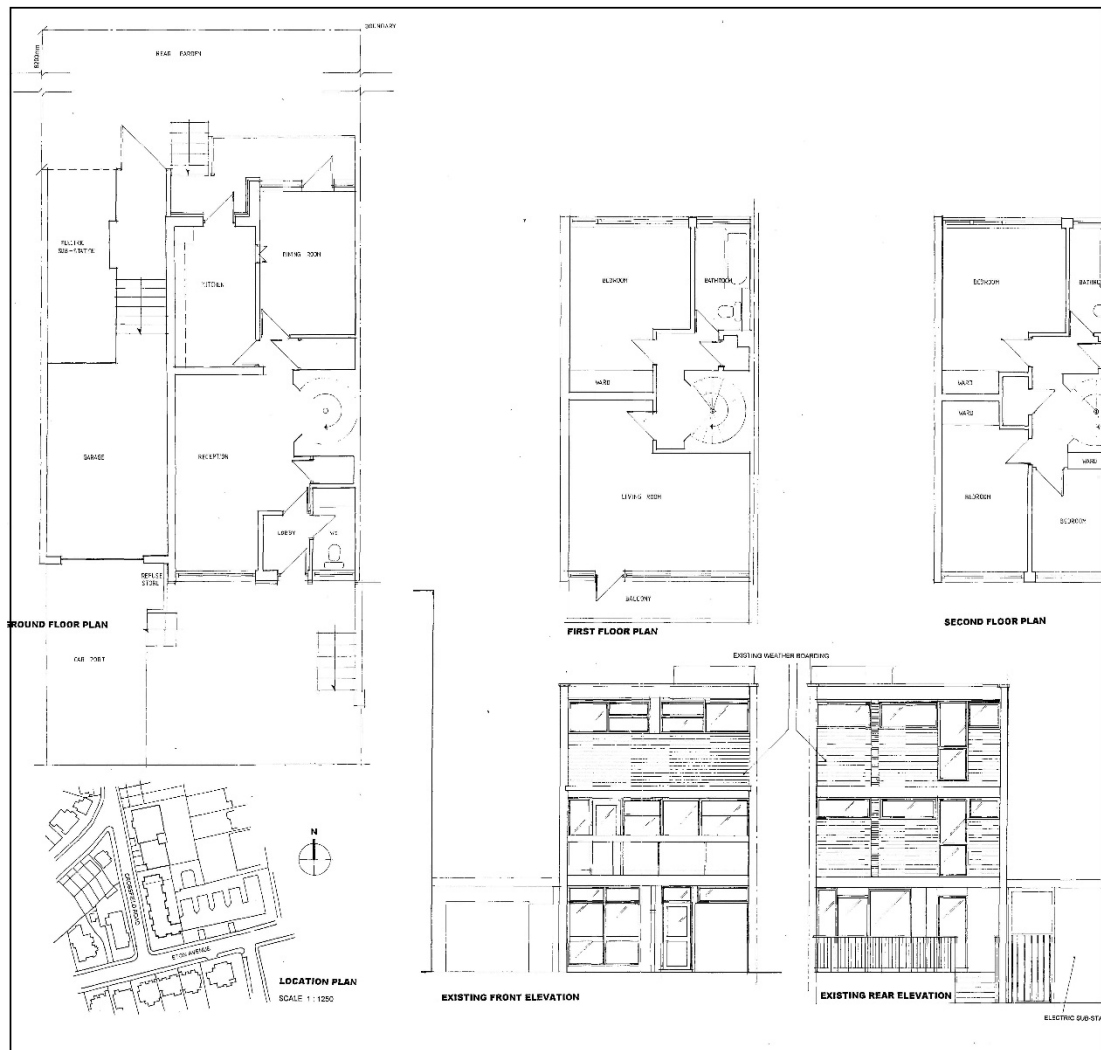
FIGURE 1 Existing arrangement of 24 Crossfield Road 1998

37. Figure 1 below is taken from a 1998 planning application for No.24 and shows the arrangement of the property at that time. The application was to remove the garage and extend to the boundary. It was refused and so the current arrangement is unlikely to differ very much from that shown.
