26 Lower Merton Rise: Basement Impact Assessment Additional Works

Report reference: 62274.00.01R2, July 2017

Basement Impact Assessment: 26 Lower Merton Rise

(Surface Water and Groundwater)

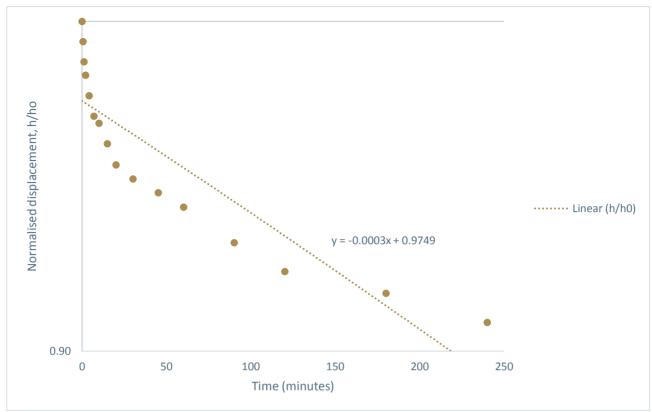
Figure 3

WS1 – Normalised displacement vs Time

Rising head tests were carried out in WS1 and WS2 following the Hvorslev method (1951). This method involves the sudden removal of water and subsequent monitoring of the water level recovery. Figures 3 and 4 show the recovery response of each borehole over 4 hours and the complete purging results are included in Appendix D.

This test was undertaken to determine the recharge rates and Figures 3 and 4 clearly show a slow response over 4 hours. Because of this, the recharge rate in each borehole is not considered to be notable and no further analysis is required.

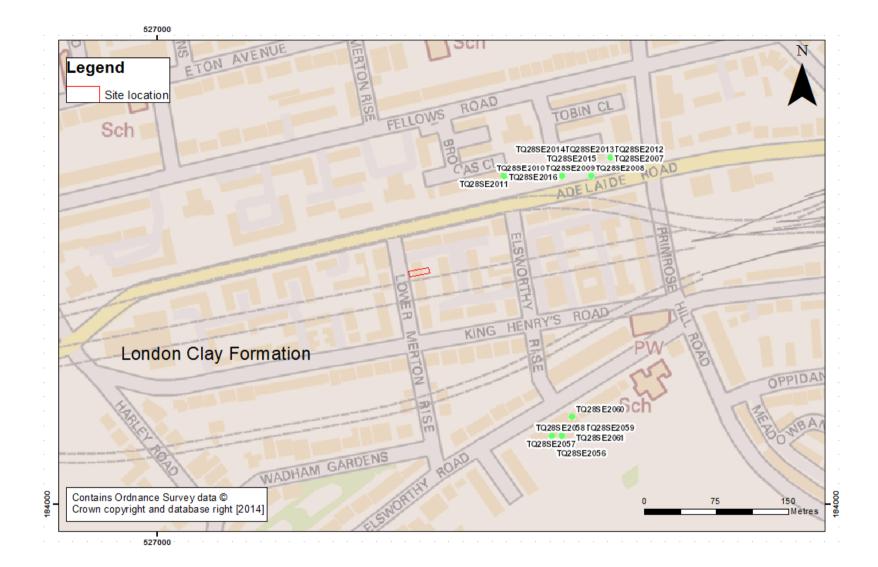
Site geology
