3.3 Existing Buildings and Boundary Conditions

3.3.1 Overview

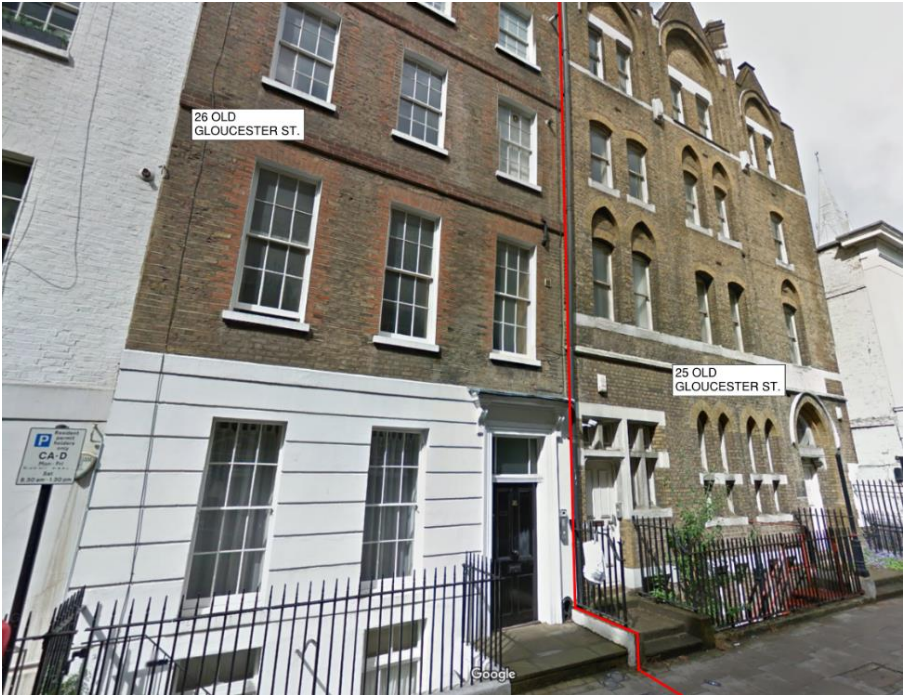
Site Photo 2
Main frontage
26 Old Gloucester St. boundary

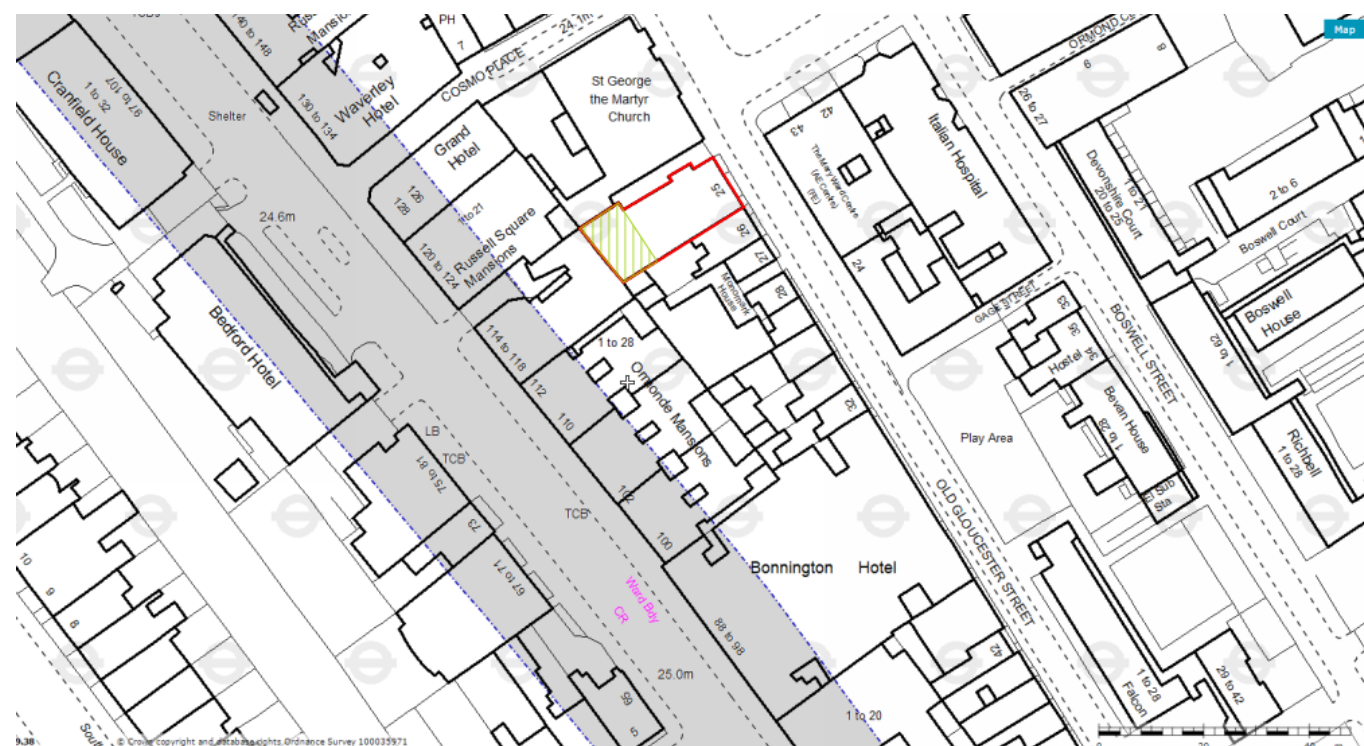
LUL Exclusion Zone Map

The Piccadilly line runs in line Southampton Row which is parallel to Old Gloucester Street. As per the map shown below, the site and proposed works are entirely clear of the LUL exclusion zone and as such will not impact on the LUL assets.

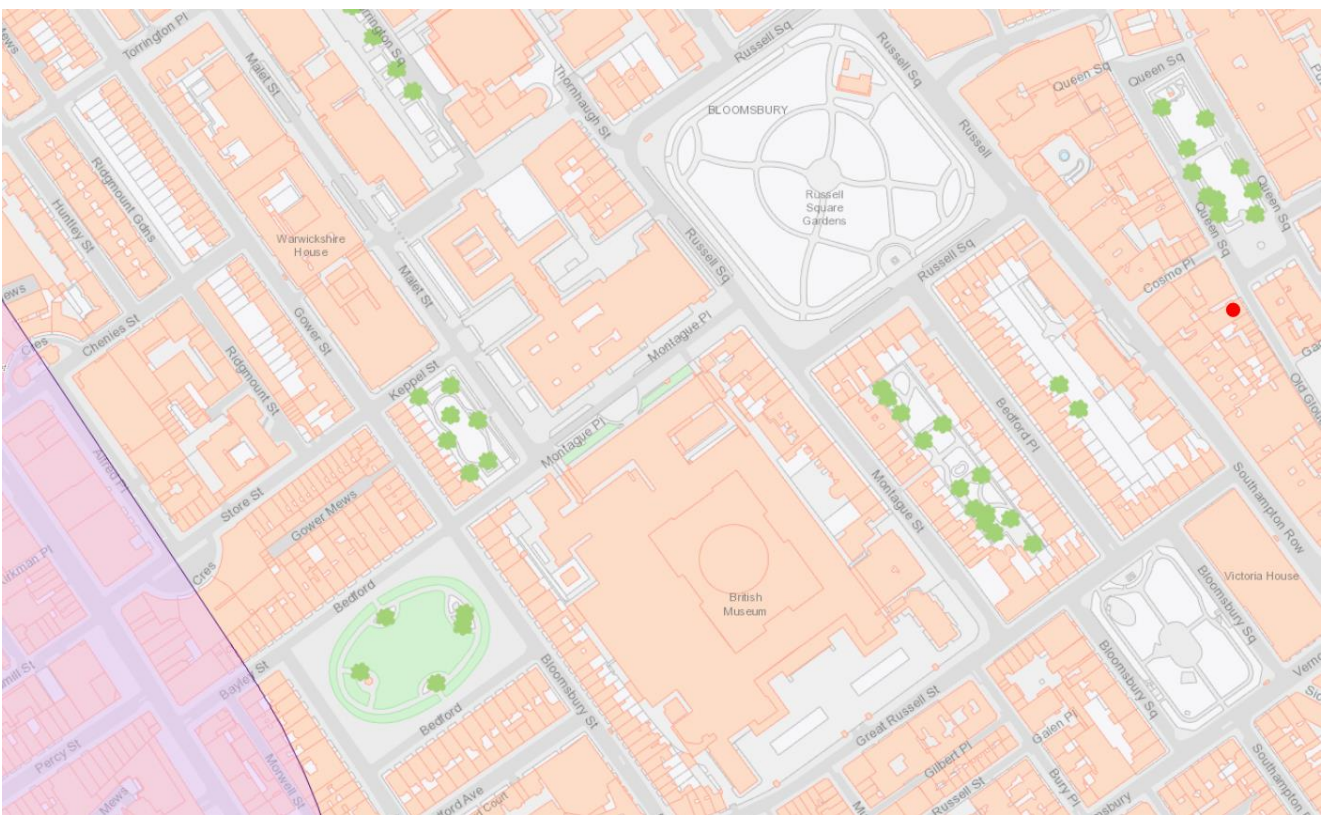
Crossrail 2 Safeguarding Zone Map

As with the existing railways, the site is outside of the safeguarding zone the future development of Crossrail 2, and as such does not impact the development in question.

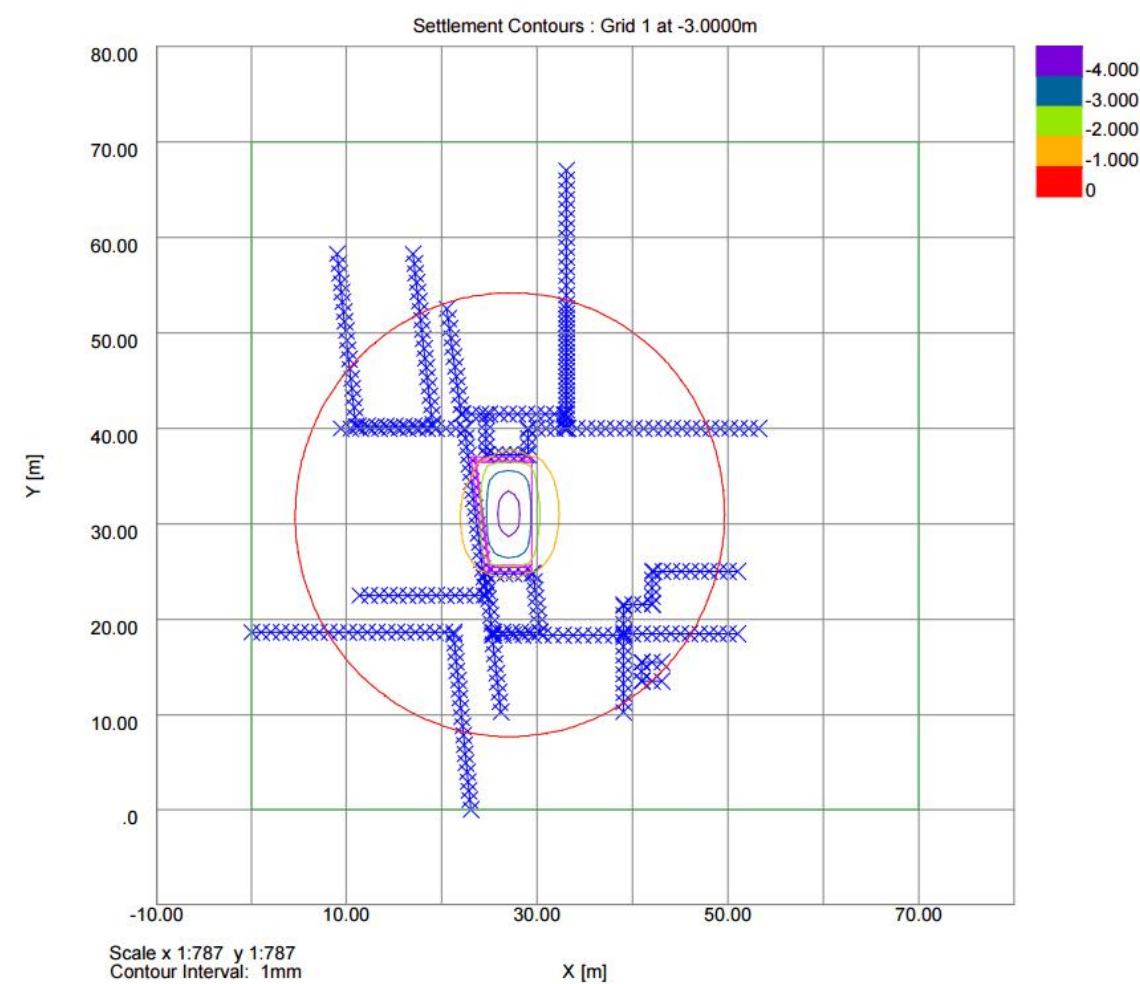
Contours showing short term movements

All projects which involve an appreciable level of excavation will cause a degree of movement and the GEA analysis has helped to quantify this for the project. Generally, the ground behind the retaining wall will tend to move vertically down and horizontally toward the excavation on all sides. The maximum predicted movements are illustrated below.

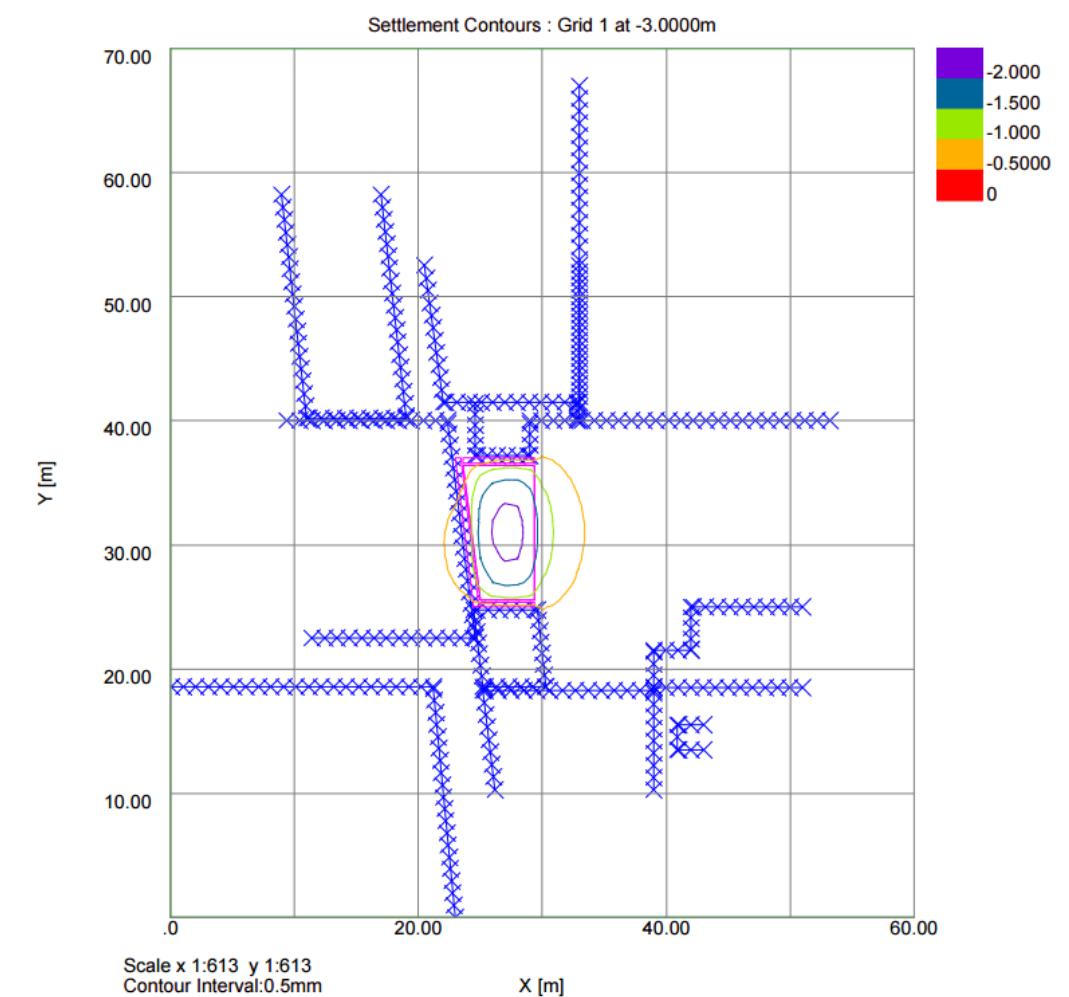
Contours showing overall term movements
