REVISION	DATE	DRAWN	CHECKED	DESCRIPTION	SCALE	DATE
CLIENT					1:50 @ A1/1:100 @ A3	19 May 2010
PROJECT					DRAWN	CHECKED
Dickens Museum		JH	JH			
DRAWING TITLE					JOB NUMBER	DRAWING NO.
As Proposed Lower Ground Floor Plan					232049	200
						Q

# As Proposed Lower Ground Floor

REVISION	DATE	DRAWN	CHECKED	DESCRIPTION	SCALE	DATE
CLIENT					1:50@A1/1:100@A3	19 May 2010
PROJECT					DRAWN	CHECKED
DICKENS MUSEUM		JH	JH			
DRAWING TITLE	JOB NUMBER	DRAWING NO.	REVISION			
As Proposed Ground Plan	232049	201	Q

REVISION	DATE	DRAWN	CHECKED	DESCRIPTION	SCALE	DATE					
K	05/12/2012	AB	JH		1:50@A1/1:100@A3	25 Aug 2010					
J	18/05/2012	JH	DV	Layouts updated to incorporate relocation of exhibition							
I	25/04/2012	GE	DV	Construction Issue							
CLIENT	Focus Consultants (UK) Ltd	PROJECT	Dickens Museum	DRAWING TITLE	As Proposed First Floor Plan	JOB NUMBER	232049	DRAWING NO.	203	REVISION	K

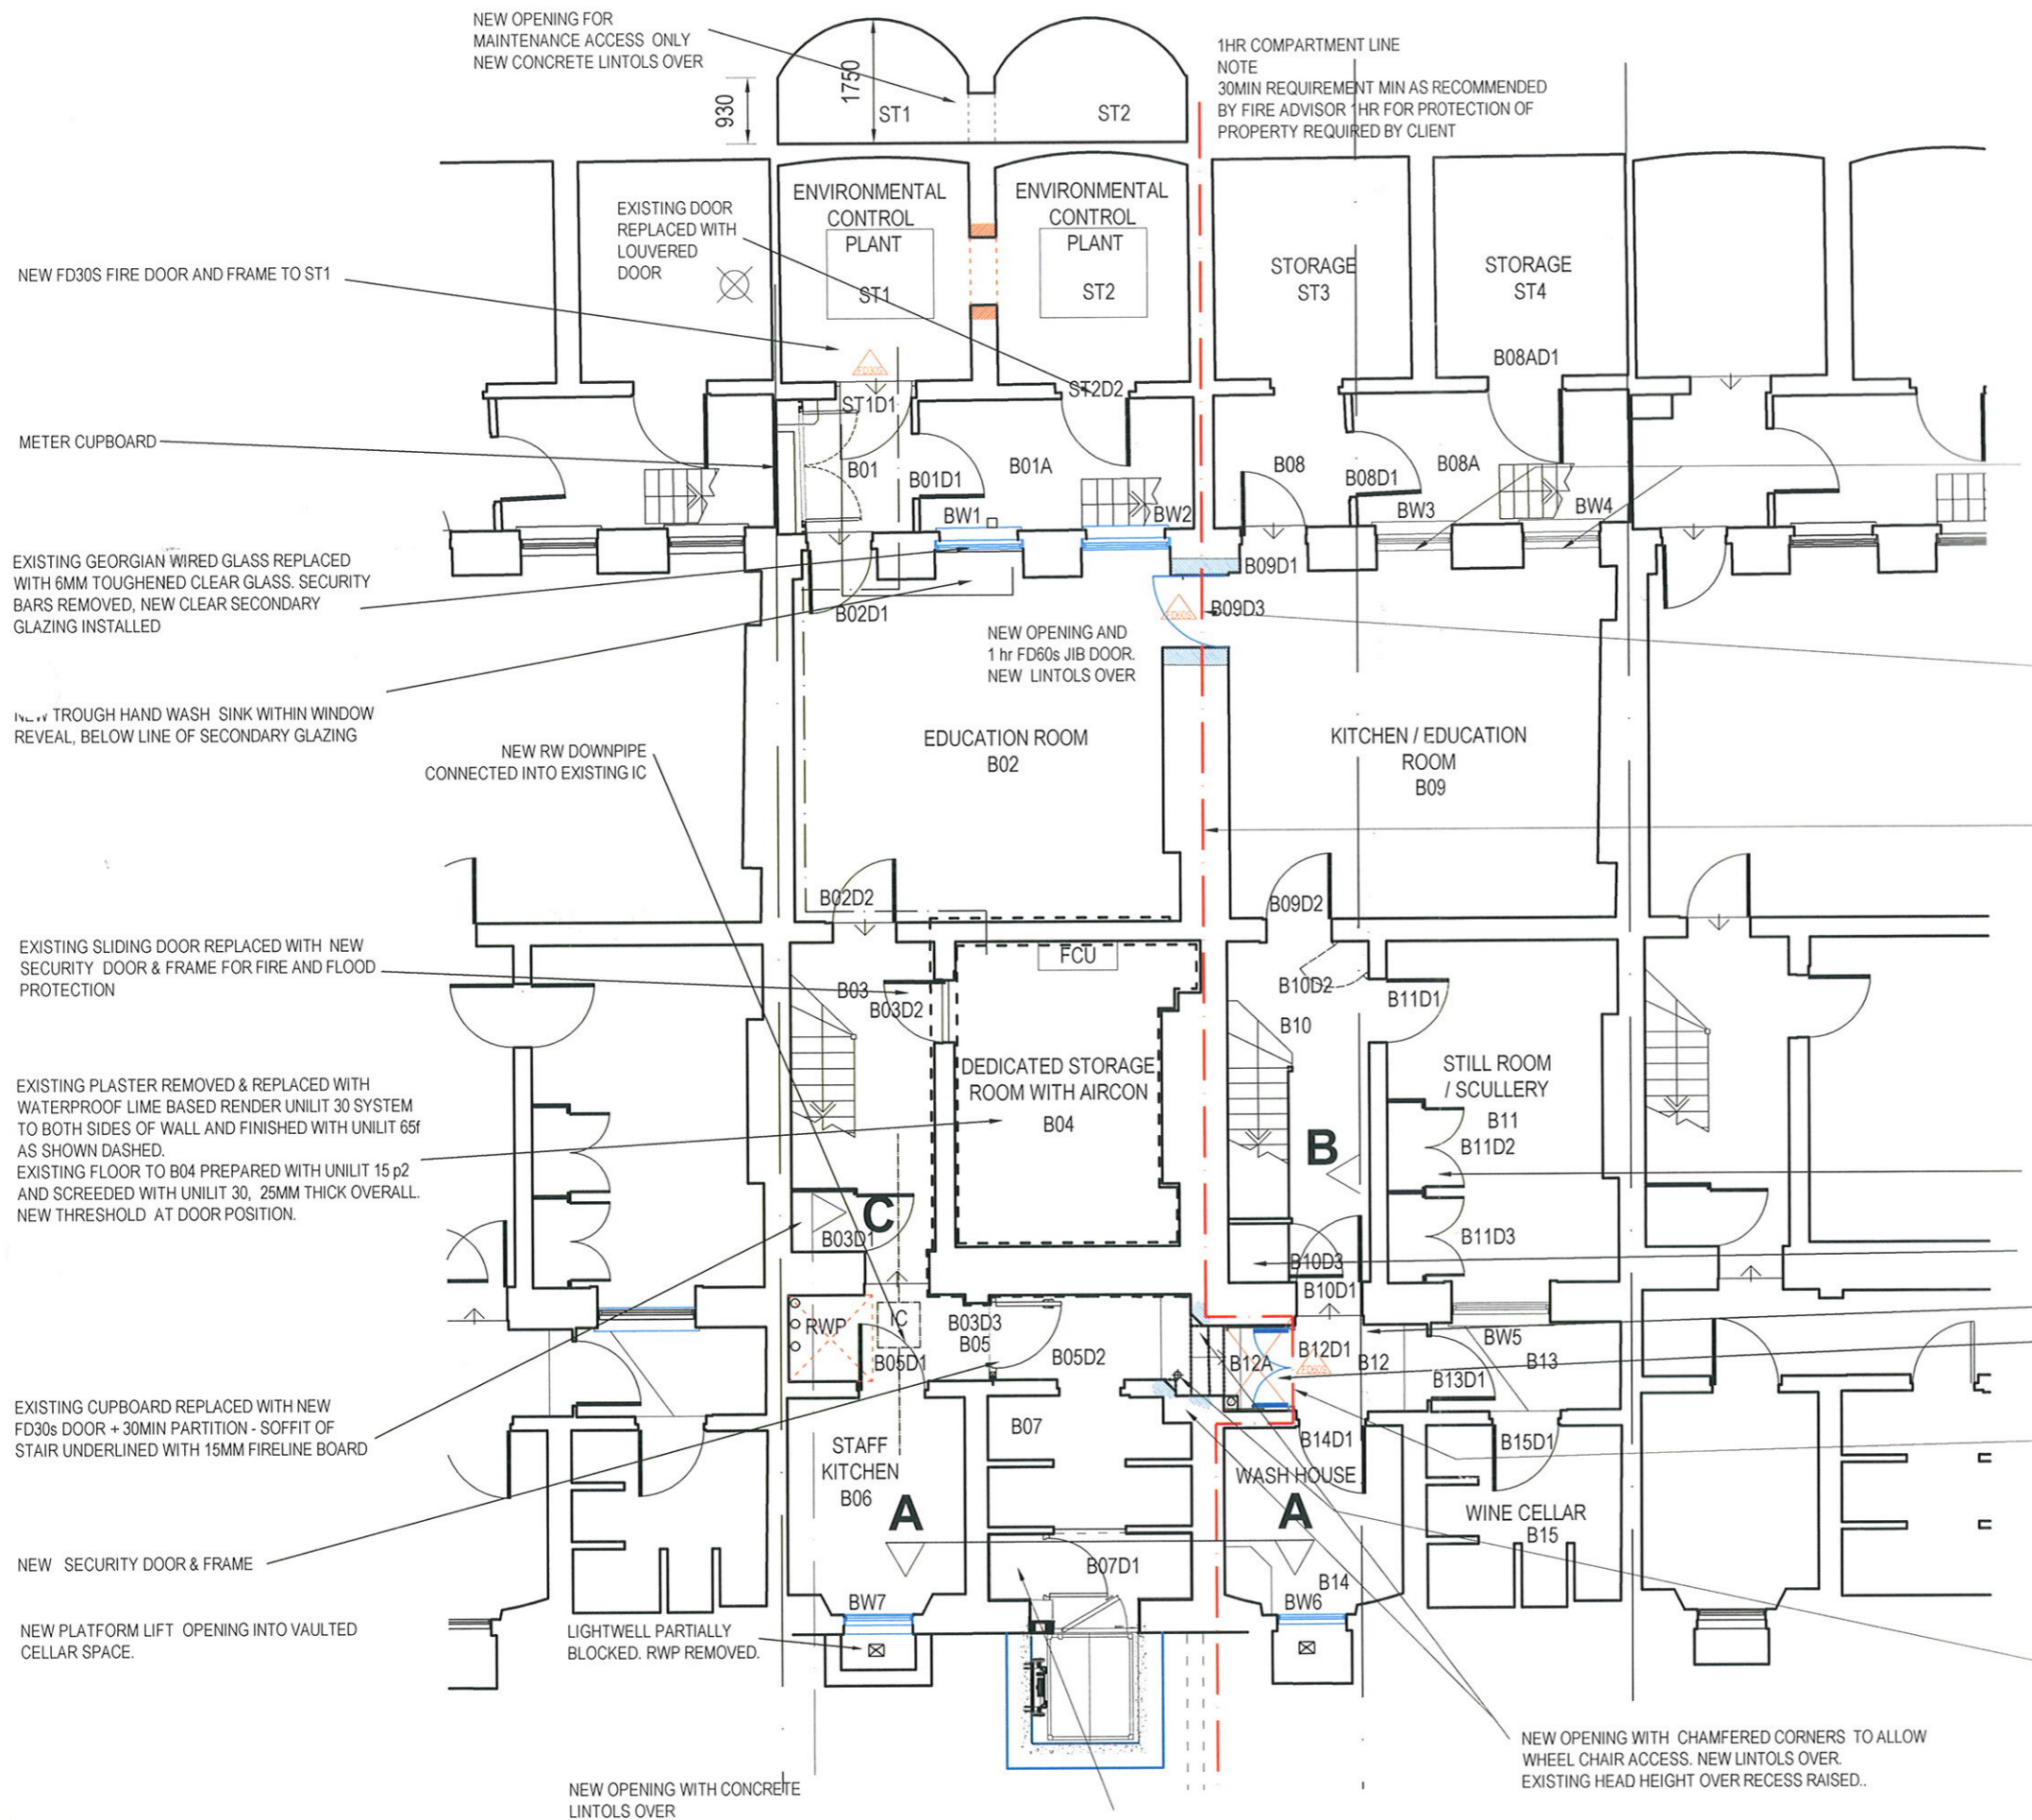
NEW OPENING FOR MAINTENANCE ACCESS ONLY  
NEW CONCRETE LINTOLS OVER

1HR COMPARTMENT LINE  
NOTE  
30MIN REQUIREMENT MIN AS RECOMMENDED  
BY FIRE ADVISOR 1HR FOR PROTECTION OF  
PROPERTY REQUIRED BY CLIENT

NEW FD30S FIRE DOOR AND FRAME TO ST1

EXISTING GEORGIAN WIRED GLASS REPLACED  
WITH 6MM TOUGHENED CLEAR GLASS. SECURITY  
BARS REMOVED, NEW CLEAR SECONDARY  
GLAZING INSTALLED

NEW TROUGH HAND WASH SINK WITHIN WINDOW  
REVEAL, BELOW LINE OF SECONDARY GLAZING

EXISTING SLIDING DOOR REPLACED WITH NEW  
SECURITY DOOR & FRAME FOR FIRE AND FLOOD  
PROTECTION

EXISTING PLASTER REMOVED & REPLACED WITH  
WATERPROOF LIME BASED RENDER UNILIT 30 SYSTEM  
TO BOTH SIDES OF WALL AND FINISHED WITH UNILIT 65f  
AS SHOWN DASHED.  
EXISTING FLOOR TO B04 PREPARED WITH UNILIT 15 p2  
AND SCREEDED WITH UNILIT 30, 25MM THICK OVERALL.  
NEW THRESHOLD AT DOOR POSITION.

EXISTING CUPBOARD REPLACED WITH NEW  
FD30s DOOR + 30MIN PARTITION - SOFFIT OF  
STAIR UNDERLINED WITH 15MM FIRELINE BOARD

NEW PLATFORM LIFT OPENING INTO VAULTED  
CELLAR SPACE.

AREA TO BE RENDERED OUT WITH UNILIT 30 TO  
WALLS, CEILING AND FLOOR.  
FLOOR TO CUPBOARD AREA ONLY. NEW  
LOUVERED DOOR AND FRAME. LIFT CONTROL  
BOX TO BE FIXED BACK TO 25mm WBP PLY  
BACKING BOARD FIXED THROUGH RENDER.  
SEE LIFT DRAWING

NEW JIB DOOR B02 / B09 ON LINE OF  
NEW COMPARTMENT LINE FD60S.  
DOOR TO BE KEPT CLOSED.

30MIN COMPARTMENT LINE  
REQUIRED BY FIRE OFFICER.  
UPGRADED TO PROVIDE 60MIN  
FOR ENHANCED PROPERTY  
PROTECTION

EXISTING WC REMOVED AND NEW  
STRUCTURAL OPENING FORMED TO  
ALLOW WHEELCHAIR ACCESS TO No.  
48. APPROX 80mm RAMP UP.

EXISTING DOOR, FRAME AND FIXED  
PANEL REMOVED.  
NEW 1 HR DOUBLE FIRE DOOR ON  
ELECTRONIC HOLD BACKS ON FIRE  
COMPARTMENT LINE  
CEILING / FLOOR OVER LOBBY  
UPGRADED TO PROVIDE 1HR FIRE  
PROTECTION

NEW OPENING WITH CHAMFERED CORNERS TO ALLOW  
WHEEL CHAIR ACCESS. NEW LINTOLS OVER.  
EXISTING HEAD HEIGHT OVER RECESS RAISED..

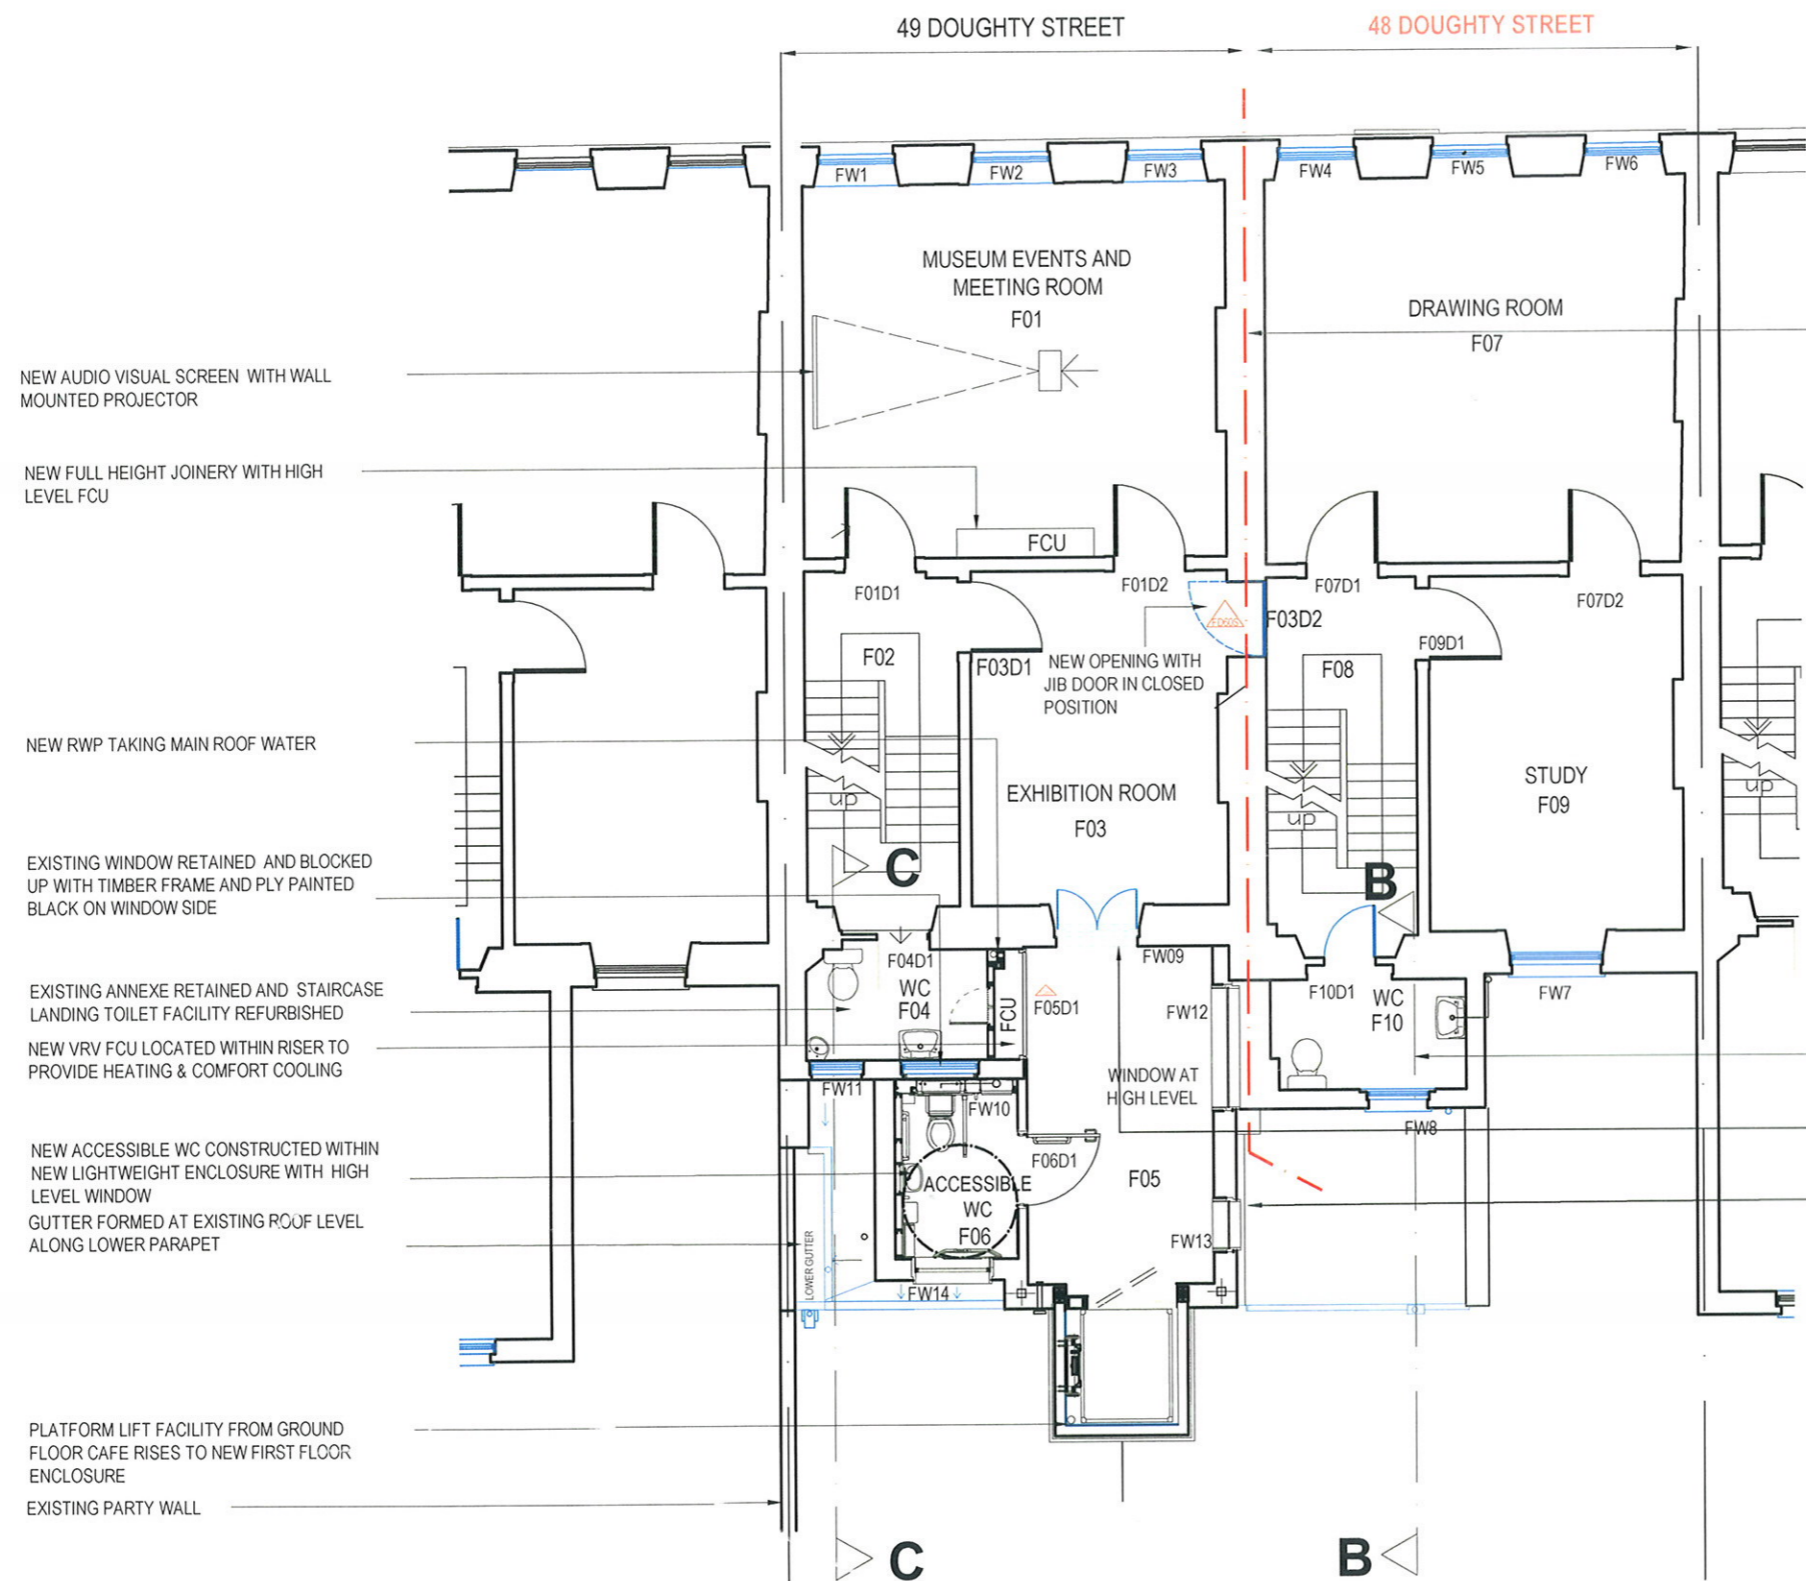
# As Proposed First Floor

NEW AUDIO VISUAL SCREEN WITH WALL MOUNTED PROJECTOR

NEW FULL HEIGHT JOINERY WITH HIGH LEVEL FCU

NEW RWP TAKING MAIN ROOF WATER

EXISTING WINDOW RETAINED AND BLOCKED UP WITH TIMBER FRAME AND PLY PAINTED BLACK ON WINDOW SIDE

EXISTING ANNEXE RETAINED AND STAIRCASE LANDING TOILET FACILITY REFURBISHED

NEW VRV FCU LOCATED WITHIN RISER TO PROVIDE HEATING & COMFORT COOLING

NEW ACCESSIBLE WC CONSTRUCTED WITHIN NEW LIGHTWEIGHT ENCLOSURE WITH HIGH LEVEL WINDOW  
GUTTER FORMED AT EXISTING ROOF LEVEL ALONG LOWER PARAPET

PLATFORM LIFT FACILITY FROM GROUND FLOOR CAFE RISES TO NEW FIRST FLOOR ENCLOSURE

30MIN COMPARTMENT LINE REQUIRED BY FIRE OFFICER. UPGRADE TO PROVIDE 60MIN FOR ENHANCED PROPERTY PROTECTION

NEW JIB DOOR TO F03 / F08 ON LINE OF NEW COMPARTMENT LINE FD60s. DOORS HELD OPEN ON NEW FLUSH WALL MOUNTED ELECTROMAGNETIC HOLD OPENS. CONCEALED OVERHEAD CLOSER WITH FIRE & SMOKE SEALS. DOOR OPENING WITH PUSH PAD ENTRY

SASH WINDOW ADAPTED TO ALLOW INTRODUCTION OF NEW DOORS BELOW WITH CLEAR HEAD ROOM TO FIT BELOW MEETING RAILS

NEW TIMBER CLAD ENCLOSURE BUILT UP OFF NEW STEELS INDEPENDANT OF EXISTING STRUCTURE  
PARAPET WALLS RETAINED.  
NEW TREATED SW FASCIA AND ALUMASC CI GUTTERS.  
NEW ALUMASC CI. HOPPER AND DOWNPIPE.

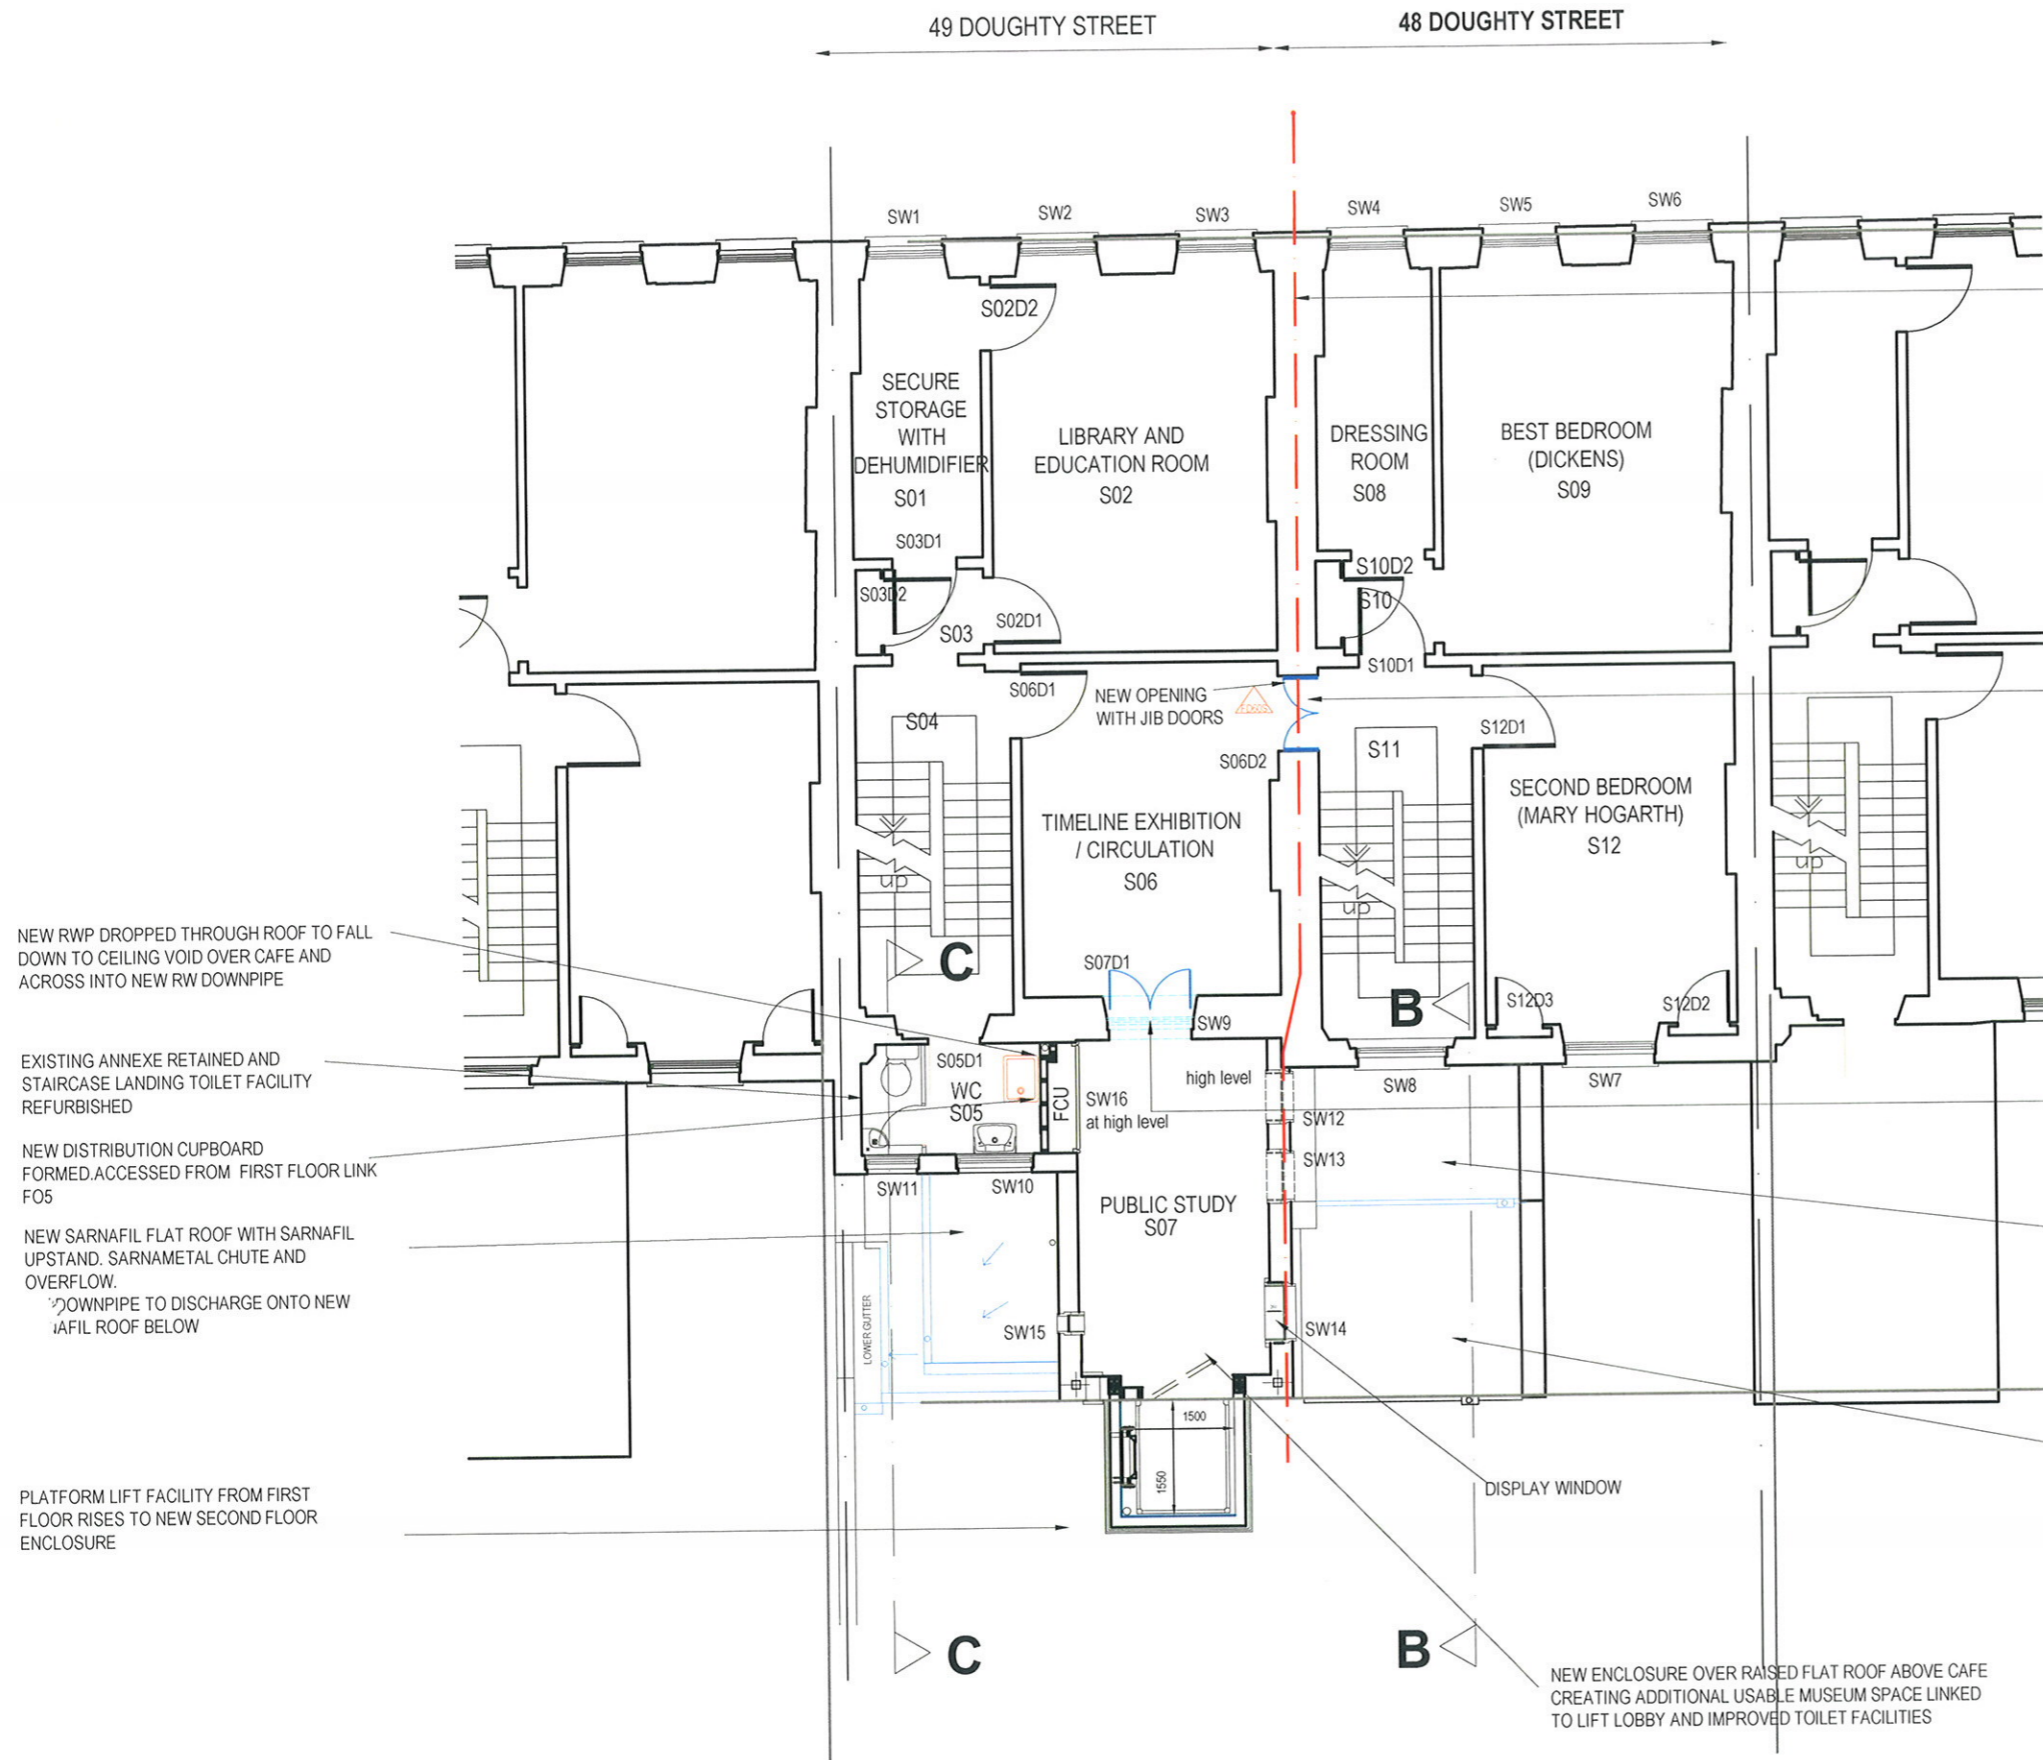
NEW RWP DROPPED THROUGH ROOF TO FALL DOWN TO CEILING VOID OVER CAFE AND ACROSS INTO NEW RW DOWNPIPE

EXISTING ANNEXE RETAINED AND STAIRCASE LANDING TOILET FACILITY REFURBISHED

NEW DISTRIBUTION CUPBOARD FORMED, ACCESSED FROM FIRST FLOOR LINK F05

NEW SARNAFIL FLAT ROOF WITH SARNAFIL UPSTAND, SARNAFIL CHUTE AND OVERFLOW.  
DOWNPIPE TO DISCHARGE ONTO NEW SARNAFIL ROOF BELOW

PLATFORM LIFT FACILITY FROM FIRST FLOOR RISES TO NEW SECOND FLOOR ENCLOSURE

30MIN COMPARTMENT LINE REQUIRED BY FIRE OFFICER. UPGRADE TO PROVIDE 60MIN FOR ENHANCED PROPERTY PROTECTION

NEW UPPER SASH WINDOW INSTALLED. EXISTING SASHES PUT IN STORAGE AND NEW 2 LIGHT SASH MADE UP TO MATCH TO PROVIDE ADEQUATE HEADROOM UNDER.

NEW TIMBER CLAD ENCLOSURE BUILT UP OFF NEW STEELS INDEPENDENT OF EXISTING STRUCTURE. PARAPET WALLS RETAINED. REPLACE 2 NO BAYS OF LEAD WITH CODE 6 AND FOR NEW CODE 5 LEAD FLASHINGS NEW TREATED SW FASCIA AND ALUMASC CI GUTTERS. NEW ALUMASC CI. HOPPER AND DOWNPIPE.

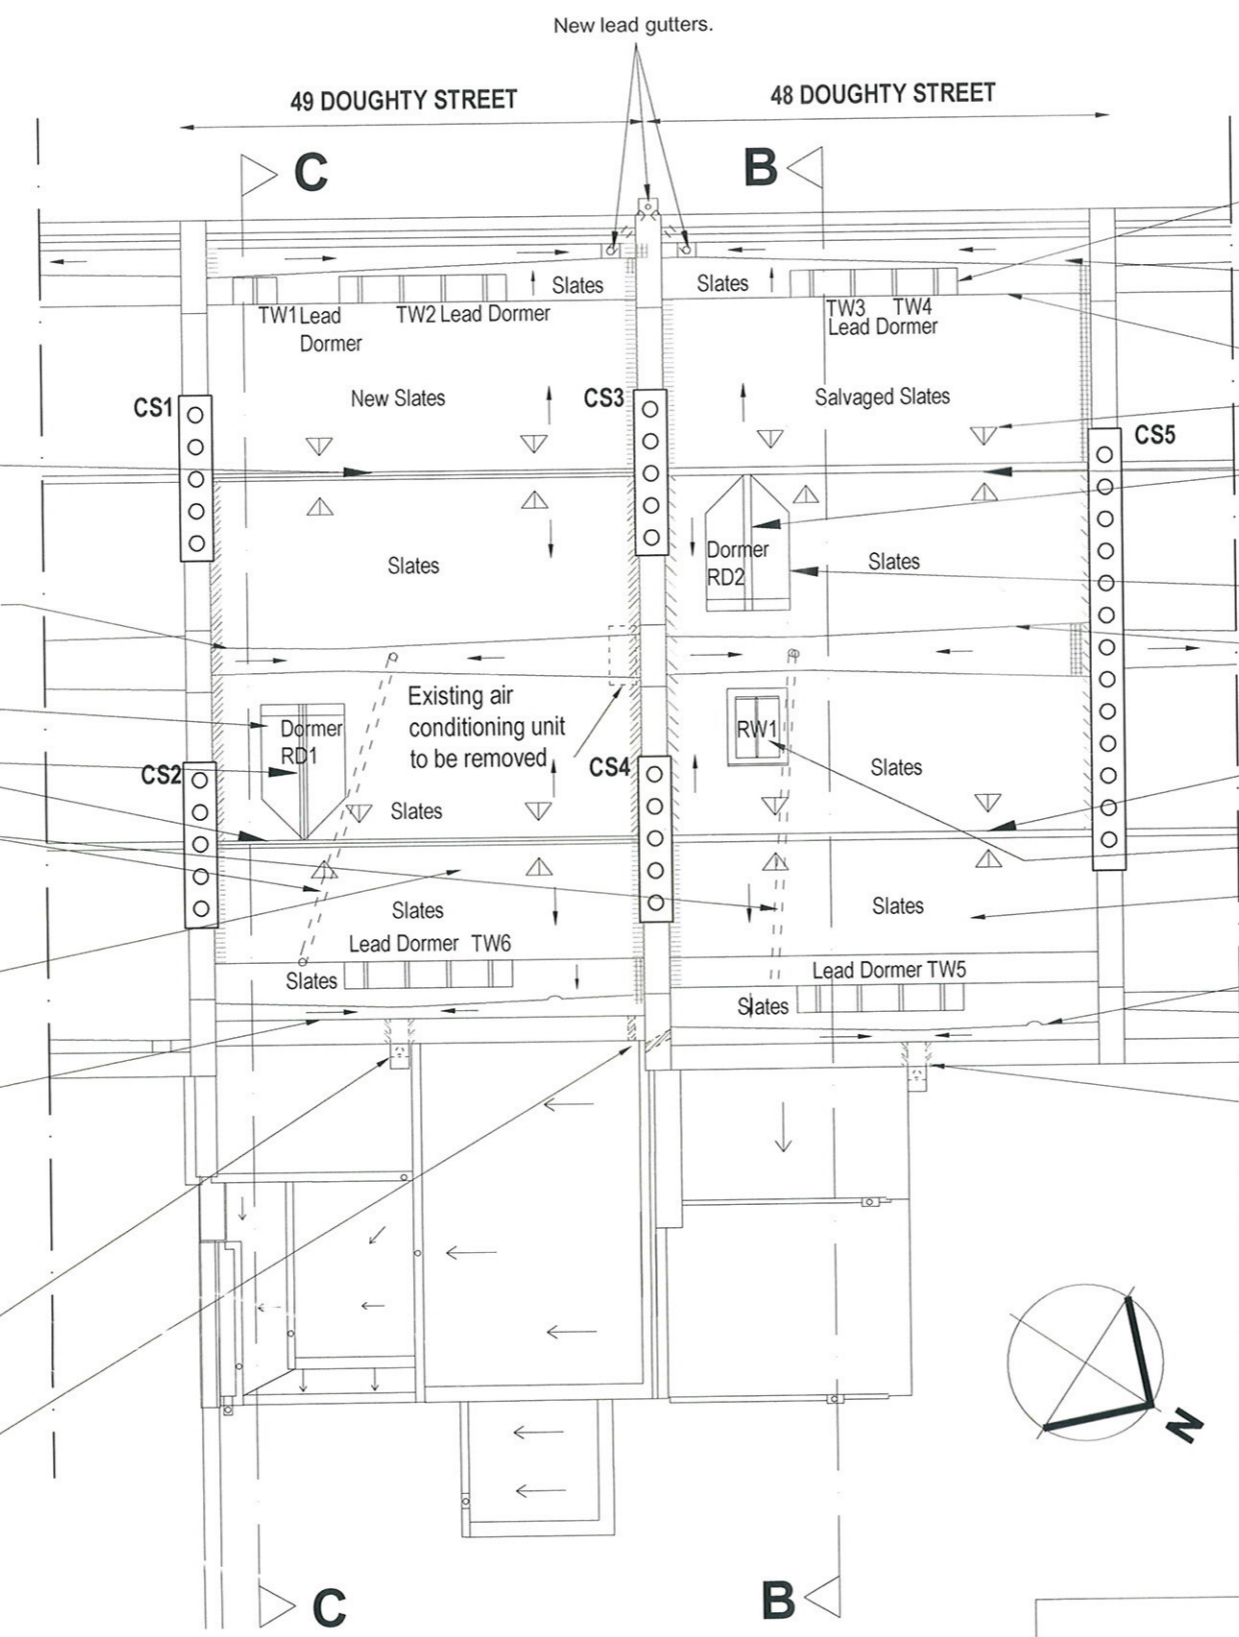
- New lead gutters.
- Dormer windows replaced
- All dormers structural (front+rear) repaired + re-leaded
- Salvaged slates reused on mansard roofs and outer main slopes (front elevation priority).

- New lead trip detail on all mansard pitch change
- New lead hood ventilator
- Red clay half round ridge tiles
- Gutters replaced with Sarnafil.
- Access to roof void only.

- Red clay half round ridge tiles
- New conservation roof light
- Existing lead lined trough replaced with new Sarnametal enclosed pipe discharges out at charge of pitch as existing.

- Existing gutter stripped complete. Gutter boards and supports replaced. New gutter laid to falls on 22mm WBP Ply on 50 x 75mm nogging.
- Existing opening widened to form new Sarnametal chute and overflow

Roof light RW1 replaced with Conservation roof light, double glazed with security looks

- Existing stepped lead flashing replaced with code 3 soakers + code 5 lead stepped flashing
- Existing straight lead flashing or band replaced with code 3 soakers + stepped code 5 lead flashing
- Existing cement fillet removed with new code 3 lead soakers and code 5 lead stepped flashing
- Existing plastered parapet party walls to be.....

Existing gutter stripped. Gutter boards replaced and supports replaced. New gutter laid to falls on 22mm WBP Ply on 50 x 75mm nogging.

Existing hopper + rainwater pipe removed. Holes in parapet blocked with stock bricks to match. New RWP drops down through S05 roof + down to ceiling void over cafe (see GF Plan)

All slate roofs re-slatted using new Welsh slate to match existing. Main slope is cold roof construction with Vented gutter detail + new lead vents @ high level 2no to each slope. 100mm Rookwool insulation laid between + 200mm quilt insulation to be laid over existing floor joists. Existing Insulation to be removed to allow inspection of ceiling joists.
