**Design and Access Statement and Heritage Statement
for works to Grade 2 Listed Building**

0381-DAS 05

June 2017.

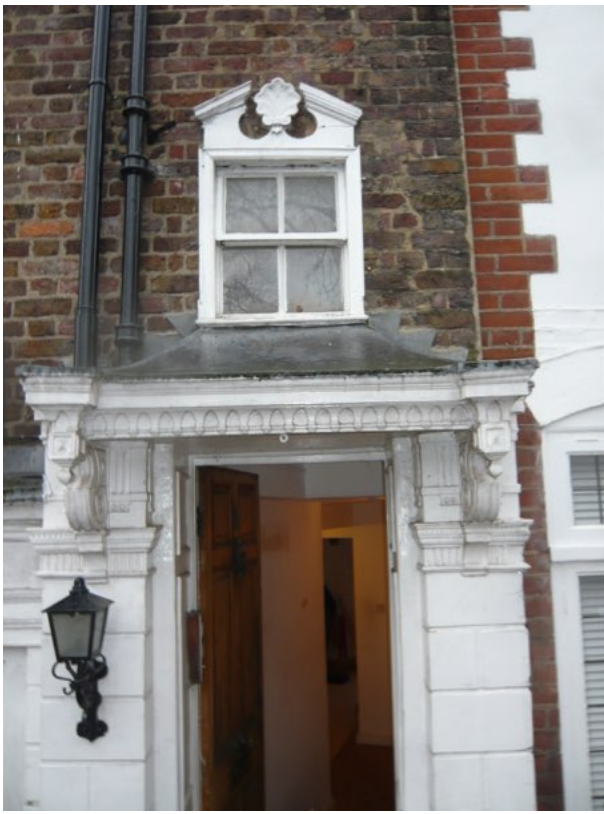
- 2.1. The 3 storey building with a roof terrace fronts Perrins Walk, a private cobbled street off Heath St as described briefly above.
- 2.2. The ground floor rendered frontage to Perrins Walk has a garage door to the left, a row of 3 linked sashes with rendered panel below, and the main entrance to the right. The door case has channelled pilasters and enriched console brackets supporting an enriched hood, with panelled reveals and door, which from the differences between the 1972 and 1973 drawings may have been added in 1973. Channelled Pilasters also flank the garage entrance and support an entablature with a patterned frieze.

The floor level at the door is set set 4 steps higher than the garage door threshold. The 3 linked sashes were apparently installed in 1973 following consent CTP/E6/23/16/16164, which converted a former garage to this kitchen. The drawing is available on the councils website, and it is extracts from this that are included within this report.

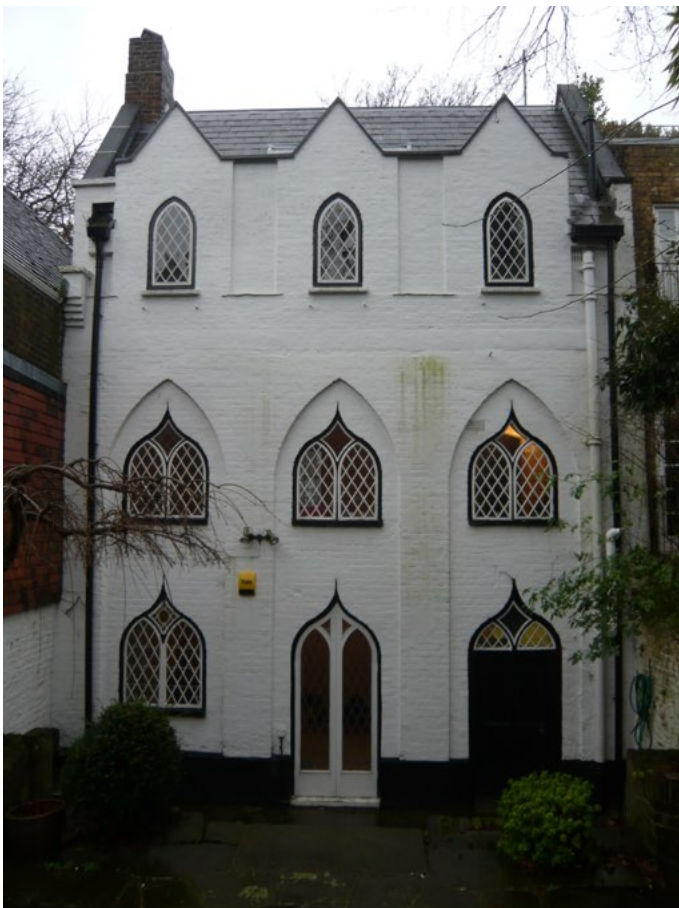
REAR ELEVATION

This later section and stair may have been constructed to give independent access to the rear and upper floors over a coach house/garage retained at ground floor level. The later canopy over the door conceals a lower pair of panes to the window above. The small windows above this are aluminium framed single glazed windows. The front timber double hung sliding sash windows are in need of refurbishment.

- 2.5. The rear, later Gothick elevation is considered to be the most significant element of the heritage asset. This is primarily painted white with ground and first floor ogee windows in arched recesses with black highlights. Tabled attic windows have lancet lights and leaded panes. The top of the lead capped parapet wall forms 3 false gables set directly above each arched window. Windows are metal single glazed with small diamond shaped glazing. At Ground and first floor, the frames are entirely iron,

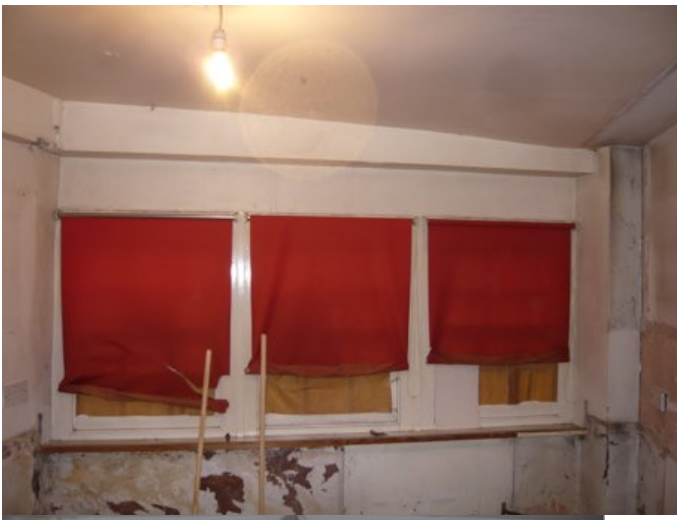
modern vertical sliding sash windows. Although the proportions of these are poor and inconsistent with the original windows above, their cill heights are still set below kitchen worktop height. This space was also formerly a garage prior to the entrance being filled in in 1973. This wall is damp below the windows and appears to be single skin plastered blockwork with no dpc.

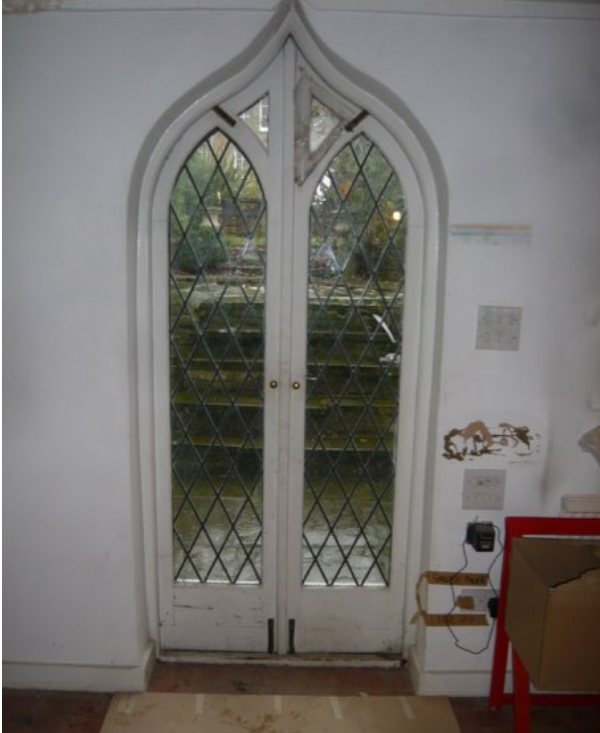
2.11. The dining room opens onto the rear garden through french doors that are noted as being new in the 1973 drawing. It is likely that this was previously a window. The door is timber, with a bulked up, but still decayed bottom rail and poor quality leaded glazing.

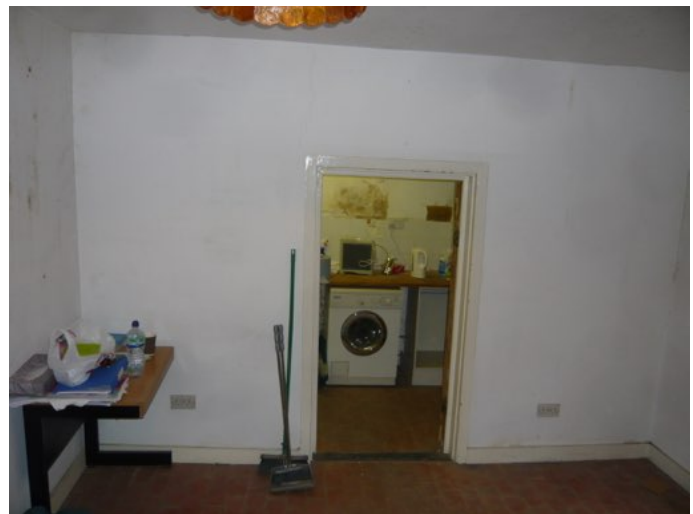
a new door. There is a small step down into the utility room. This wall has been investigated further as set out in the accompanying Investigation Report.

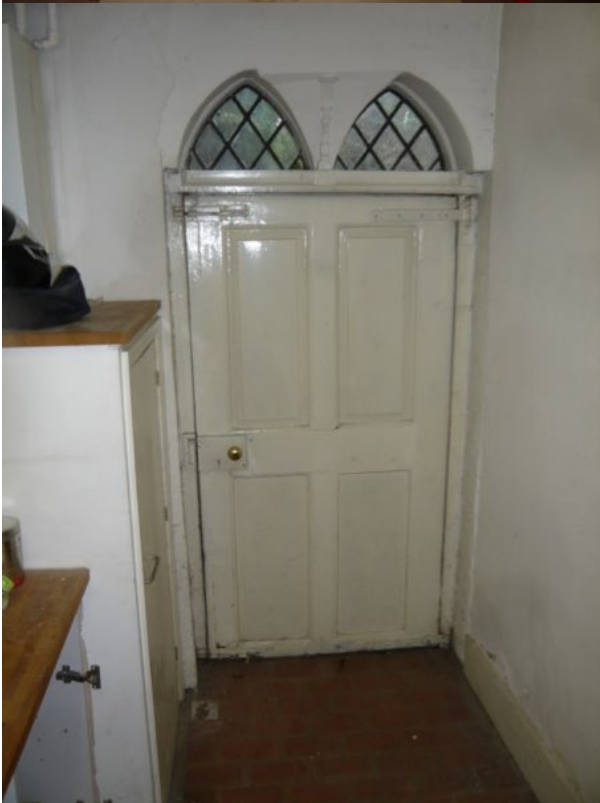
2.13. Through this door is a galley utility room which also has a cut down door to the rear courtyard garden area. This cut down panelled door has also been widened internally with the reveals appearing to have been cut away. The central top segment of the arch has also been

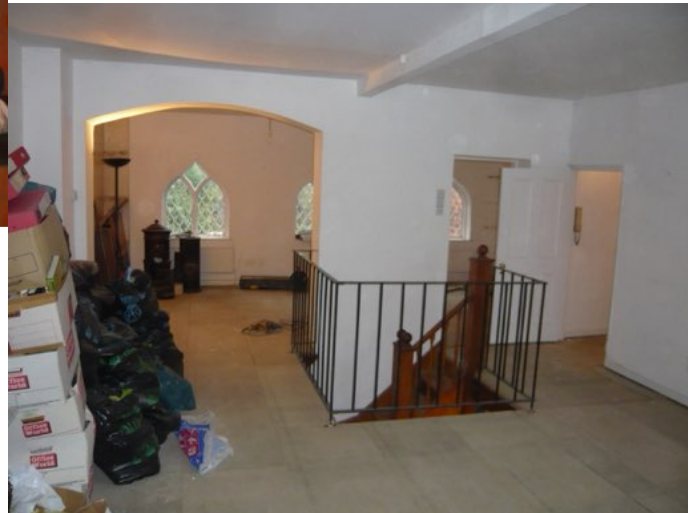
2.16. The stair is a 1973 stained timber winding tread stair of no architectural or historic interest, separated by a single T +G board from the corridor to the utility room to the rear. The wall between the stair and the dining room is a substantial wall that may have been previously an external wall. There have been new openings inserted in 1973. This remaining wall has cracking to the gypsum plaster indicating structural stress. This wall continues up to first floor level. Inspection

by a Structural engineer, Pilar Chapero of Chapero Marsh has confirmed that this is indicative of structural stress requiring remedial work.

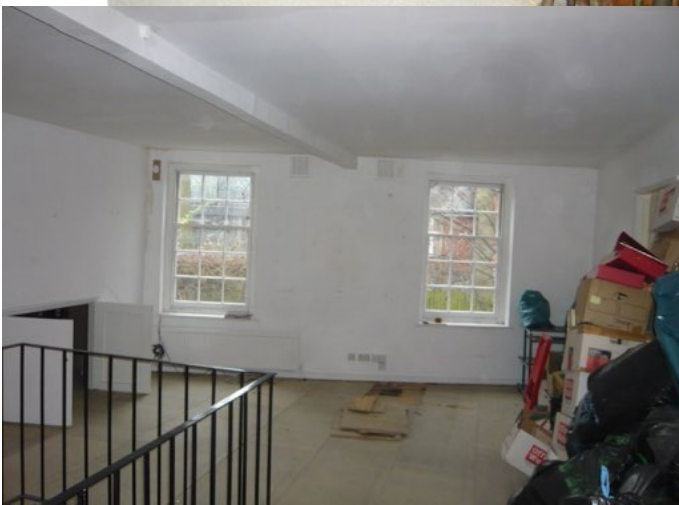
works agreed with the Conservation Officer, this boarding was removed to expose the mix of older and modern boards as described within the accompanying Inspection Report. There is a slope across the floor that the chipboard layers appear to have attempted unsuccessfully to resolve. There is a step at the threshold of the doorway that contains some services, with a differential height to the floor level on each side. The 1972 drawing shows the installation of a spiral stair in the rear right corner of this room, replacing a straight/winder stair across the party wall to No.23. The modern pine boarding at this location over the current utility room is consistent with this.

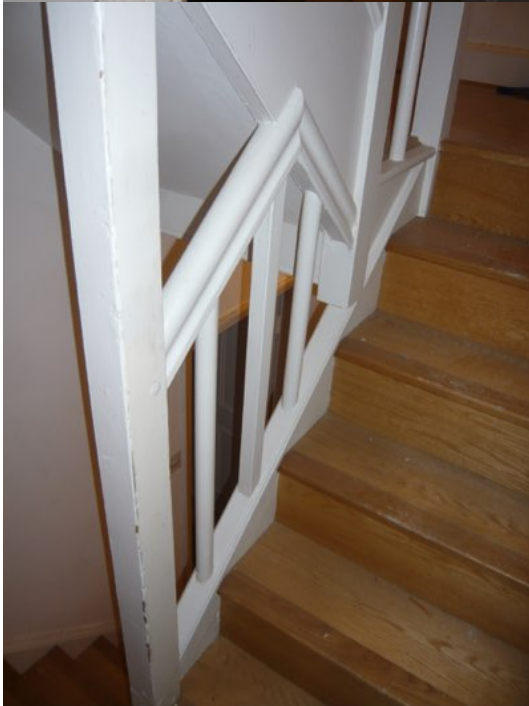
2.23. The stairs appear to be original, but the nosings on the treads have been cut off to apply a laminate floor finish without a nosing.

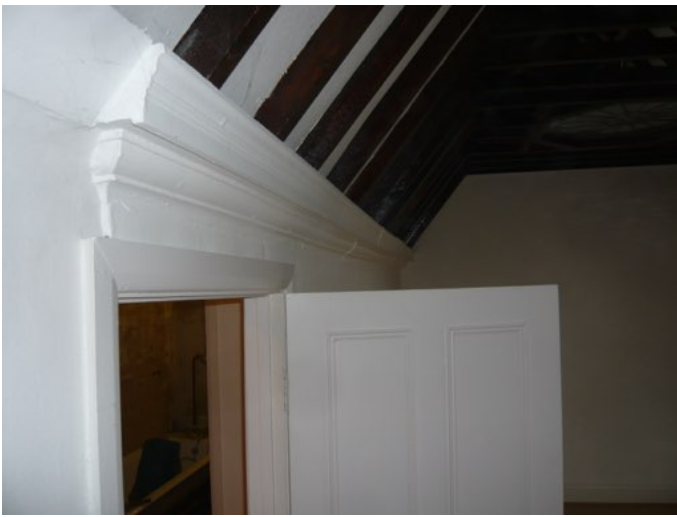
leaking valley gutter. This is finished in gypsum plaster. The floor was laminate boarded but the original boards have now been uncovered and will be retained. There is no sign of the furniture layouts that are marked on the 1973 drawings. There is a small 120mm fixed glazed square window to the side wall that is on the 1973, but not 1972 drawings. The door is modern flush with planted mouldings, in a chamfered architrave.

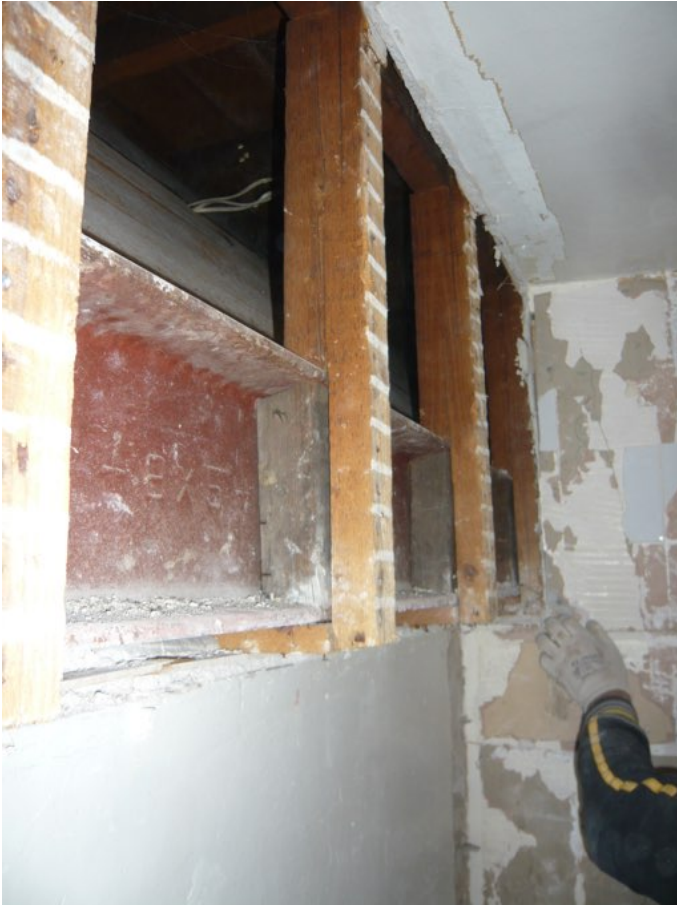
2.28. At the end of the hall is a bathroom with plasterboard walls and boxing to a 200mmx125mm steel eaves beam that supports the inner eaves of the slate roof range. The boxing to the steelwork runs at high level projecting into the corridor. There appears to be a boxed steel post subject to further investigation, and the location of this post is consistent with additional stresses to the walls below apparent in the cracking. The 1972 drawing indicates that below this was an open front to a wardrobe set into what is now the bathroom.

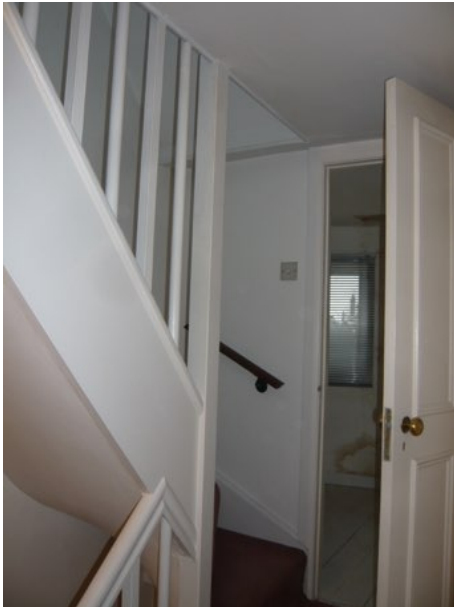
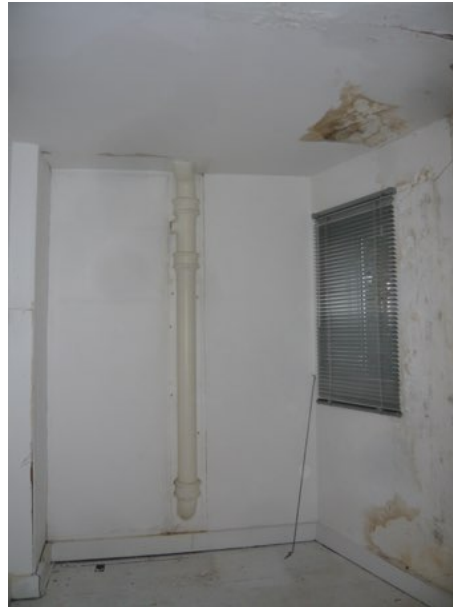
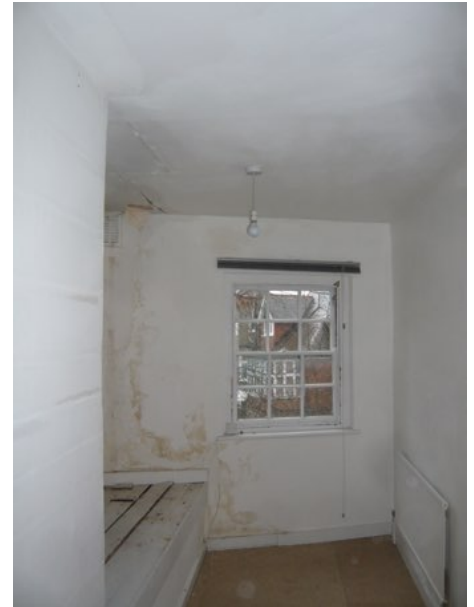
with the wall to a small bedroom 3 at the left reveal of this. The internal walls to this bedroom are entirely plasterboard. The ceiling and external walls are lined with lining paper, but investigation has confirmed that these are also modern plaster and plasterboard. The door is modern flush with planted mouldings, in a chamfered architrave.

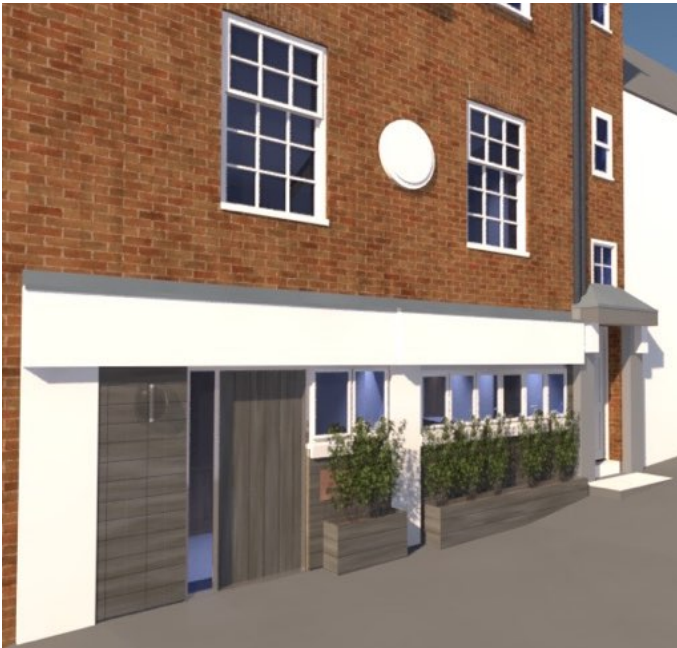
External Elevations - Front

5.7. The front elevation will retain its existing character and general appearance, including all decorative details, pilasters and entablatures, which will be repaired and redecorated. The front elevation is visually separated into different elements as described above. The ground floor is separated from the main brickwork elevation by the entablature, enhanced and completed by the pilasters, which frame the former garage door openings as separate elements of the overall composition. The main symmetrical part of the elevation is flanked by the matching but slightly different brickwork of the stair tower, with its smaller windows set to landing rather than general floor heights.

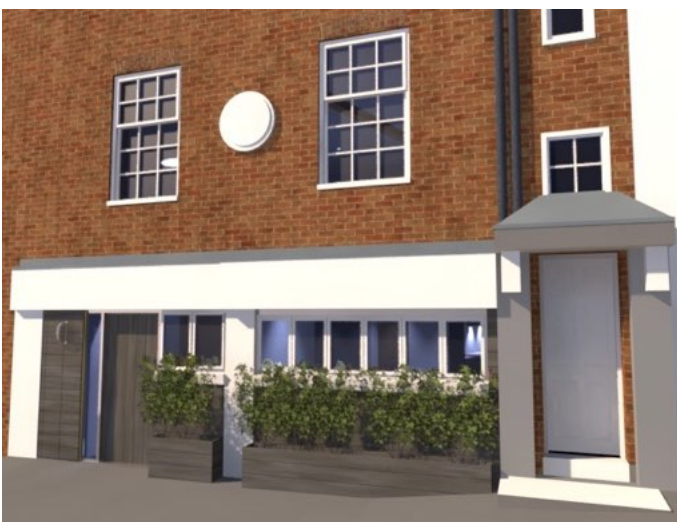
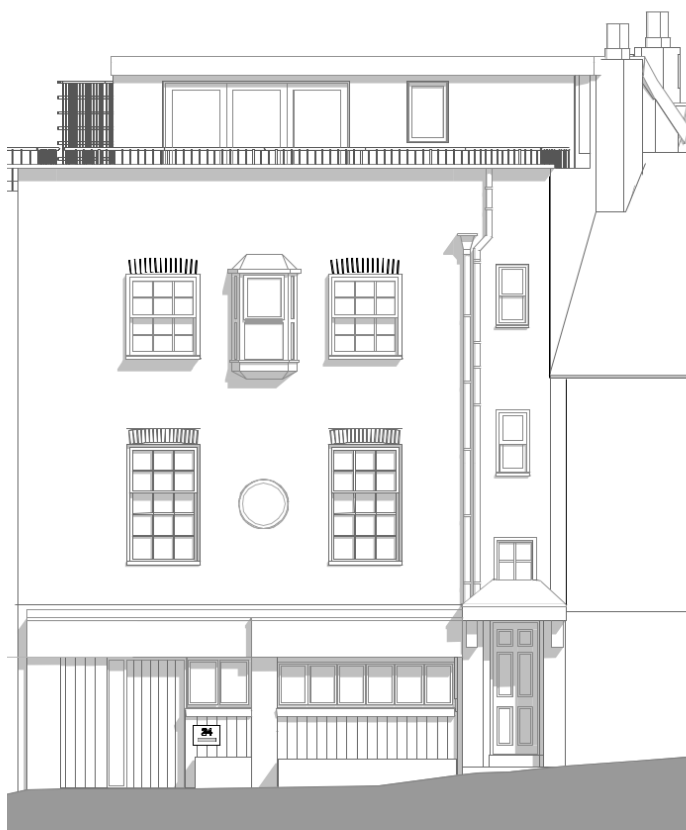
5.8. The main areas of alteration will be the removal of the remaining garage door and the removal of the wall and linked sash windows at ground floor level that infilled the previous 1970s garage. These will both be replaced by timber clad infill walls with a strip of slim framed aluminium polyester powder coated windows above, set directly below the entablature that previously

headed the garage doors. A new timber modern front door, integrated in appearance with the adjacent timber cladding will be included as described in the section on the ground floor layout below and as shown in the adjacent render. This is intended to

represent the general arrangement and does not show the detail of the pilasters or entablature, which will remain. The new infill is designed to pick up on the former garage door recessive character, but in an attractive, non-literal way. An integral planting box, also timber clad, will be constructed below the right hand infill, with space for a planting pot adjacent to the left hand. The existing tree and short hedgerow at the boundary with no. 23 will be retained at the request of neighbours.

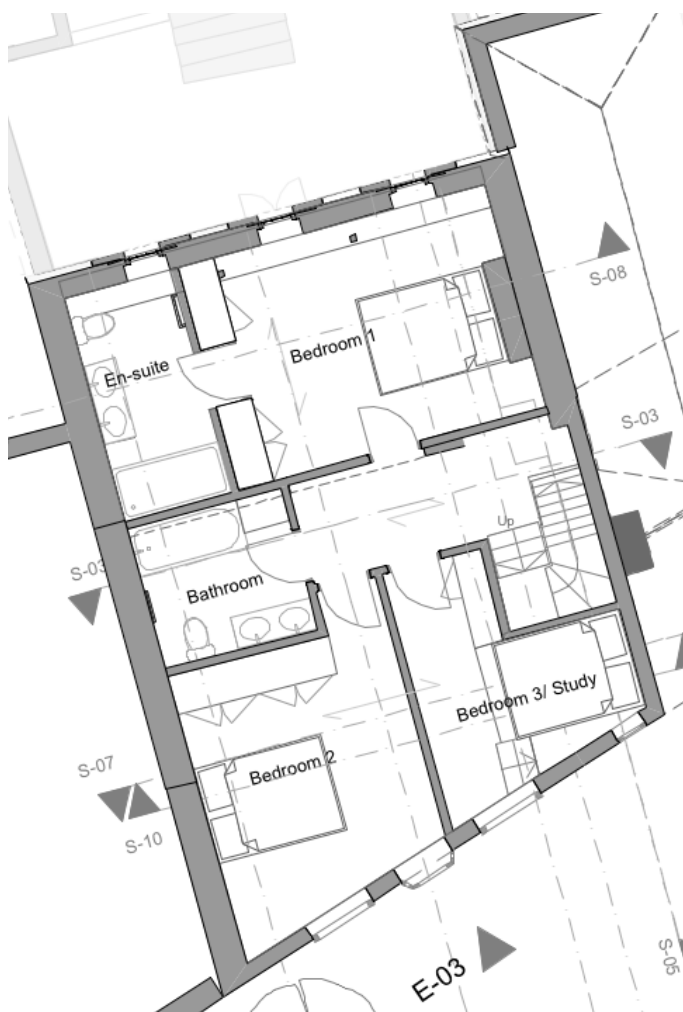
Second Floor

5.29. The 2nd floor level, although this is largely modern timber stud would be retained largely as is, with some alterations to the doors and openings.

5.30. The smaller, split level bedroom (Bed 3/Study) makes use of the raised area as a bed, with the head at the party wall, and the raised area extended by 200mm to extend the length of the bed to 2m long. This would be extended by a further 200mm to provide some storage underneath the bed. This is improved by the removal of the vent pipe as described above. The existing door at the landing level, which has a modern flush door with applied mouldings and chamfered architraves would be removed and replaced with timber stud construction. The door at the main, lower landing level, also a flush door with chamfered architraves would be relocated within the modern stud wall to allow space for a wardrobe and cupboards along the foot of the bed. The glazed overpanel will be

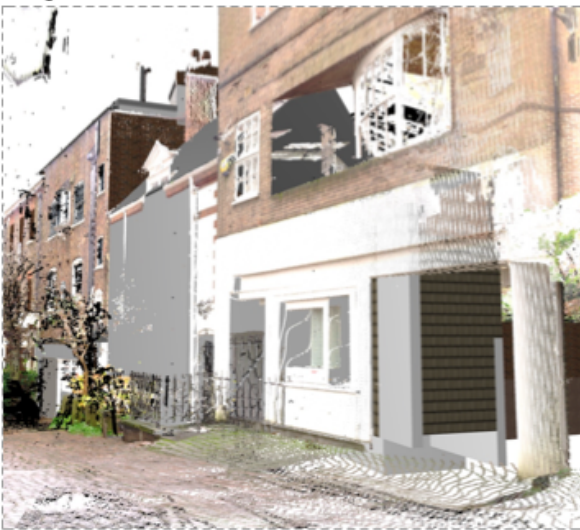
Existing Far view

5.38. From Perrins Walk, the current view above the parapet includes the felt roof of the service cupboard, from which emerges a 100mm black vent pipe from the foul water system to a further 1.3m height. It is this vent pipe that is most prominent in this view. A review of the servicing and drainage requirements generally facilitates the removal of this service cupboard and vent, reducing the bulk of the building at this corner.

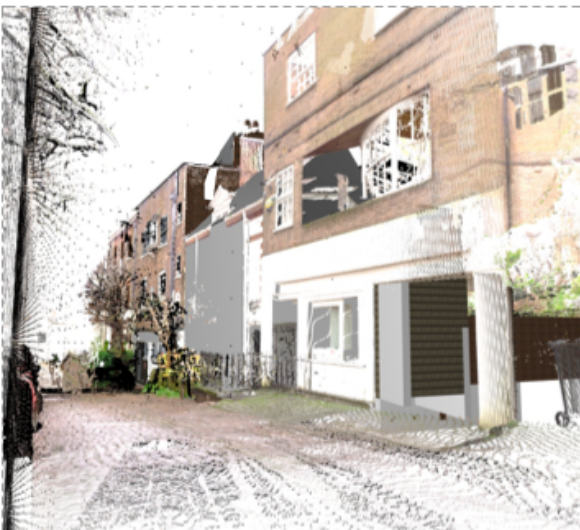
Proposed Far view

5.39. To the right of this is a brick chimney, with the UPVC cladding to the corner of the flat roofed stair enclosure visible to the left and of this. Earlier proposals brought the side wall of the enclosure further forward towards the front elevation, but the impact on the street scene was considered to be undesirable. The proposal was therefore revised back to the line of the existing stair enclosure to minimise any impact on the street scene or increase in bulk or massing.

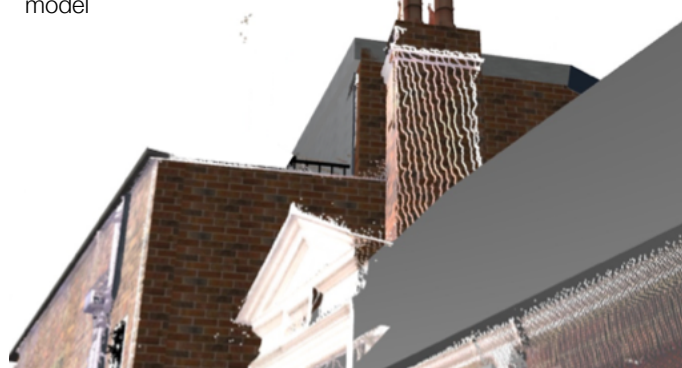
Proposed Close up View, combined point cloud and model

5.41. Alongside the shape of the extension, consideration was also given to the most appropriate materials to use for the cladding in place of the UPVC. Both lead and slate were initially considered. An initial preference for lead in this context emerged, in preference to vertical slate hanging, both in terms of resilience and coherence of appearance in the context. Upon further review of the 3d model and point cloud together, whilst the lead would be generally a more appropriate material, its darker hue could be considered to be more imposing a feature when seen against the sky than the existing UPVC, which again may be detrimental to the streetscape. Further consideration of this has resulted in a change of materials to an unfinished zinc. This has a lighter appearance with a soft reflectance that will further tone down shortly after installation and exposure to the air. This softer reflectance will pick up the colours and shapes of the sky when seen from Perrins Walk, further reducing the apparent bulk of this block, even beyond the and is therefore considered to provide the most appropriate balance of form and material in the streetscene. The images shown are indicative of massing rather than being photo render of the materials. The use of zinc cladding on a number of buildings in the vicinity, including on nearby upper storeys of buildings on Perrins Walk further support this approach.

5.37. Following adoption of Option 2 as the preferred approach, the design has been further developed and revised with priority on the 2 main areas of visibility, as seen from the position of visibility further up Perrins Walk, and from the rear of the properties at Church Row. The elevations included do not represent the visibility of the proposal from any position, so reference should be made to the main viewing positions set out in the 3d views on the model and point cloud integrated as included in the drawings and shown in the adjacent renders.

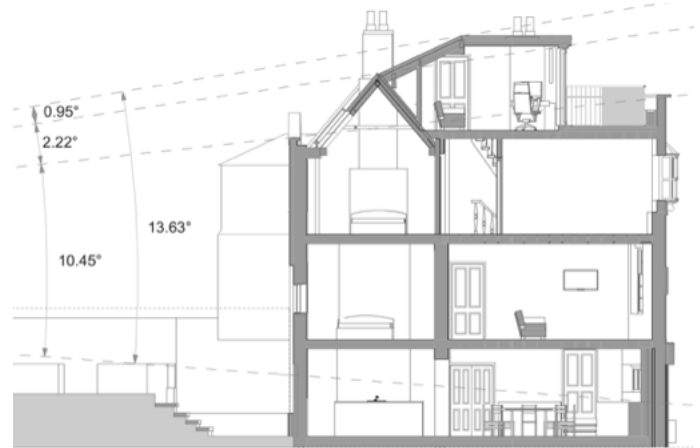
5.44. The majority of the view from the rear is also concealed by some significant trees. The images enclosed to some extent overlay the visibility of the proposed extension by omitting the foliage in order to adequately explain and illustrate the proposal. In reality, it will be further concealed from the rear by foliage.

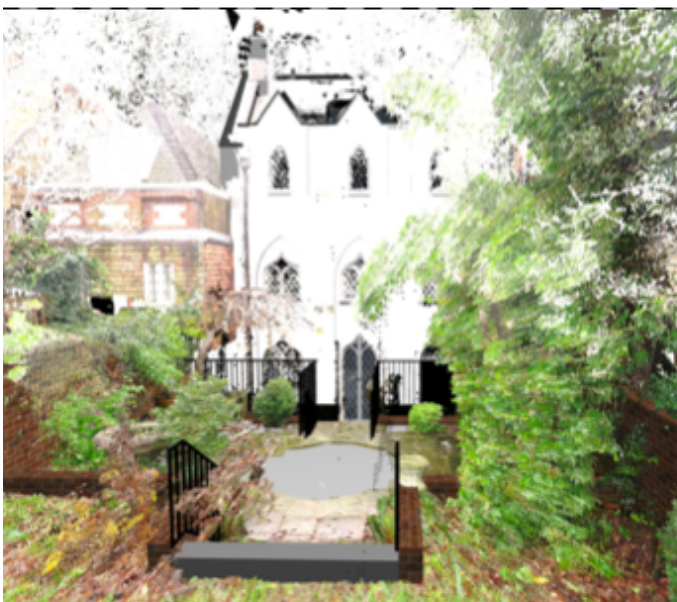
Proposed

5.45. In discussion with the Conservation Officer the preference for an approach more integrated with the existing slate roof emerged. The ridge and structure of the existing roof will remain as is, and the rear facing slate roof slope will be unaltered. A lower pitched, mansard roof will rise from this, also clad in slates reclaimed from the current inner/front facing roof slope. This will be in matching materials, but will have limited visibility from the rear, even at the rear of the houses on Church Row as illustrated on drawing 0381-02.2.6. The angle of visibility of the rear elevation, the roof, and the proposed mansard arrangement to illustrate this further. The relationships are also illustrated on the enclosed 3d sheets that show both the model and the point cloud for a precise representation.

5.46. A flush conservation rooflight (CR-8 from The Rooflight Company) is set within this new mansard slope, largely concealed behind the projecting chimney this will be largely imperceptible from ground floor level, but will bring daylight to the stair well below and to the 2nd floor landing/lobby area. The flat roof above will be a single ply membrane, with a fascia in zinc matching the walls. This will drain to the mansard roof into the valley gutter to the rear.

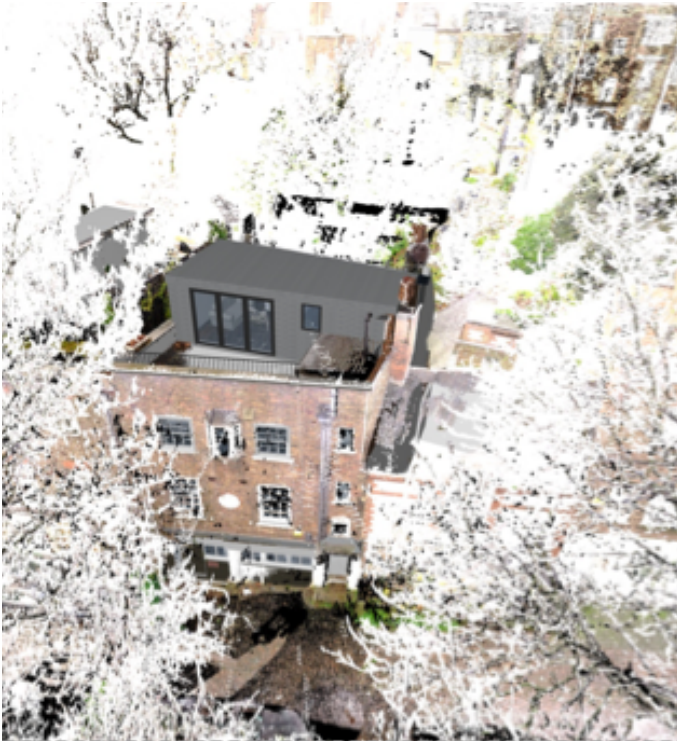
5.47. The terrace area will be slightly higher

than the existing to facilitate the addition of thermal insulation, and will be finished in a single ply membrane

5.48. The front facing elevation is set back from the parapet to retain a generous, usable roof terrace area accessed from a large polyester powder coated folding sliding door. There is also a window from a small study area. This is also clad in zinc to give a recessive, softly reflective appearance, that will only be visible from the terrace, and at an angle from the position of maximum visibility further up Perrins Walk as illustrated on the accompanying drawings.
