Flat A 15 Well Walk 2017/3214/P

I am commenting on aspects of this application as they relate to trees and to groundwater as Tree Officer of the Heath & Hampstead Society, and a member of its Planning sub-committee.

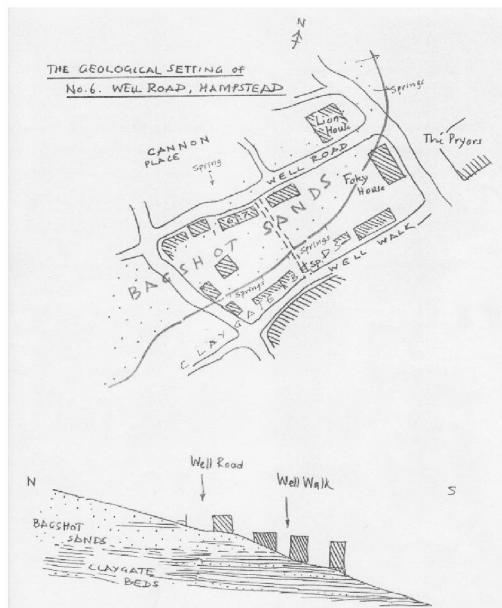
Dr Eric Robinson of University College London has drawn a geological map of the area (originally for another address in the locality), which indicates the springs and the spring line and should be of concern for 15 Well Walk:

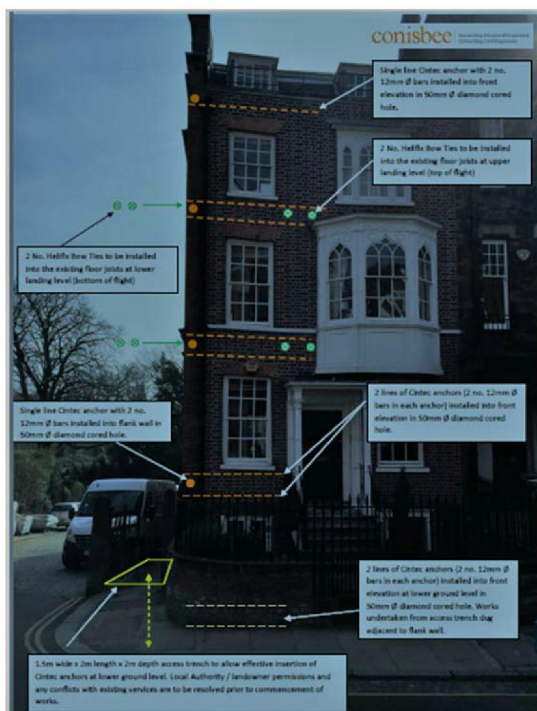
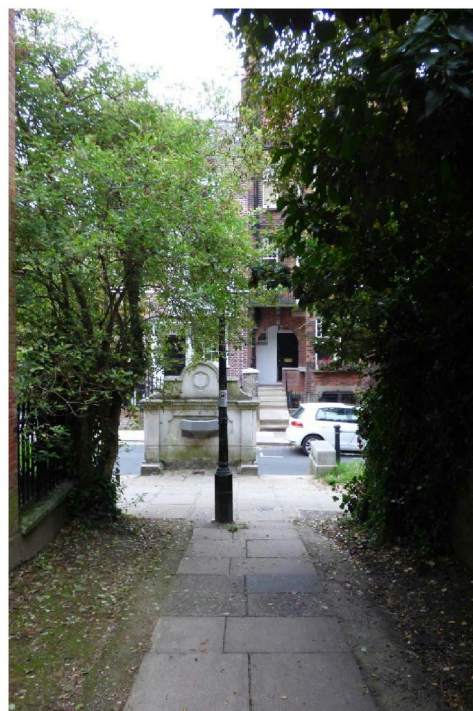
Some of the groundwater still running below houses on even moderate slopes can affect them by contributing to ground slip, but its main action is erosion of the significant proportion of silt within the Claygate Beds causing subsidence. Number 46 Well Walk for example – almost directly opposite 15 Well Walk – is having underpinning and now significant tying-in work too to strengthen it and withstand the sub-foundation volume loss from silt erosion by groundwater action. Movement monitoring from 2013 presented in 2016/0242/P showed that ongoing movement *was active*. Looking at 46 Well Walk from the road it can be seen that the main groundwater flow is below the house, west of the front door. This is in line with the eastern side of Wells Passage and thus closely associated with 15 Well Walk.

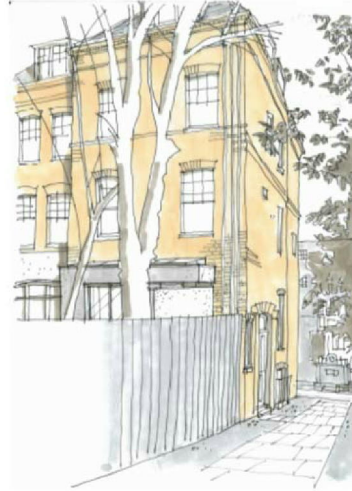
View of rear of property as proposed from Well Walk Passage
Showing new bay window & screen wall
