26 Lower Merton Rise: Basement Impact Assessment Additional Works

Report reference:
62274.00.01R2Rev1, July 2017

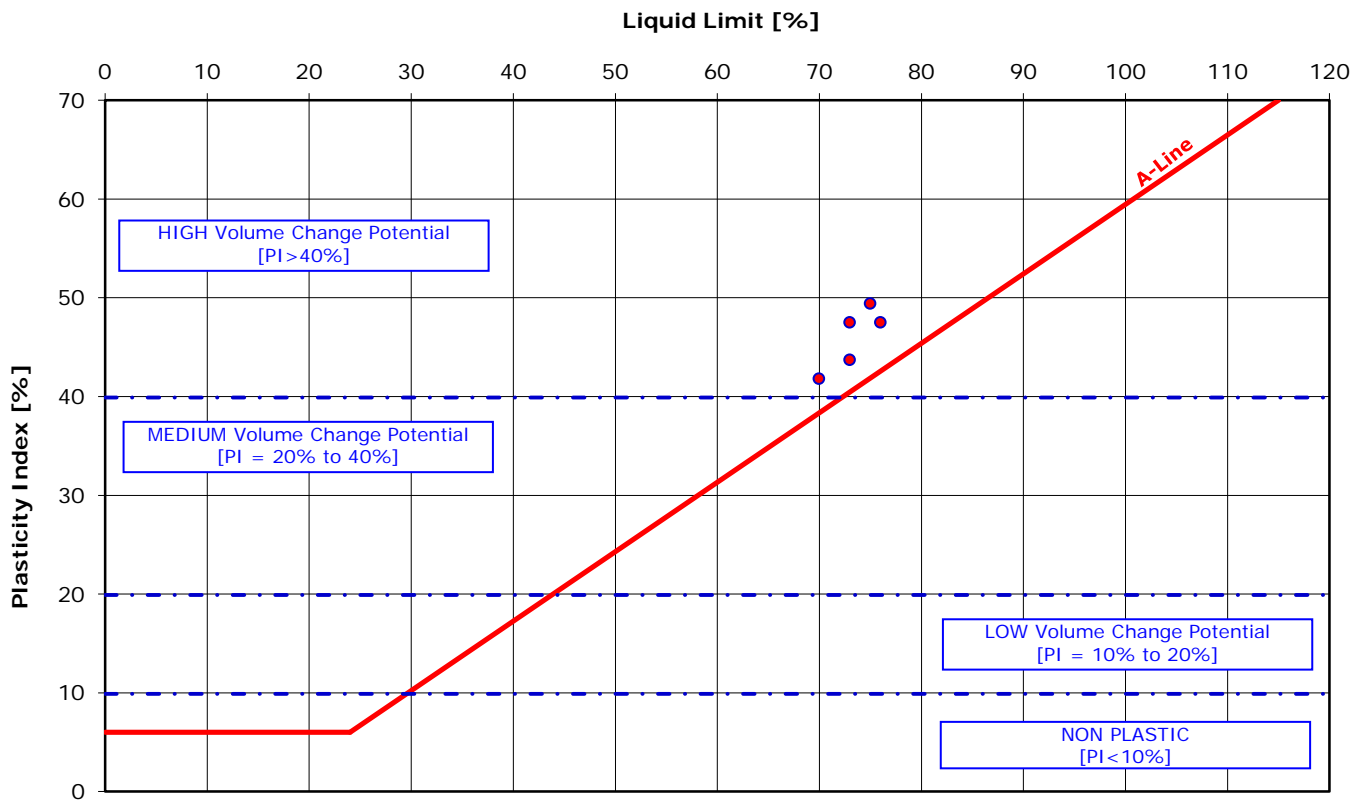
Plasticity Chart

Modified Plasticity Index, I'p:

$$I'p = \frac{I_p \times (\% \text{ passing } 425\text{mm})}{100\%} \quad [\text{where } I_p = \text{Plasticity Index}]$$
