# **Ross & Partners**

# Movement Monitoring of 26 and 30 Redington Road

In connection with New Residential Development at 28 Redington Road Hampstead London NW3

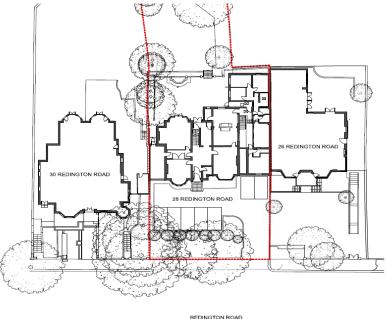
The site, as shown below is a long, narrow strip measuring approximately 100m from front to rear and 21m from side to side.

Most of the site comprises of soft landscaping. The site survey gives surface levels at the rear of the site at 105m OD with a gentle 1.8° slope towards the rear terrace at 103m OD.
