The Hall School
23 Crossfield Road,
Hampstead, NW3 4NU
The Hall School

Response to Eldred
Geotechnics Report:
Technical Advice
G1701-TA-01-EA
EW Comments

Job number: 2150206
Revision: P2
Status: Preliminary
Date: April 2017

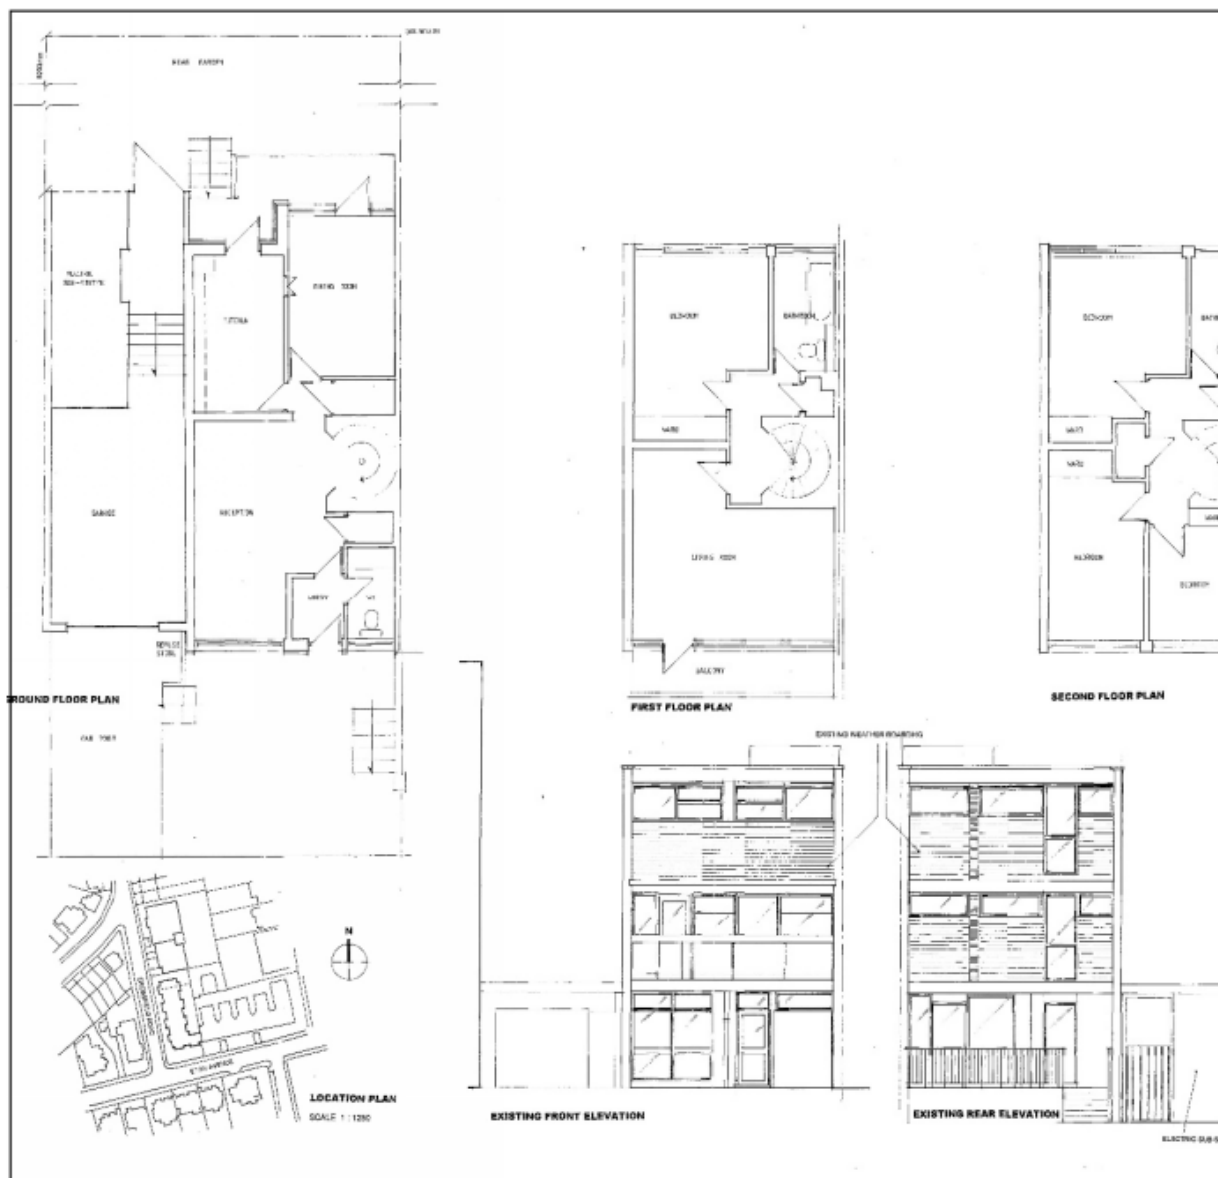
FIGURE 1 Existing arrangement of 24 Crossfield Road 1998

37. *Figure 1 below is taken from a 1998 planning application for No.24 and shows the arrangement of the property at that time. The application was to remove the garage and extend to the boundary. It was refused and so the current arrangement is unlikely to differ very much from that shown. The construction of the front and back walls of the houses is of material significance for this case. Like many other housing terraces of the time, it followed the architectural fashion to have glazing that extended for the full width of the houses at all floor levels, with tiled or other probably non-brickwork apron walls below.*

38. *In this case it can be seen that most of the glazing and doors in the ground floor of No. 24 are full height on both elevations. On the front elevation there is at least one full height opening to the balcony and possibly a full height glazed panel. On the rear elevation there are full height glazed panels at both first and second floors.*

39. *Solid parts of walls between and below these openings were difficult to stabilise if made of brickwork and so were often timber framed, the frames being made on site and supported by being fixed to verticals between openings and to party and flank walls. Usually, as in this case, there were no continuous internal cross walls and it was only the structure between openings in the front and back walls that provided lateral stability to the terrace as a whole and stopped the "pack of cards " effect.*
