2.6 Townscape and character analysis of the Camden Town Conservation Area

3.0 CAMDEN PALACE THEATRE (KOKO) & ASSOCIATED BUILDINGS

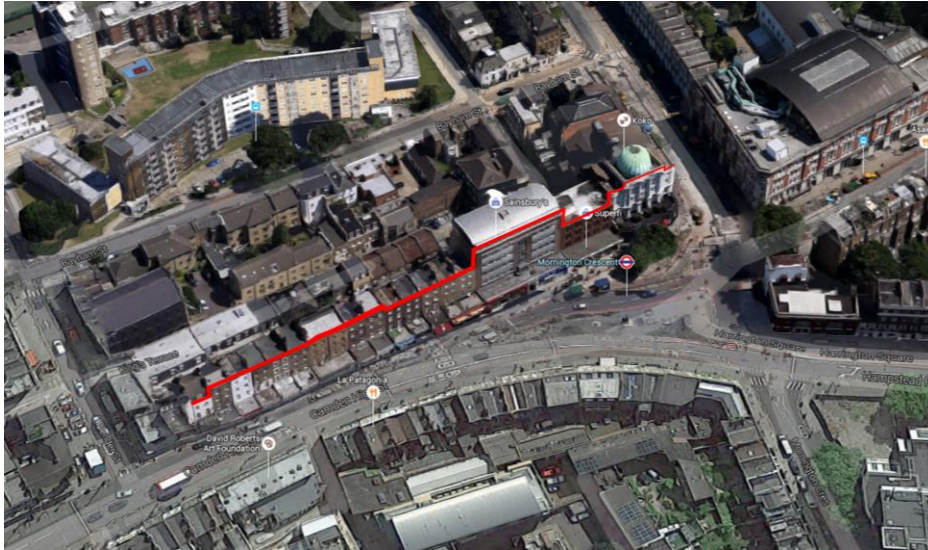
Figure 39: Roofline of south side of Camden High Street highlighted. The buildings vary in height, particularly towards the junction. The two buildings just north of KOKO are considered to have negative contribution on the townscape.

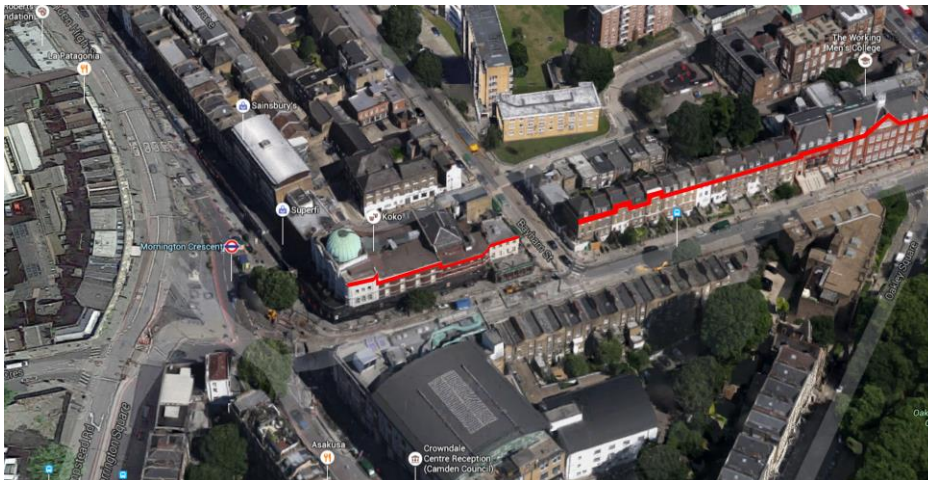
Figure 40: Roofline of Crowndale Road highlighted. Most buildings here vary between 3 and 4 storeys. Buildings in the background on Bayham Street are taller apartment blocks built relatively recently.

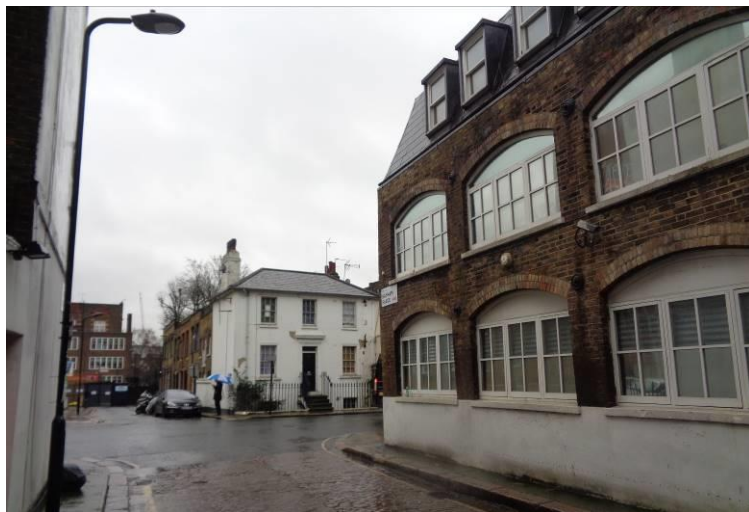
Figure 42: West block of Bayham Place looking east onto Bayham Street. 1 Bayham Place is on the RHS. The major alteration is the roof extension.

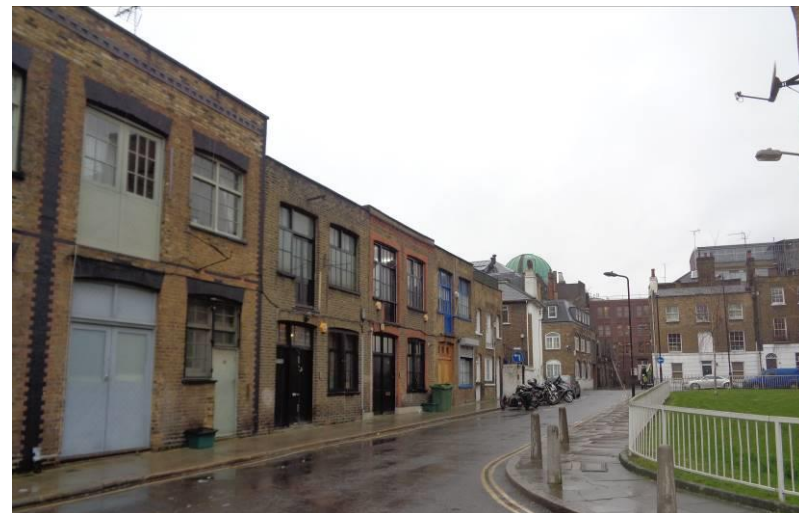
Figure 44: East block of Bayham Place showing part of the original mews buildings and their 'take-in' doors for the piano trade. KOKO's dome is visible from here.

The east stretch of Bayham Place has retained its mews buildings. In the late 19th century, these were used for sheet metal production and piano manufacture workshops and still have their original 'taking-in' doors for moving the large instruments in and out of the buildings. Such evidence of workshops is not seen in the west stretch of Bayham Place and, to a degree, the historic character is eroded by later alterations.

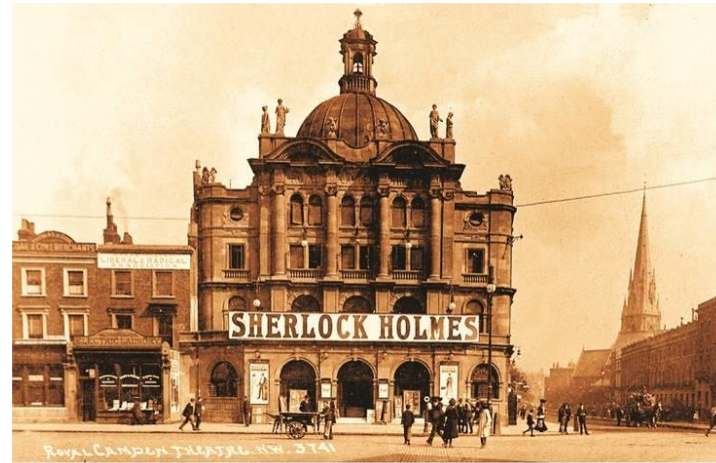
Figure 50: Here the cupola and sculptures can be seen clearly. Unfortunately, none of them survive and the letters 'Royal Camden Theatre' are no longer visible/have been rendered over.

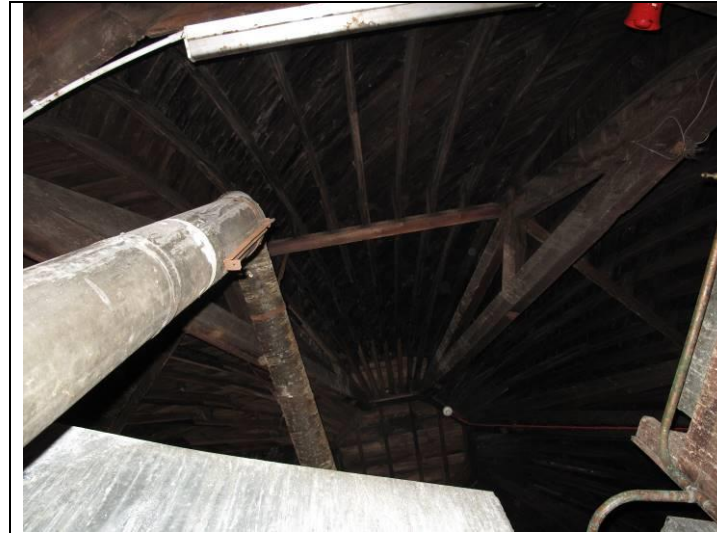
Inside of the original copper dome. The duct is probably the heat extract from the early film projectors.

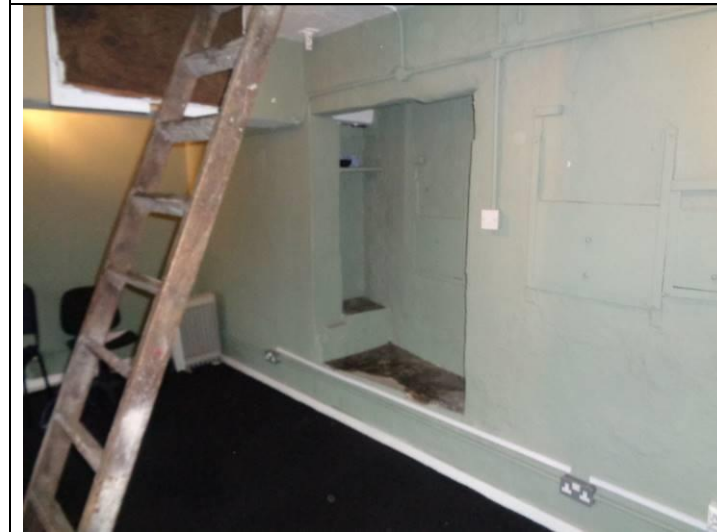
This room was the projection room when the building was a cinema. It sits directly under the dome.

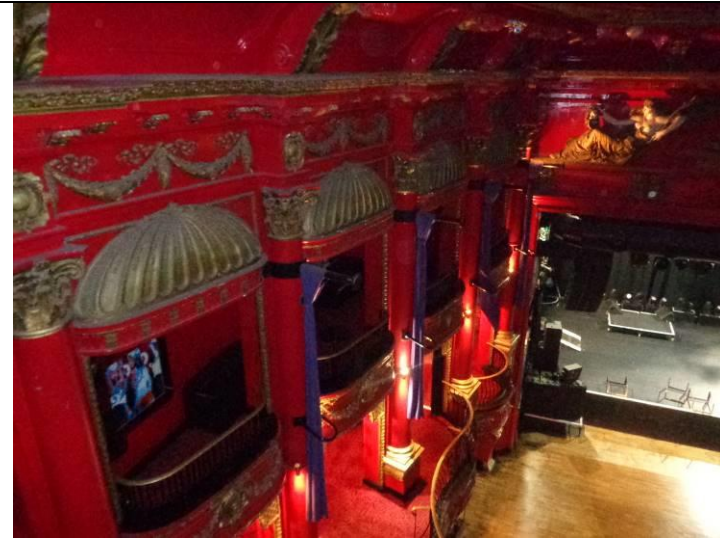
The auditorium – LHS looking toward the balconies. This part of the building originally had a gold-cream colour scheme, however, it was painted red when it was converted into a nightclub.

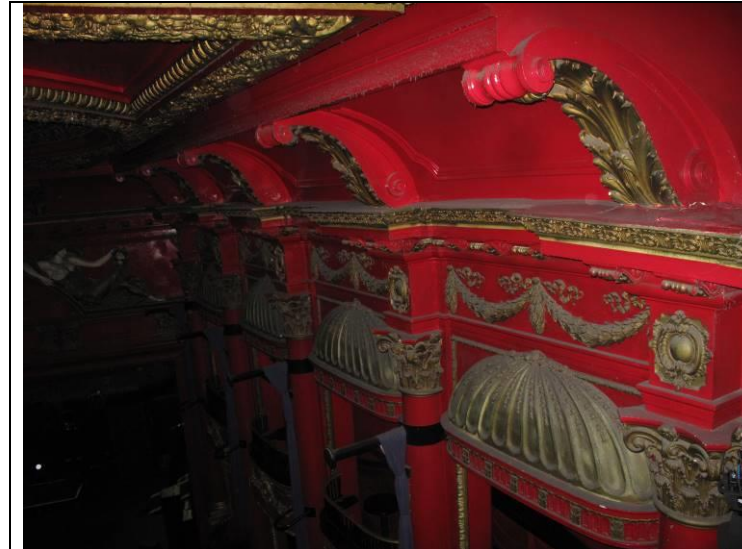
Decorative plaster corbels to the ceiling of the auditorium.

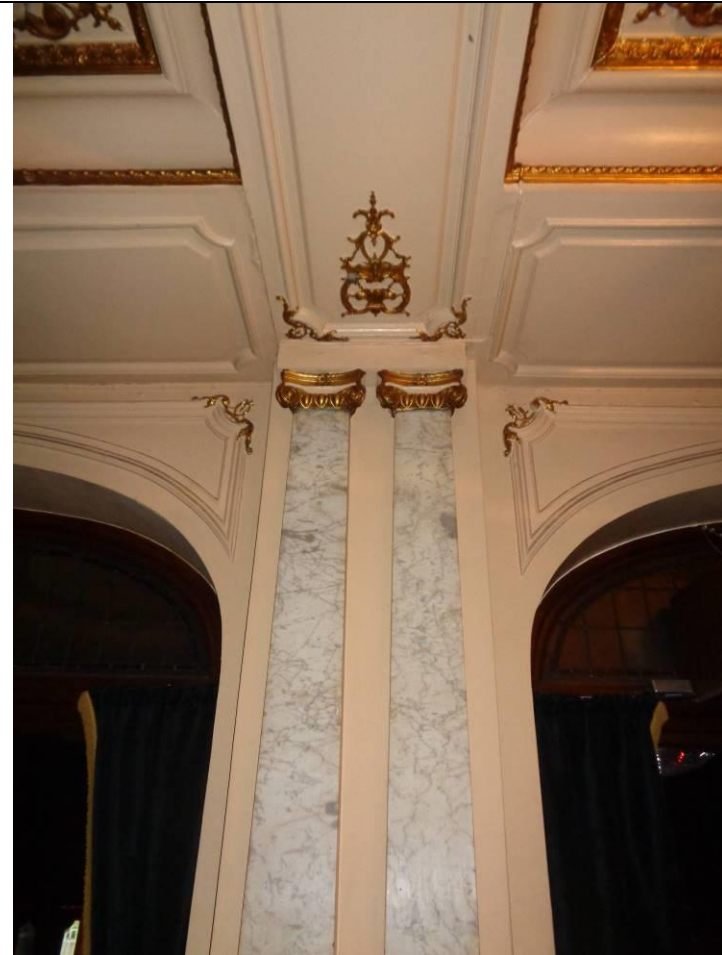
Entrance lobby with original marble pilasters and decorative plasterwork painted gold and cream. This was the original colour scheme for the auditorium.

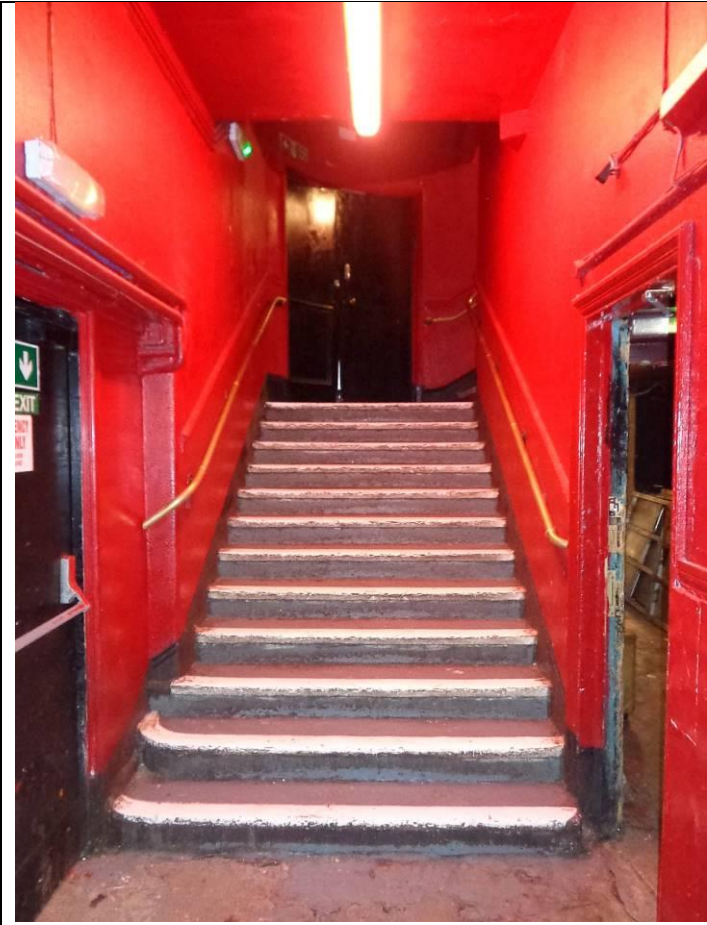
One of the side corridors, designed to be wide enough for people to escape quickly in case of fire

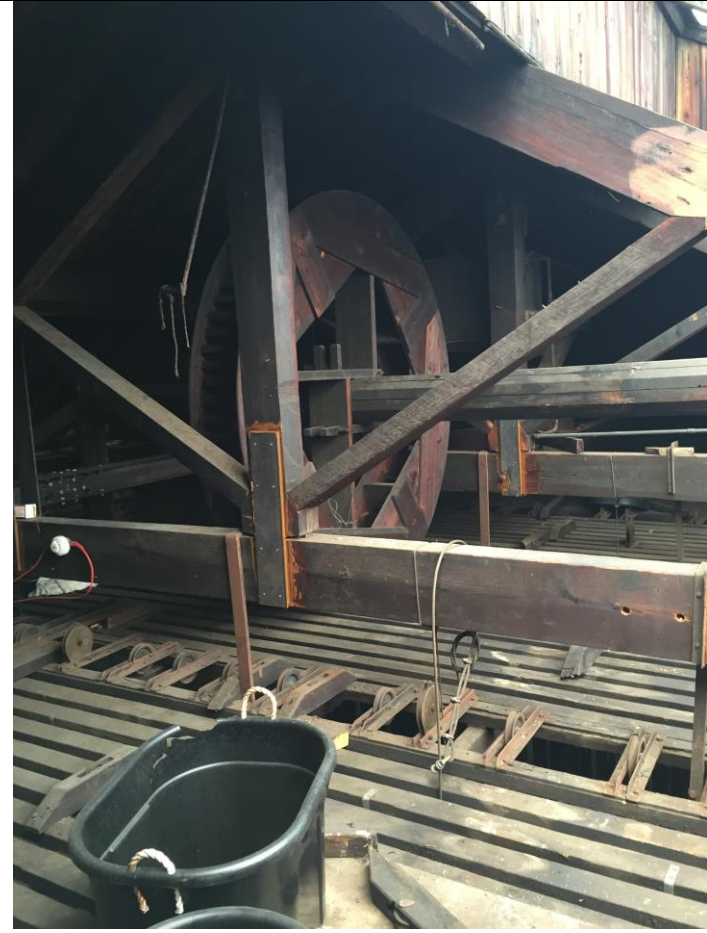
Existing original scenography equipment in the fly tower including grid and pulleys

10	Theatre internal	Addition of a new gallery within the interior of the flytower above the stage is welcome as a means of better revealing the original grid above, but should be explained in detailed structural drawings, as should the physical and visual consequences for the introduction of new mechanical plant.	Noted. Note: the new galleries and strengthening of the original galleries are indicated the structural drawings by HTS.
11	Hope & Anchor	The proposed retention of the existing change of levels within the ground-floor of the pub, and of some of the historic brickwork and structure within the ground floor, as shown in the proposed ground-floor plan, is a significant and welcome improvement on the extant permission.	Noted.

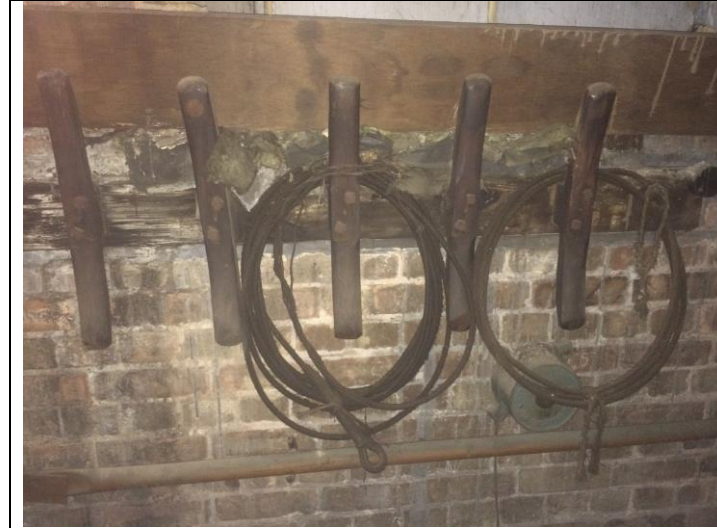
Existing original cleats at fly gallery level

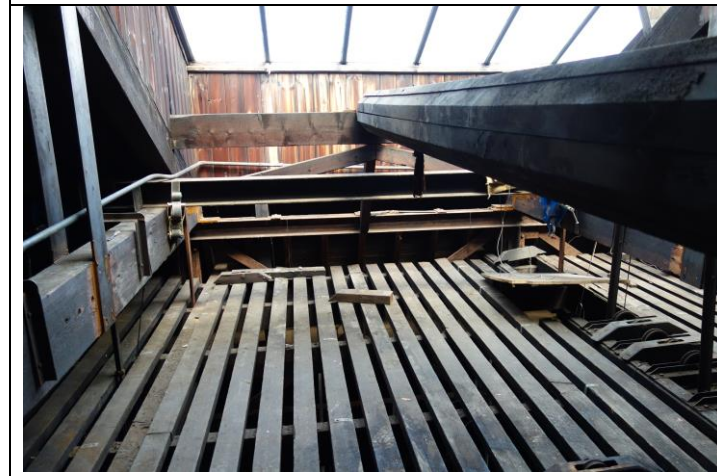
Fly tower grid

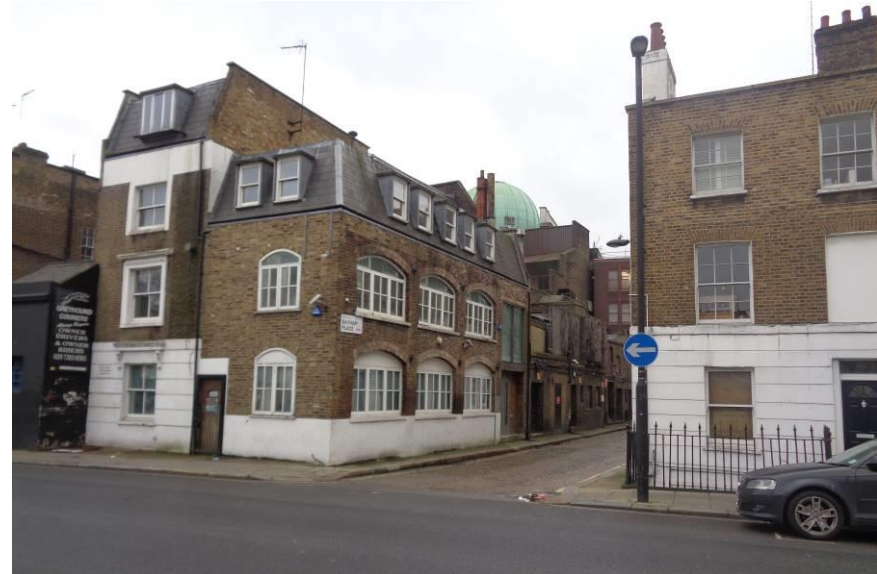
Figure 59: 1 Bayham Street (the narrow building to the LHS) and 65 Bayham Place adjacent (on the RHS). The mansard roofs in both buildings are clearly visible here.

To the rear of 65 Bayham Place are surviving mews façades. Albeit altered in form and use, their original utilitarian character is still apparent from the street. At 65 Bayham Place the characteristics of a workshop, such as the large arching window openings to let in natural light for the workers and a large carriage door (to the rear) still exist (see Figure 59).

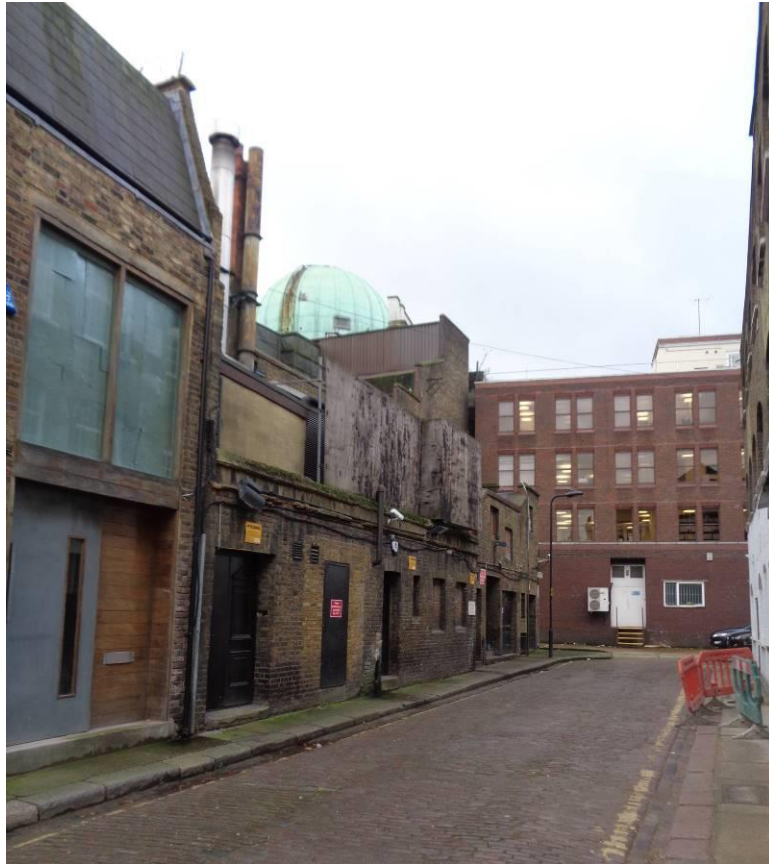
Figure 60: Bayham Place looking west. These mews buildings were altered when the theatre was built. Part of the 1900s walls are still discernible.

The mews buildings to the rear (facing Bayham Place) were substantially altered when the Camden Palace Theatre was built. Their facades were retained, however, internally the layout would have been altered to accommodate the north wing of the theatre. It is also clear where the mews have been extended upwards, again for the north wing of the theatre. See appendix 2 for 1899 architectural drawings.

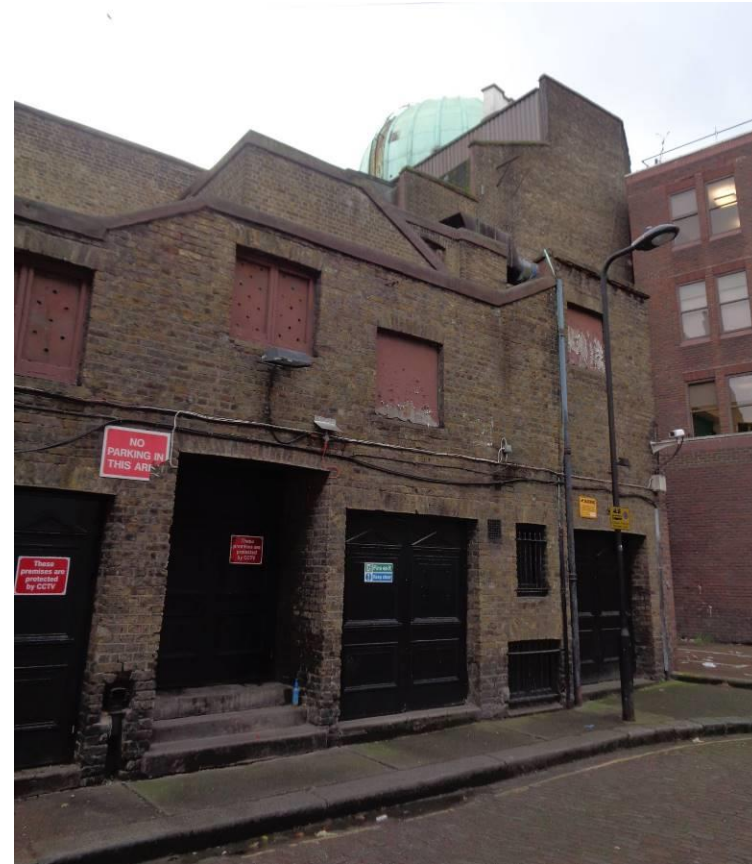
Figure 61: Bayham Place looking south. These mews buildings were substantially altered internally and externally when the theatre was built, though the original facades were retained.

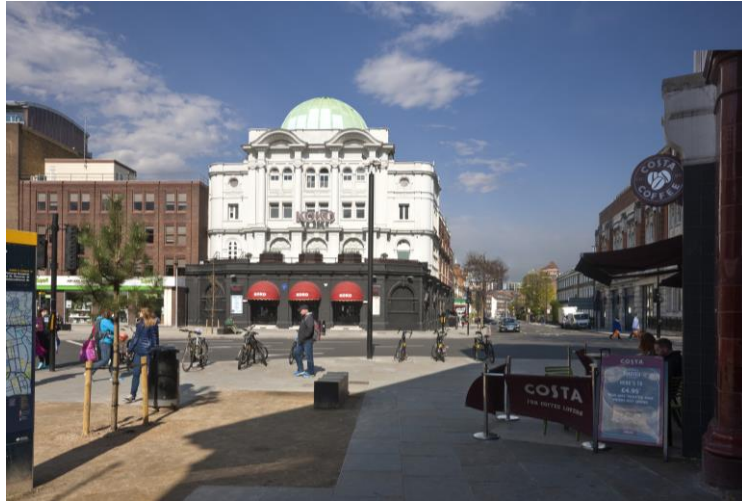
VIEW 01 – Baseline View

This view is taken from Mornington Crescent station looking east towards KOKO with Crowndale Road to the right. KOKO’s façade clearly dominates this view, which is further highlighted by its position on a corner and pedestrian/traffic node. Across Crowndale Road are grade II listed nos. 31-53 Crowndale Road terrace (only partly visible in the background) and part of the grade II listed Mornington Crescent Underground Station.

This view demonstrates the open nature of the immediate space around KOKO in contrast with the denser urban appearance further north of Camden High Street. Due to the location of this view on a significant pedestrian route and at a junction and an underground stop in conjunction with the ability to appreciate the heritage assets, this view has high sensitivity.

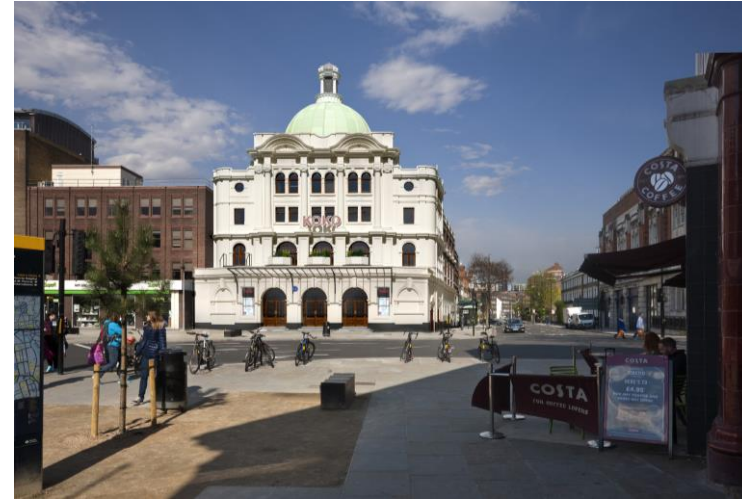
CGI View

The proposed development visible in this view comprises the cupola, windows scalloped parapet and painted façade at ground floor level. Historic records were adhered to for the proposed reinstatement for the cupola and windows and are in keeping with the design ethos of KOKO’s façade. Benefits that accrue from the proposed works to KOKO’s façade and dome include the rationalisation of the fenestration and creating a greater prominence as a landmark from the height increase. Consequently, the originally balanced composition will be reinstated, thus enhancing KOKO’s historic character.

The proposed development to KOKO’s roof, 1 Bayham Street and 65 Bayham Place are not visible from this view.

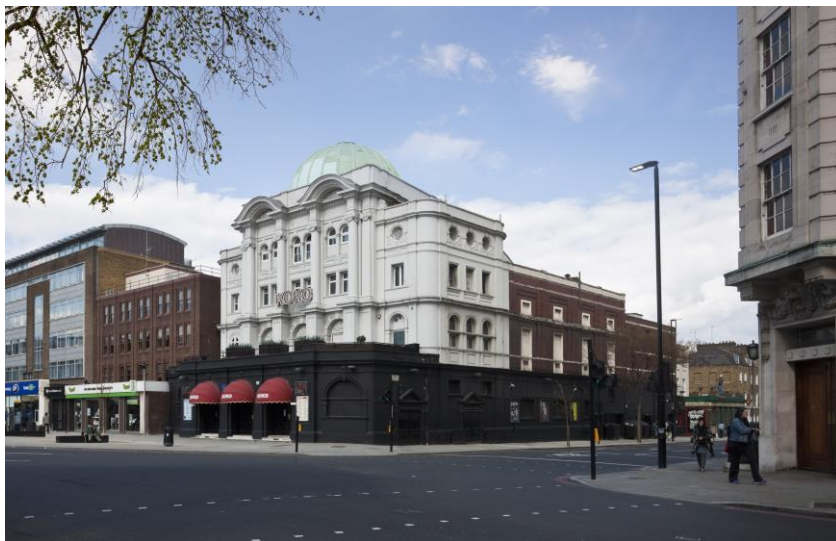
**VIEW 02 – Baseline View**

This view is taken from opposite corner of Eversholt Street looking north-east down Camden High Street (north) and Crowndale Road (east). KOKO's façade and the Crowndale Road elevation are both clearly visible and strong contributors to the townscape character of the immediate and surrounding area. This photo was taken from the pavement on the other side of Mornington Crescent Underground Station, which is considered an integral part of one of the more prominent pedestrian and traffic junctions in the Camden area. The buildings adjacent to KOKO are not listed nor of any special architectural merit. Across Crowndale Road (to the right) part of the corner building, The Crowndale Centre, can be seen. This is listed as a 'positive building' in the Camden Town Conservation Area appraisal. KOKO is divided into sections and is clearly legible in the roof line which successively steps down three levels towards Bayham Street. This is a significant characteristic that enables legibility of the building's function as a theatre; external features reflecting the division of internal spaces.

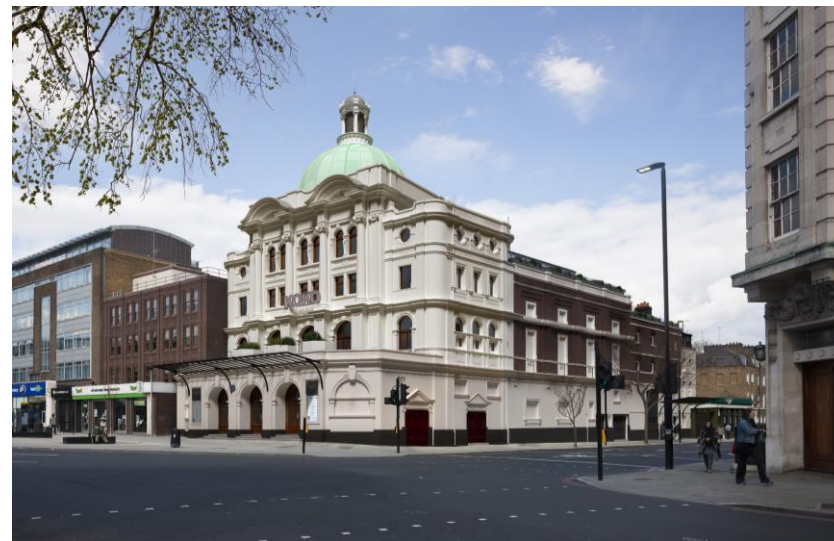
**CGI View**

Like View 1, the benefits of reinstating original features are clearly visible on KOKO's façade and dome. The elevation facing Crowndale Road is not altered and the succession of floor levels is still legible. The proposed canopy is seen clearly in this view; its lightweight design does not detract from KOKO's architectural features. The proposed development at fourth floor level is only just visible behind the front section of KOKO (the first three bays on Crowndale Road). The fourth floor extension is stepped back from the Crowndale Road elevation, thereby minimising the visual impact considerably.
