**Residual differences of technical opinion on the BIA for Hall School
23 Crossfield Rd London NW3 4NT
Application 2016/6319/P
as of 1st November 2017**

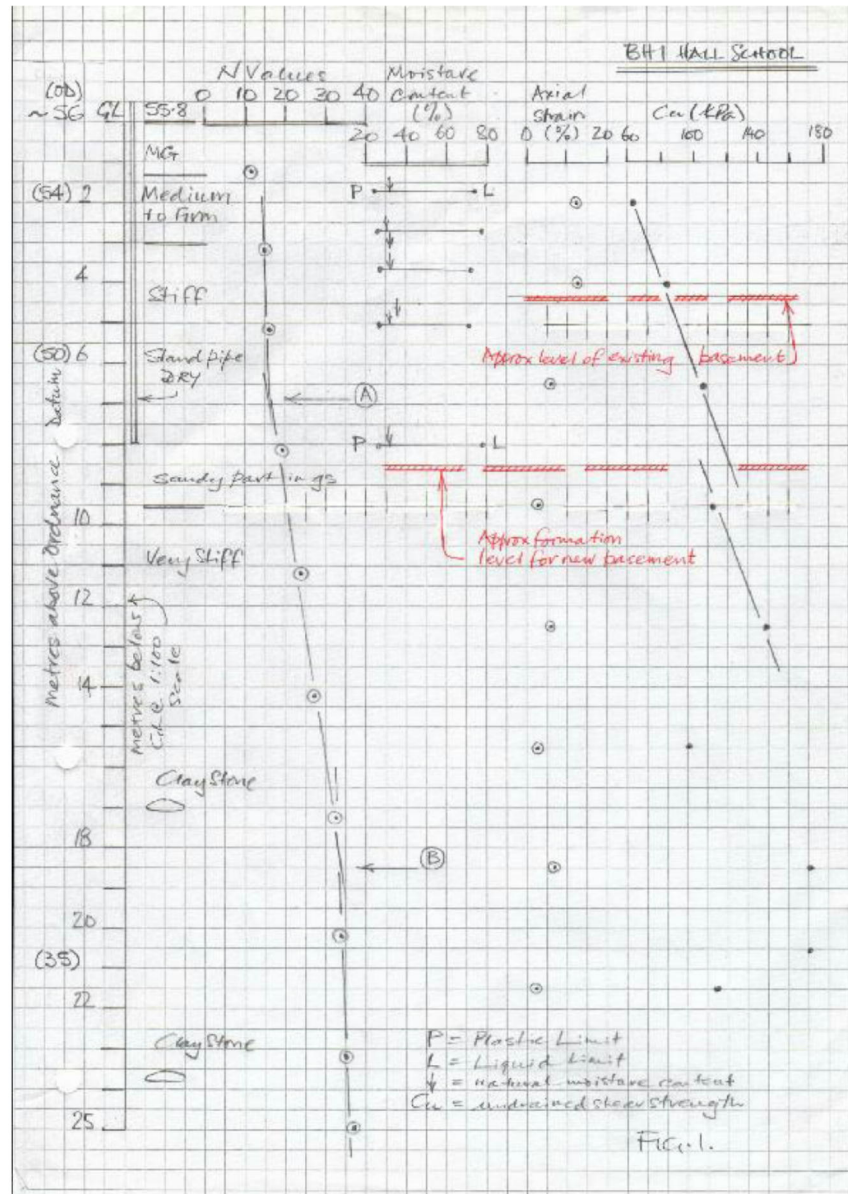
Attached Fig.1 from the First Steps report of January 2017

2.1 First Steps presented in Fig.1 accompanying their report a clear plot of the data with depth, which shows beyond doubt the change that occurs in SPT values at around 7m bgl and the lack of comparison between the gradient of SPT with depth with that of undrained shear strength with depth. (For convenience that Fig.1 is attached) From this it was observed that these circumstances deserve to be explained particularly as they occur in the depth to be excavated, involve undrained parameters which would be those expected to dominate the temporary works, and if typical of conditions outside the intended retaining wall, could have implications for ground stiffness and hence ground movement.
