46 Avenue Road

Basement Impact Assessment

Rev 06 (September 2017) issue.

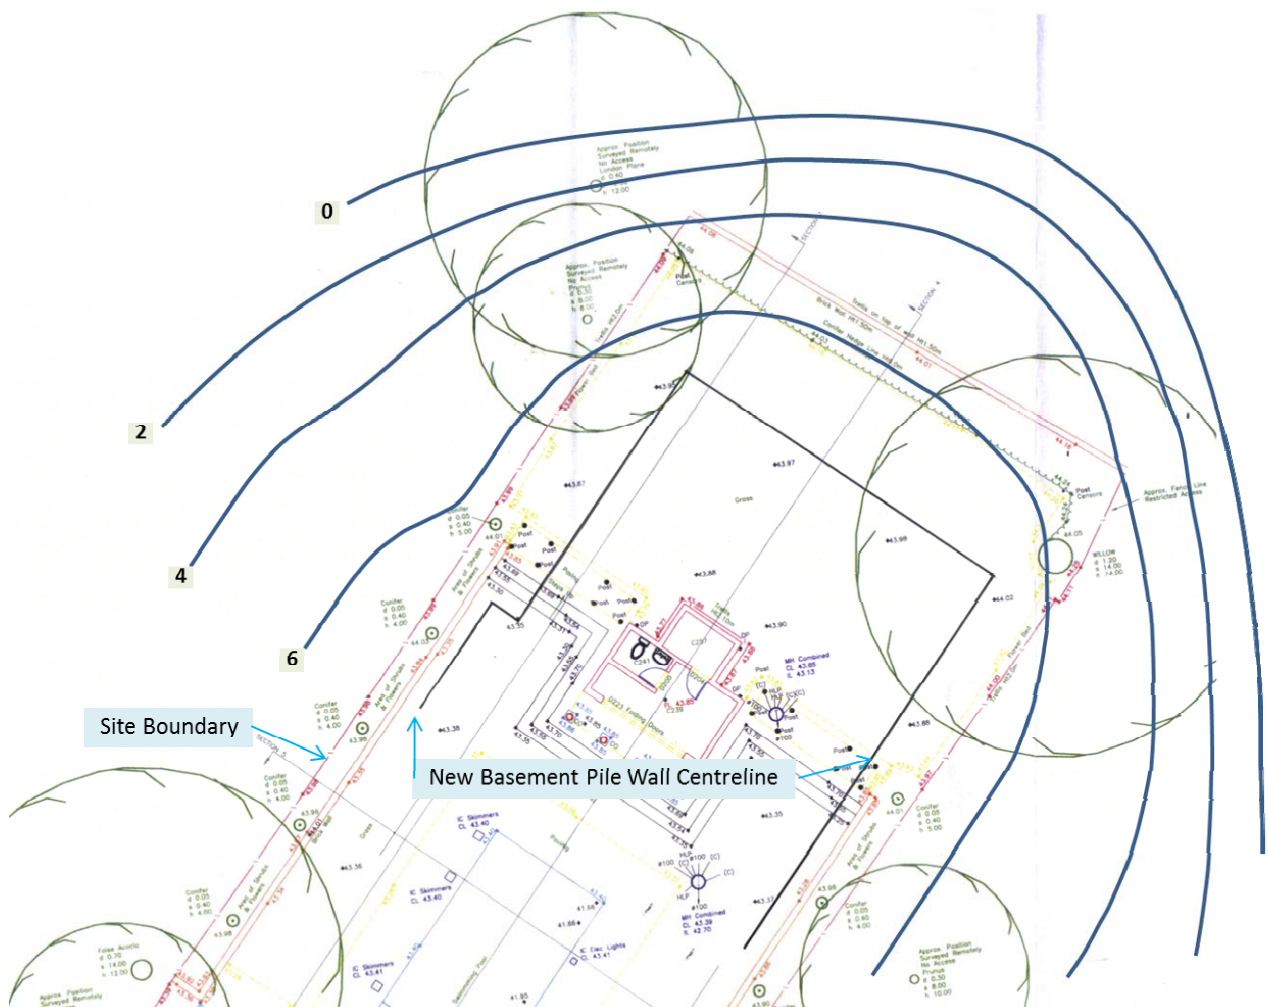
Figure 3: Northern half of Site: Contours of ground settlement arising after basement excavation (in mm)

The 'greenfield' vertical ground settlements around the outside of the excavated areas and arising cumulatively after basement excavation have been interpreted and traced as a set of contours to the nearest millimetre. This is shown below in two figures for the northern and southern half of the Site and in figure 3 & 4. For interpretation of the corner or 3D effects, the settlements in the section are taken as reducing to 2/3 of the plane strain values at the corner.

The figure is based on a survey drawing that shows, for the southern half, the existing plan arrangement of the existing structure of number 46 Avenue road clearly and a part of the two adjacent above-ground structures of number 44 and number 48 Avenue road. The centreline of the two piled walls has been drawn on to indicate their positions. A critical dimension of 3.2m is given for the southern half, being the distance between the opposing faces of the two structures of numbers 44 and 46 Avenue Road at their closest points. The maximum calculated ground settlement was approximately 7.5mm, i.e. marginally more than the largest contour line given and at a position very close to the given 6mm contour line.
