15 November 2017
Our Ref: P1019J1129/ps/rs

35 TEMPLEWOOD AVENUE – GROUND MOVEMENT ASSESSMENT (GMA)

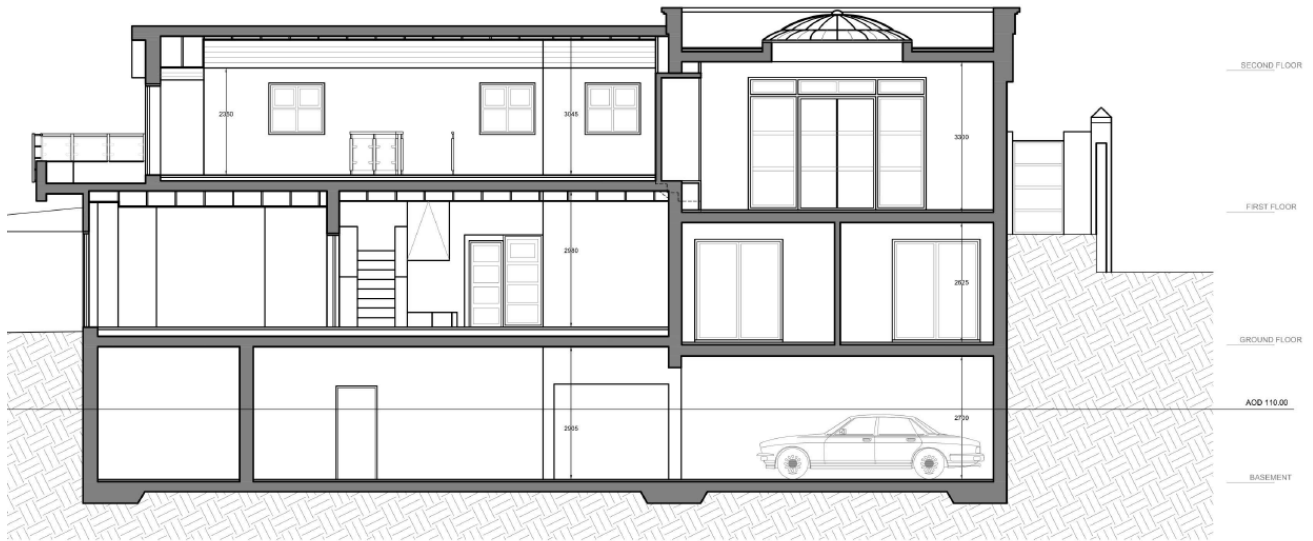
Figure 2.2: Typical long section

The existing lower ground floor (which is present over much of the existing building footprint) formation level is at around 111mOD and the proposed excavation slab formation level is 107.5mOD. Figure 2.2 & Figure 2.3 display typical long/cross sections of the proposed development with proposed footing locations highlighted in green.

Figure 2.2 shows the geometry and intensity of the footing loads as applied in the Pdisp model. The permanent building loads were evaluated on the basis of an indicative load takedown based on the proposed floor arrangements provided.

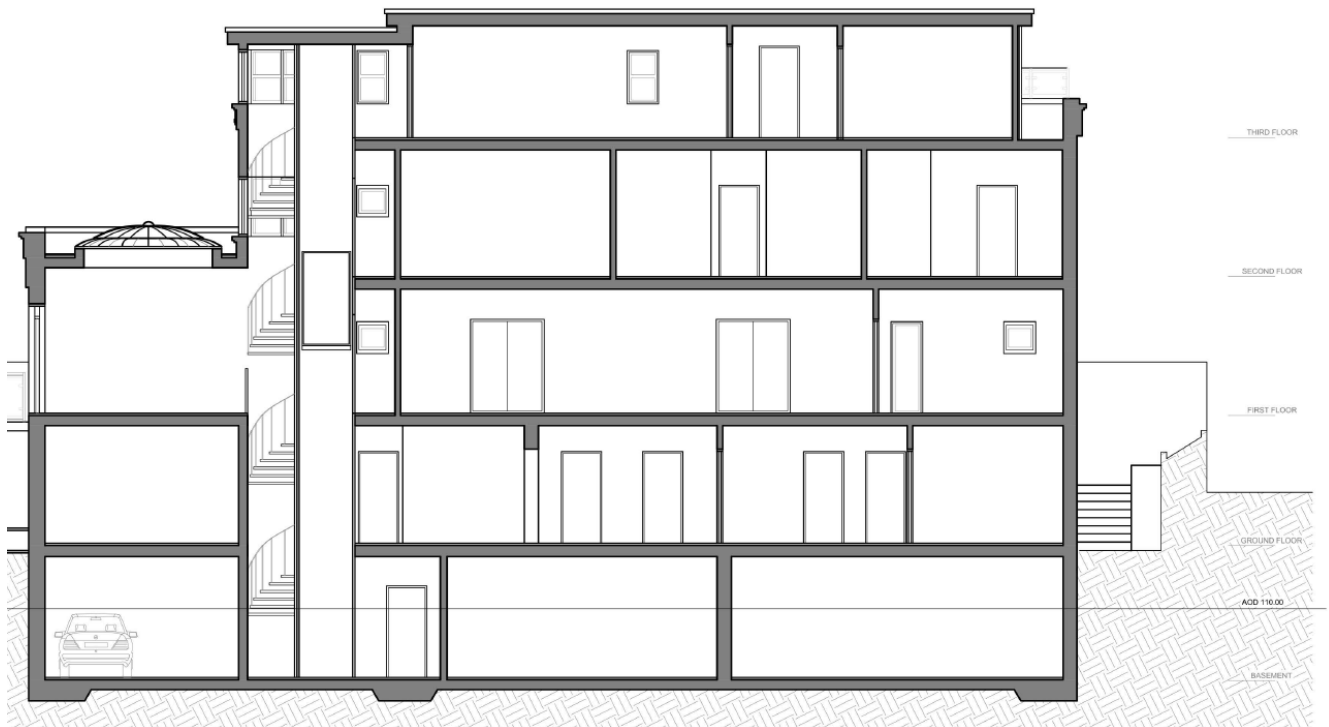
Figure 2.3: Typical cross section

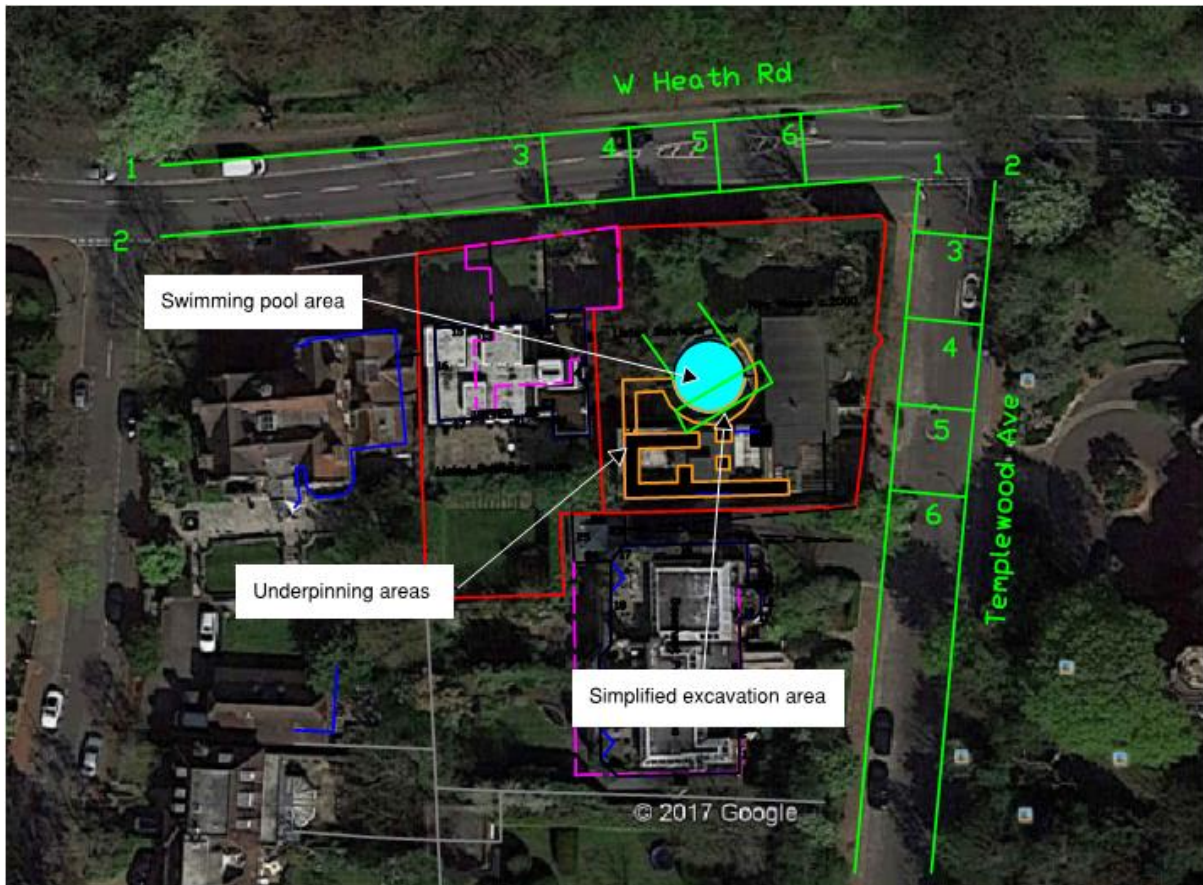
Figure 4.1: Additional analysis elements displayed in green.

The idealized geometries adopted for the analysis of the swimming pool and roadway/pavement, are shown in green in Figure 4.1.

W Heath Road and Templewood Avenue run adjacent to the site under consideration in the North and East, respectively. The impact of underpinning and excavation works on these roads has also been assessed in terms of maximum vertical and horizontal deflections at a number of locations. Soil displacements were monitored along the green lines drawn on the streets (see Figure 4.1). Lines running both parallel (segments 1 & 2) and perpendicular (segments 3-6) to the streets were defined to capture the effects more accurately.
