St Giles - Zone 3 : 6 Denmark Street
Listed Building Application

The existing building is located on Denmark Street, London WC2H 8LS. The building is undergoing a full refurbishment in accordance with Listed Building Consent - 2012/6867/L. Ian Chalk Architects have been appointed as the architects to deliver the building on site and Cord Contracting as the Contractor.

No.6 Denmark Street forms one of a number of late 17th Century terraces along Denmark Street that were developed at the same time. ICA are appointed to refurbish nos. 6, 7, 9 & 10.

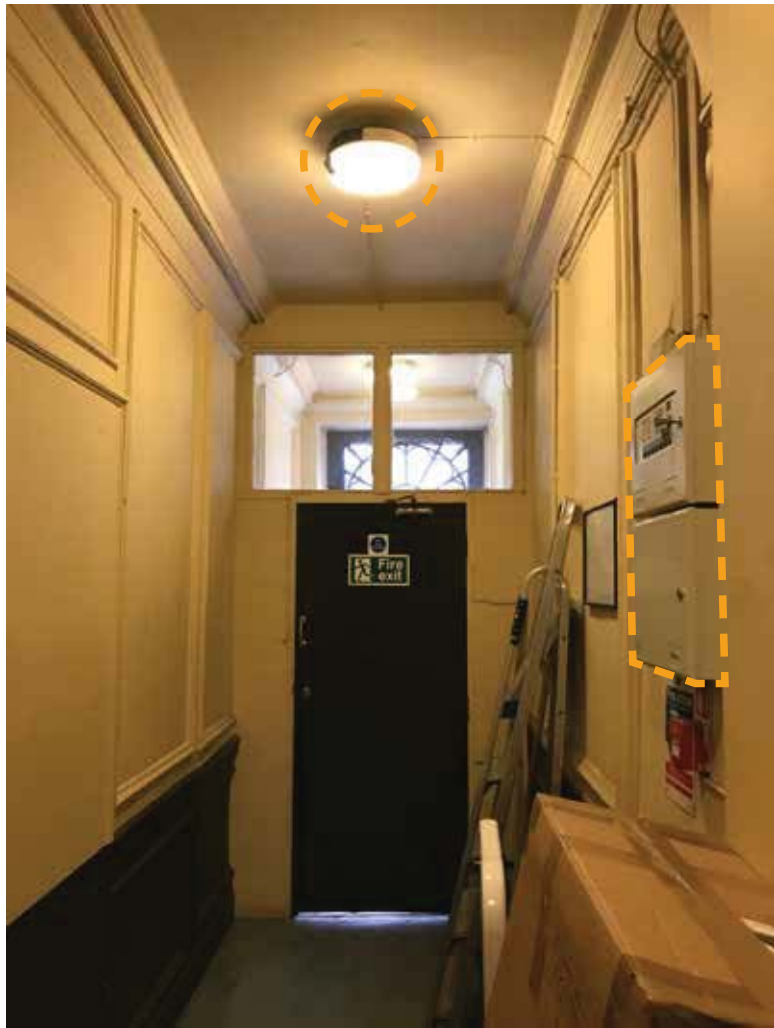
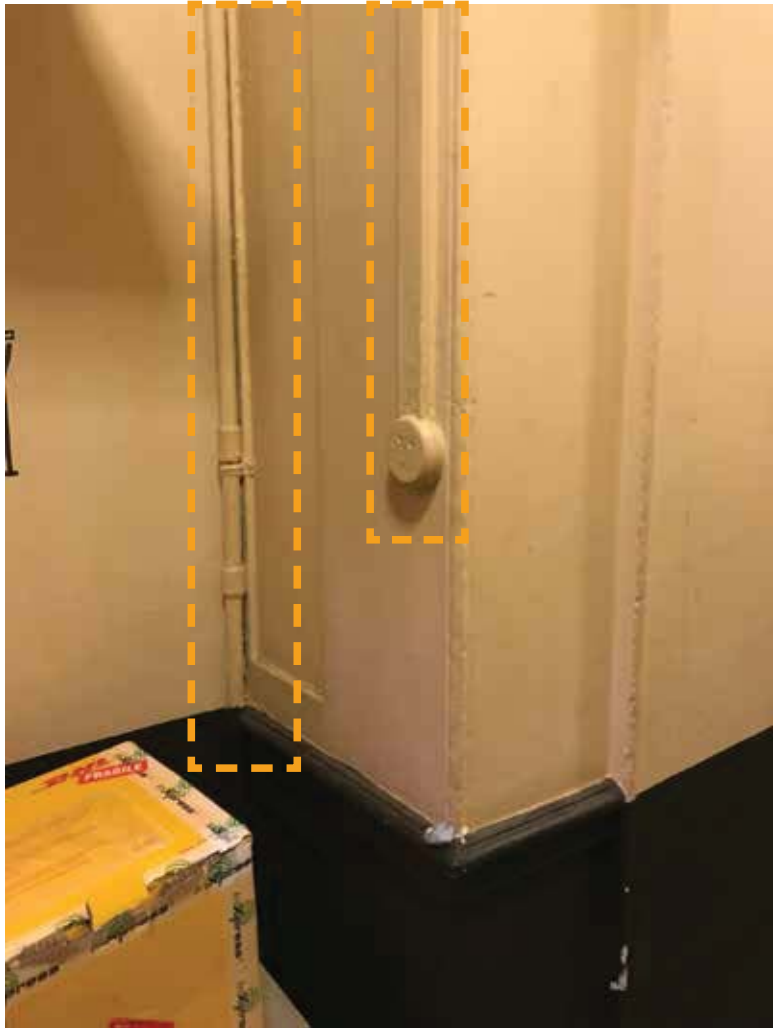
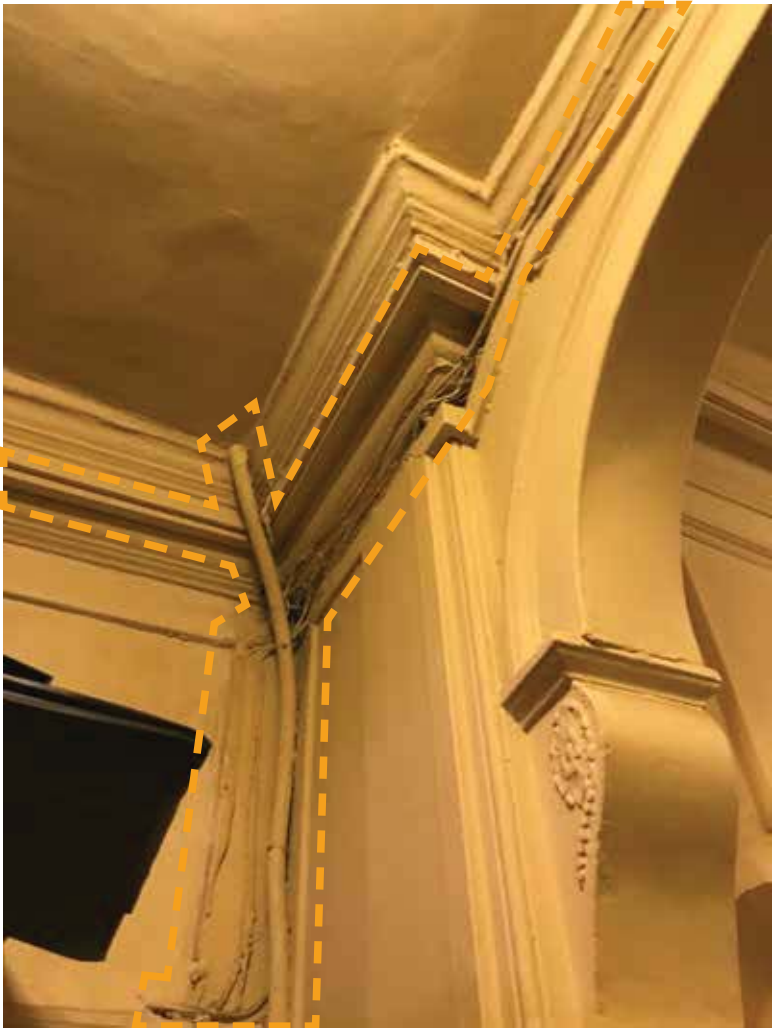
Entrance Hall of No.6, September 2017, following possession showing an array of surface mounted containment, wires and wall-mounted lighting

The existing building is generally in a poor condition and the services provision throughout is inadequate and piecemeal. This is typical of old buildings where later services have been added at varying stages. The photographs to the right show various services installations across the building.

There has been no cohesive strategy and the result is a clutter of surface-fixed wiring and pipework that compromises the reading of the historic fabric and, in places, damages the fabric where cornices/dados have been chopped out to run routes.

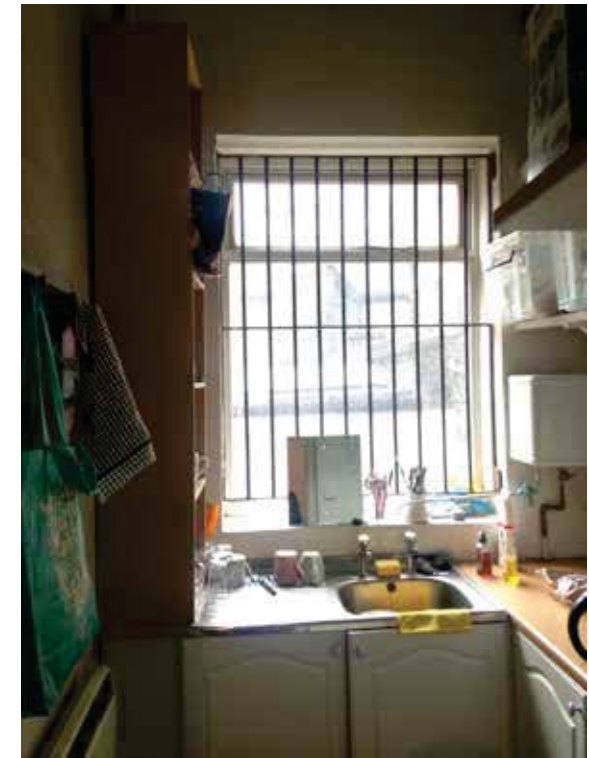
Busy kitchenettes spoil reading of closet wing

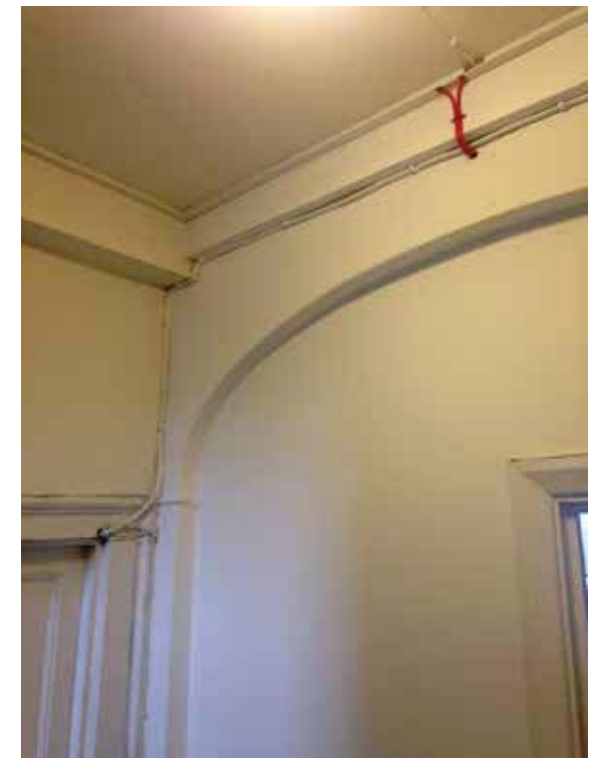
Wiring running across openings and through walls affects the existing fabric. Subsequent modifications to the spaces make for a clash of bulkheads, details and features not in keeping with the period and heritage of the building

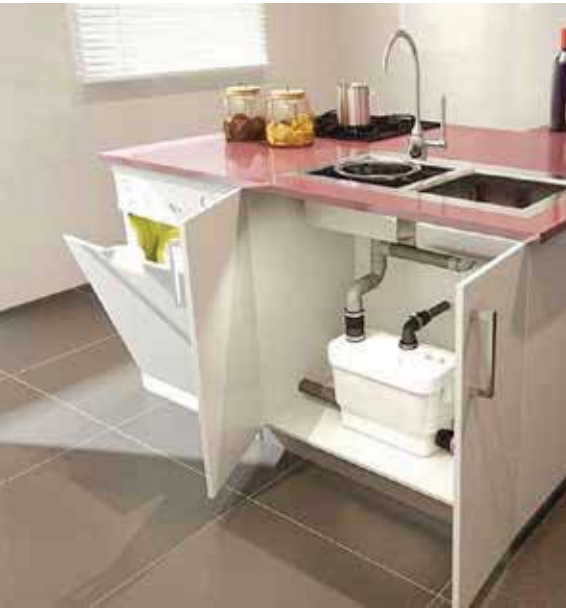
Pumped drainage unit located beneath kitchen sink

The consented scheme shows routes for drainage within the floor void, passing from the front, through the back room and out to the rear elevation. The distance of pipework required means that gravity drainage cannot be achieved due to a limited floor void. The consented scheme includes the provision of pumped foul drainage in the form of a Saniflo type pump located within the kitchen island unit.

These units, whilst having some benefits, are noisy and can become blocked - this is a particular risk in this building as the pumps will be serving kitchen sinks and food waste and grease can easily block the pumping mechanism.

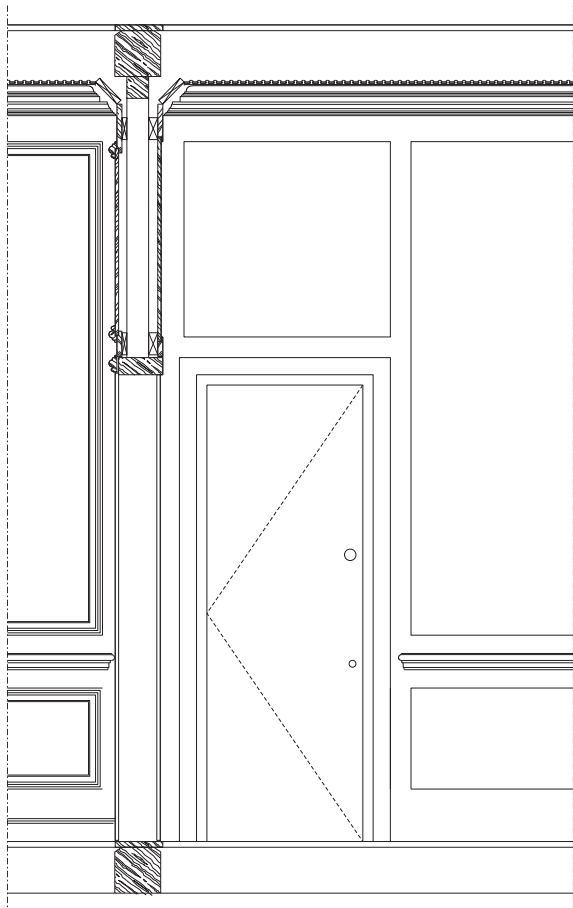
Existing section showing partition and panelling

The spine wall partition is timber framed and requires structural modification to address ongoing issues of building settlement. Once structural modifications are complete and linings reinstated, we have agreed the principle of installing a new vertical distribution riser within the back room. This riser will be panelled with a high-level plaster cornice, all detailed to match existing. This riser can be installed within the upper floors of the house and allow for efficient introduction of modern servicing.

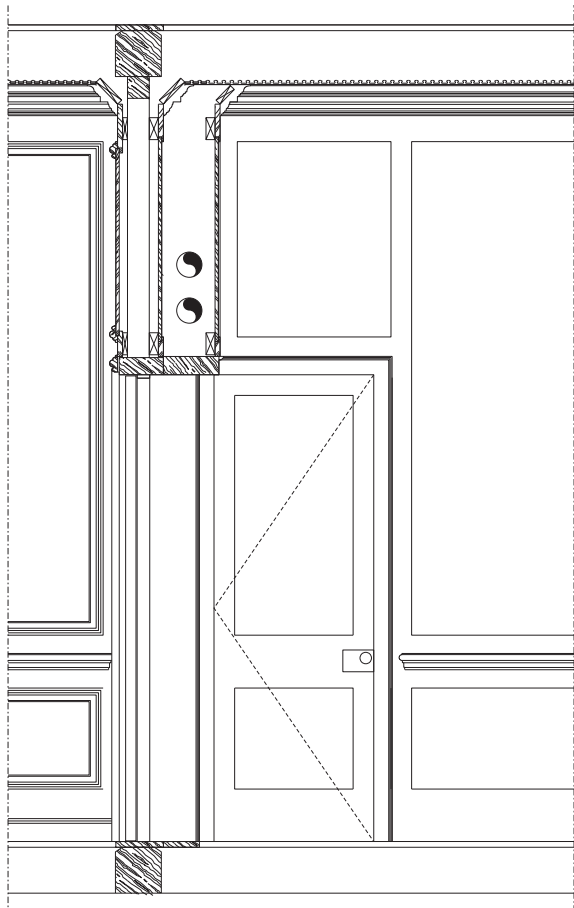
Proposed section showing services zone concealed behind new panelling

For No.9, we have been in discussion with Camden Conservation and have agreed in principle an alternative strategy that we felt would be a more appropriate way of servicing the existing building. This approach entailed carrying out minor modifications to the partition wall that separates front and back rooms.

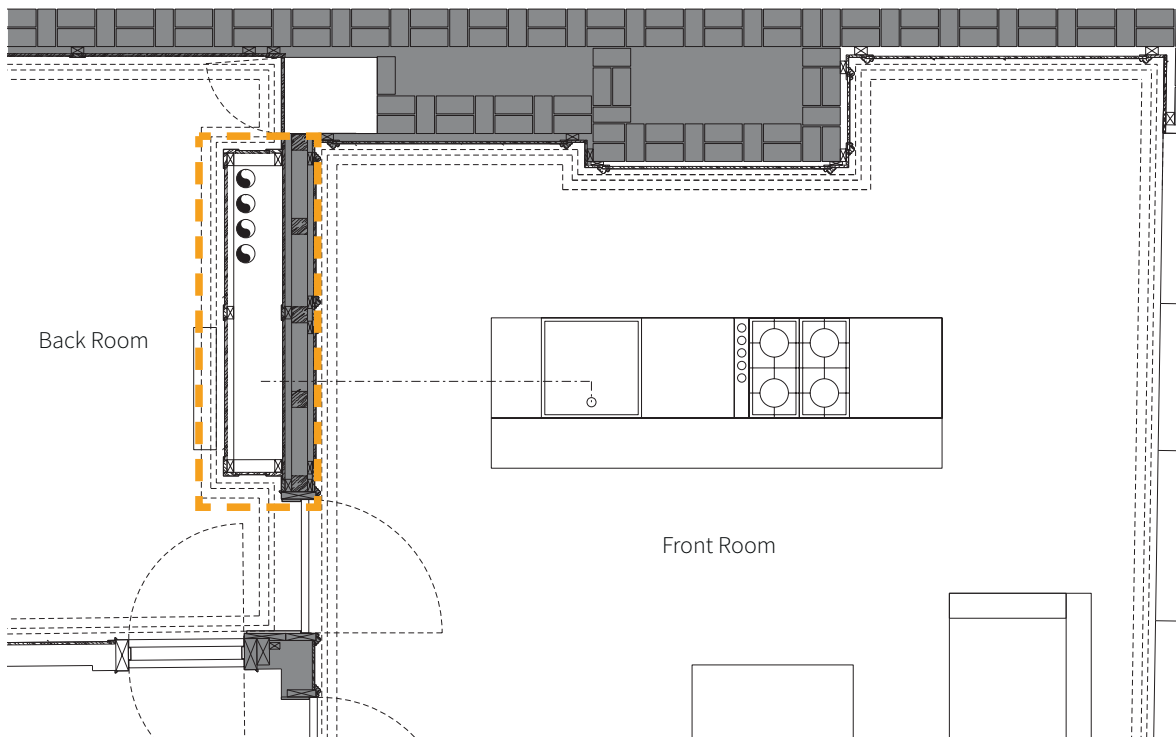
Proposed plan showing services zone concealed behind existing panelling with doors and architraves reinstated

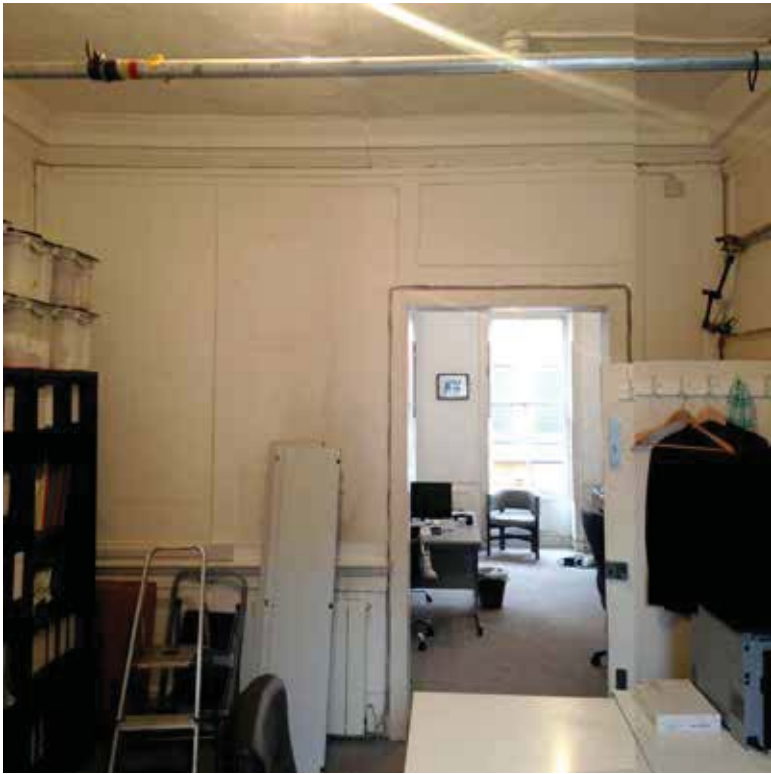
First Floor back room - existing spine wall, large opening to front room a later modification that shall accommodate a new door and be modified to more appropriately suit the panelling

Our preferred solution, as with No.9, is creating a false spine wall. Whilst there is a small amount of harm by passing vertical pipework through existing floorboards and lath and plaster ceilings, this is kept to a minimum and allows both front and rear rooms to be serviced from a single riser. The false wall will be panelled to match existing, with a new plaster cornice. All existing panelling will be retained in-situ and any new works will be scribed into the existing, ensuring that the false wall can be removed in future and the original panelling revealed.

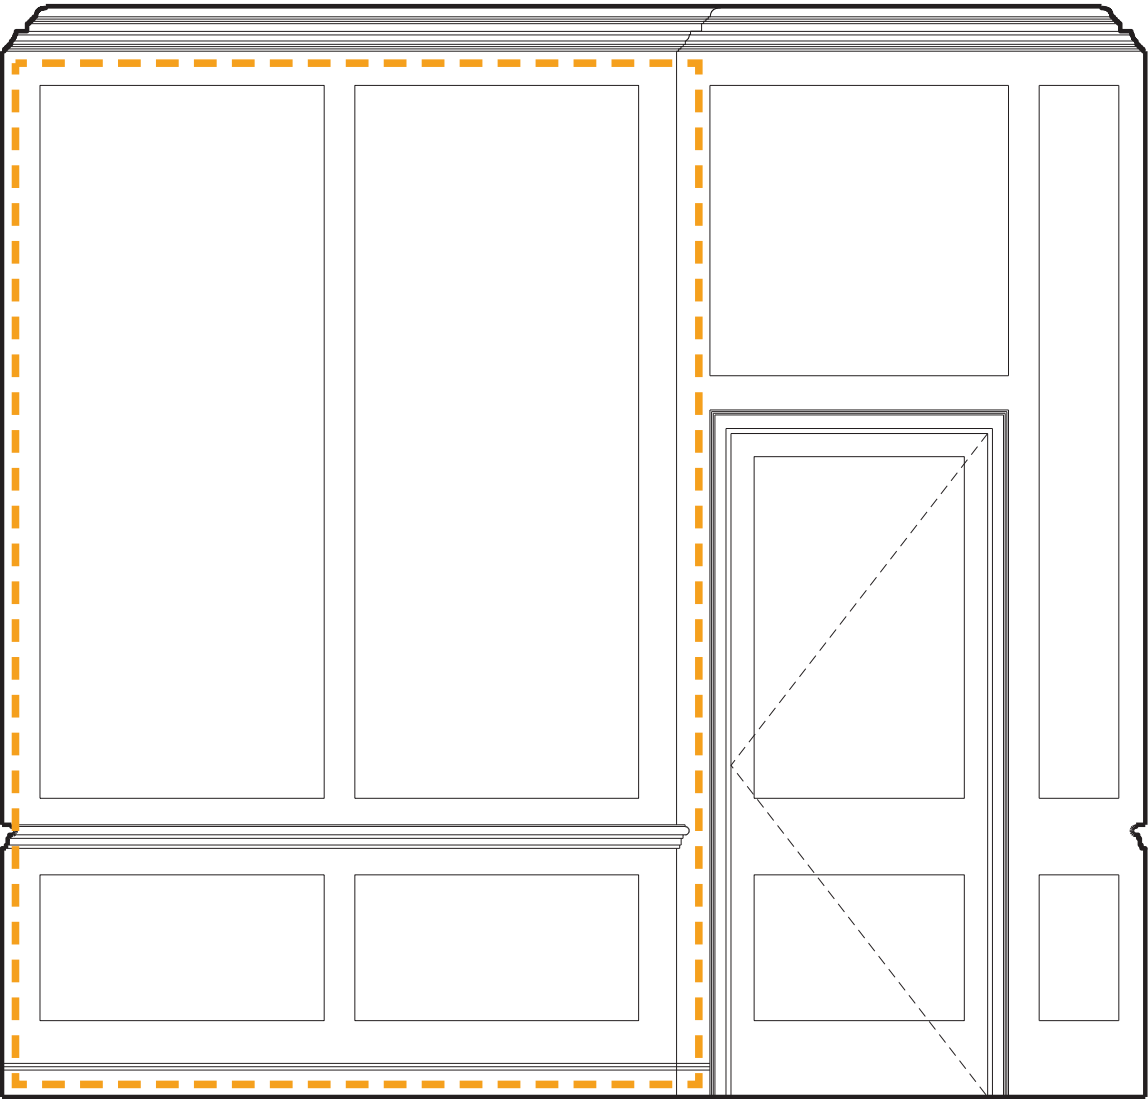
Proposed elevation showing services riser, panelled to match existing. Door access remains unaffected

The structural works required to arrest the sinking of the spine wall (see accompanying Engenuiti Report) also offer an opportunity to integrate the services route in this location with minimal further intrusion to the existing building.

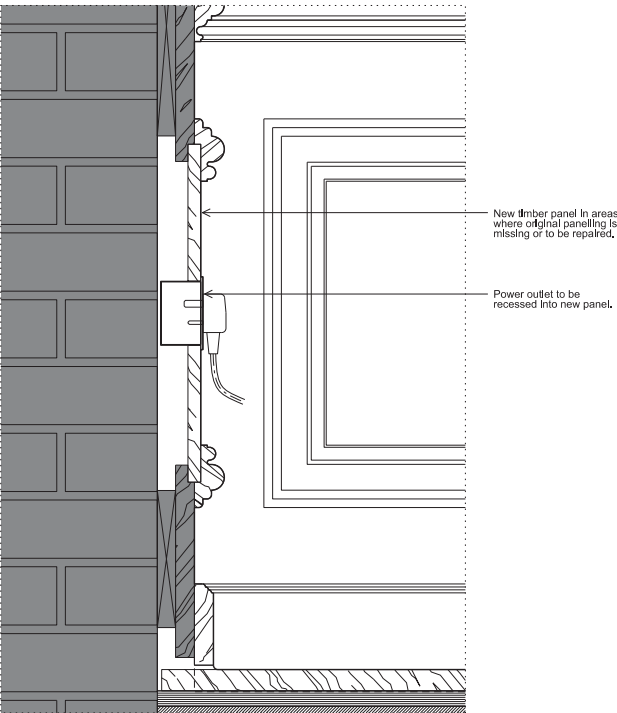
Recessed back-box and flush-mounted switch plate

Where panelling has been damaged/lost and needs replacing, we will incorporate recessed back-boxes with flush plates into new panelling.

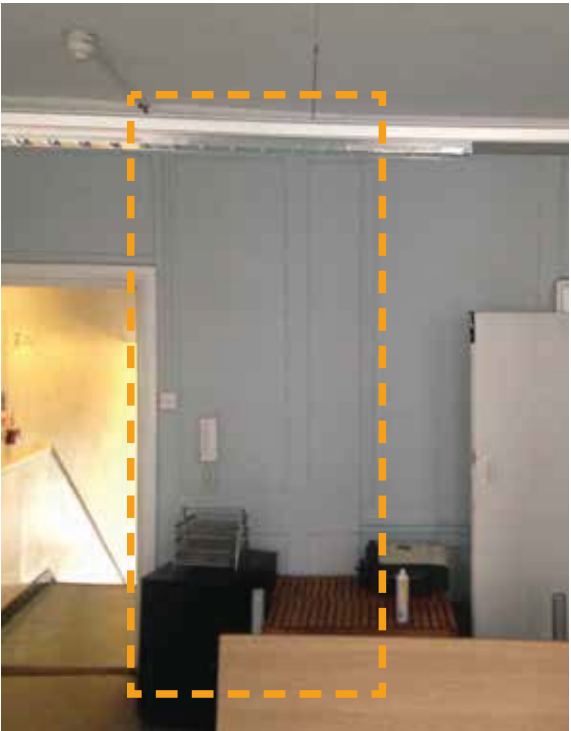
Example of modified panelling in no. 6 Denmark Street. This panel will require replacement and offers the opportunity to incorporate flush-mounted switch plates

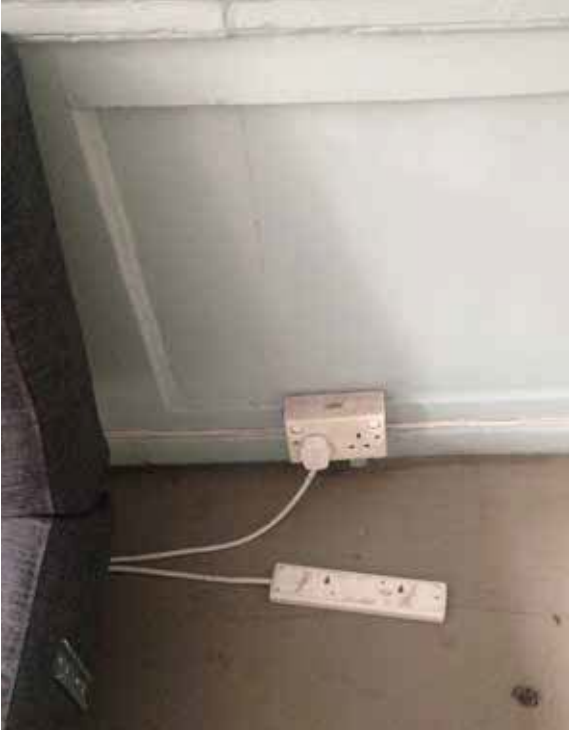
Example of low electrical sockets to be removed to allow repairs to skirting and panelling

Note- Where existing power outlets are provided at low level on skirting, outlet to be removed and skirting repaired.

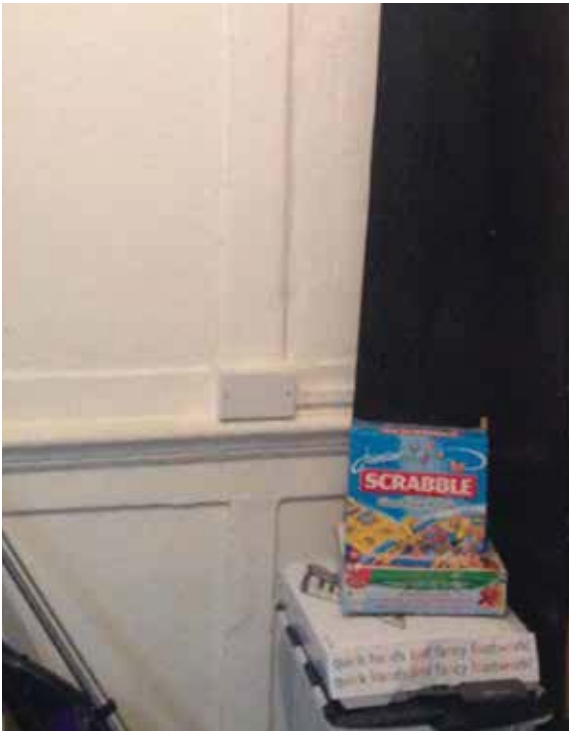
Example of dado level services' cut-outs in existing panelling in no. 6 Denmark Street. Repairs will be required here while switch plates will be located somewhere less conspicuous

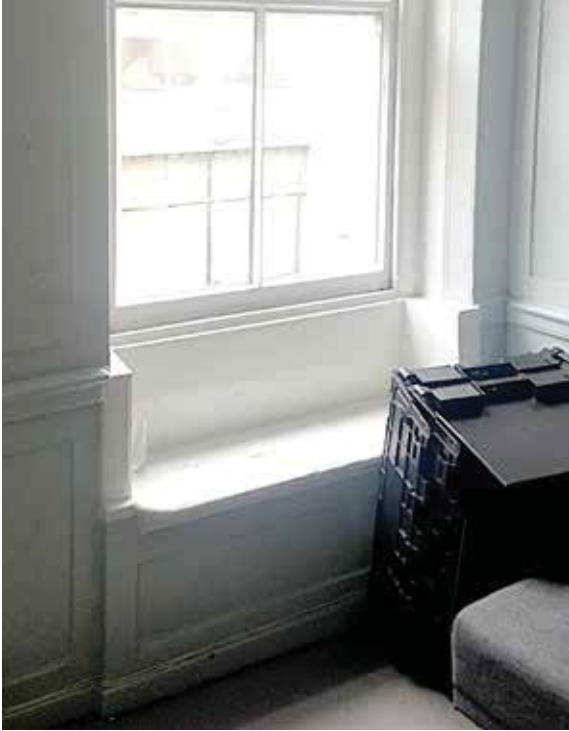
Example of fully intact panelling - surface-mounted back-box and switch plate will be required here

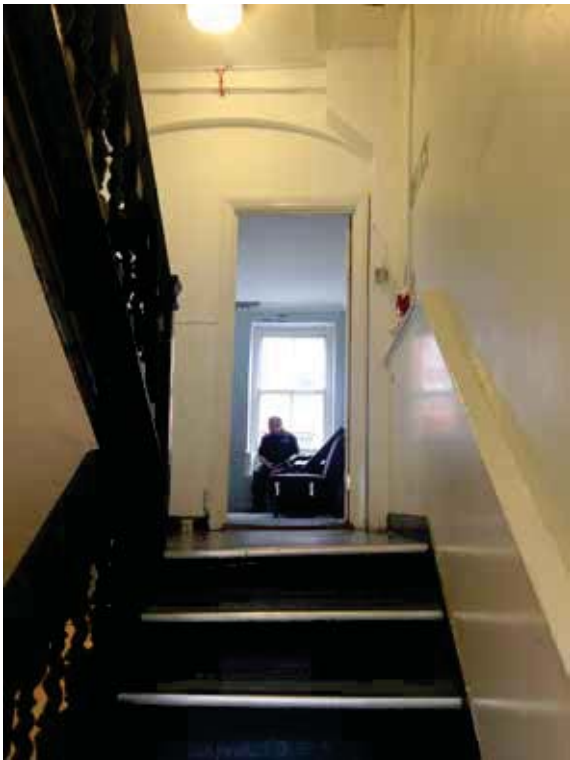
Landing showing signs of floor deflection

Currently, the structure is showing signs of failure, particularly in the stairwells. Initial inspection has uncovered historic attempts to address the continual subsidence and while improvements have been made, the problem remains.

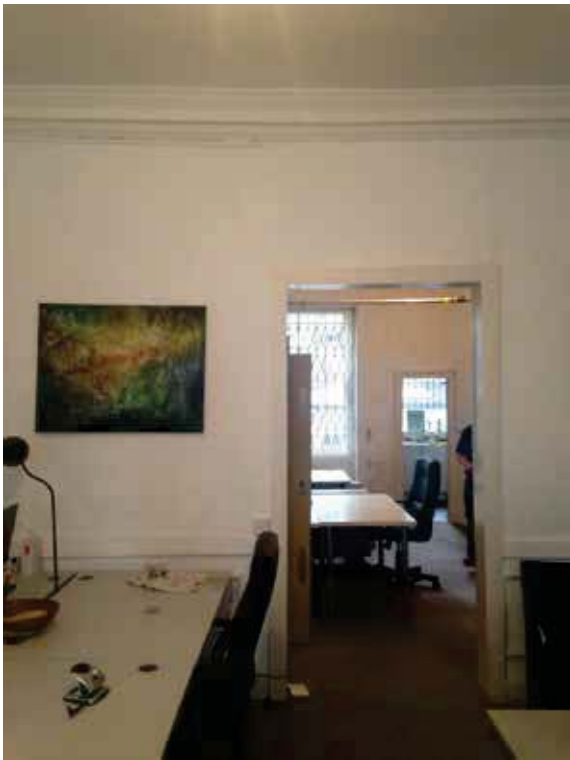
Cornice line above openings showing signs of deflection

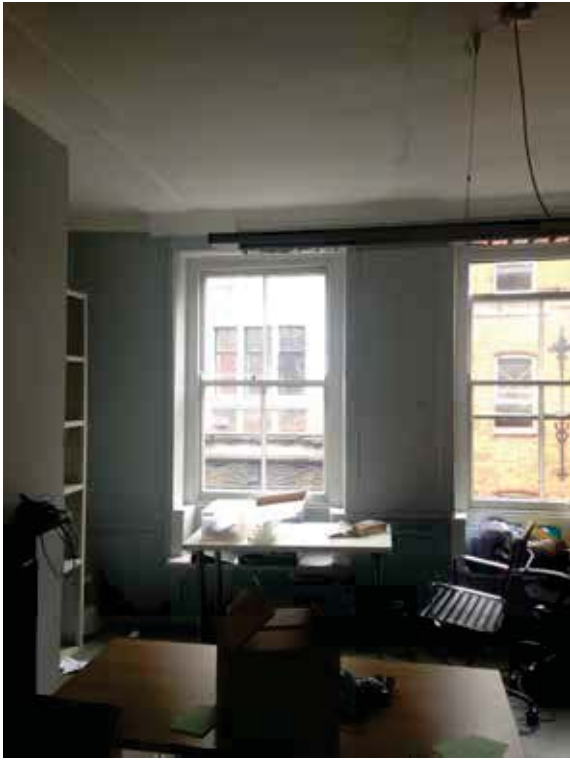
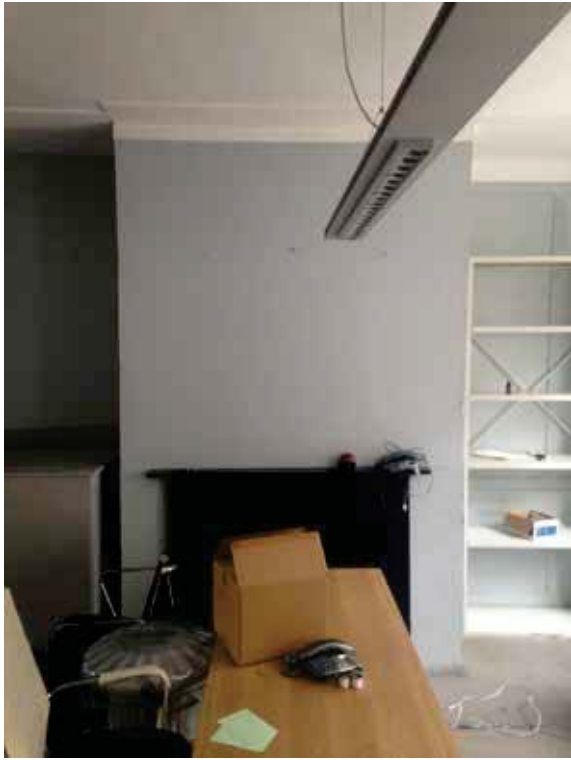
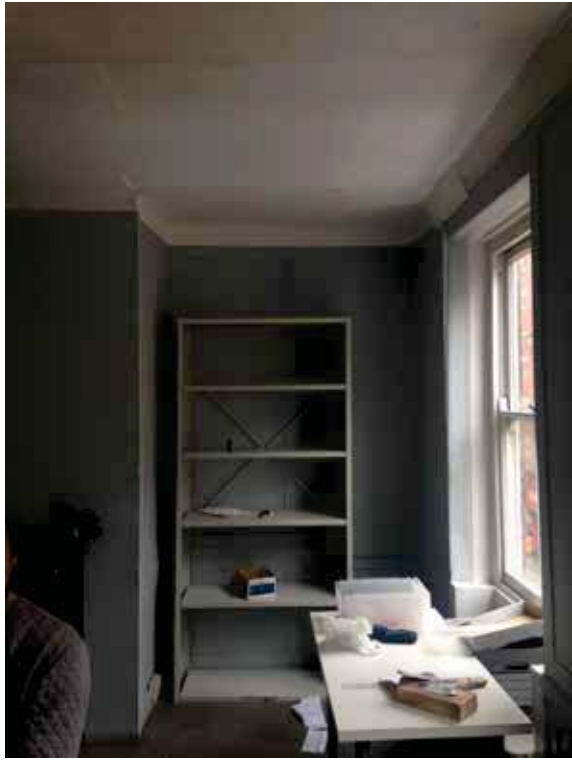
Examples of missing cornice line

The existing cornice line has sections missing and others which are damaged. This is most likely due to the historic introduction of cupboards to the fireplace niches which have now been removed. The consequence of these modifications is an incomplete & inconsistent cornice line which harms the reading of the room

This application seeks to carefully inspect and restore the existing cornice line and to reinstate sections where it is missing in order to return the room to its historic image. We will work with a plaster specialist and take squeezes of the existing cornice to match.

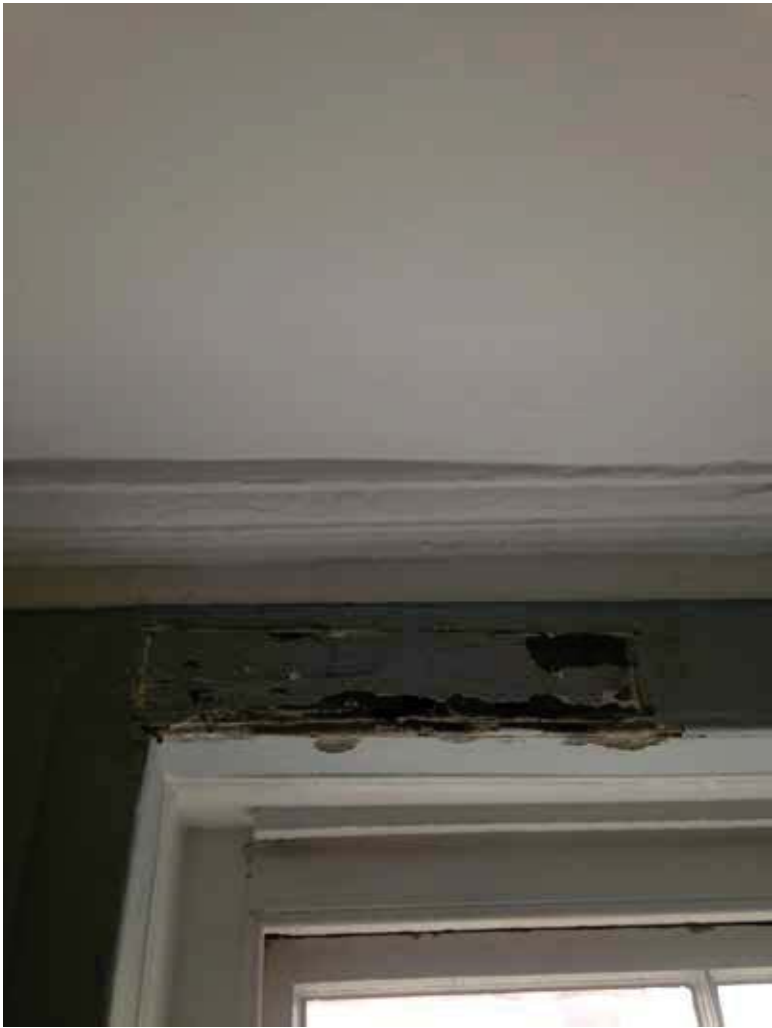
Missing cornice line above

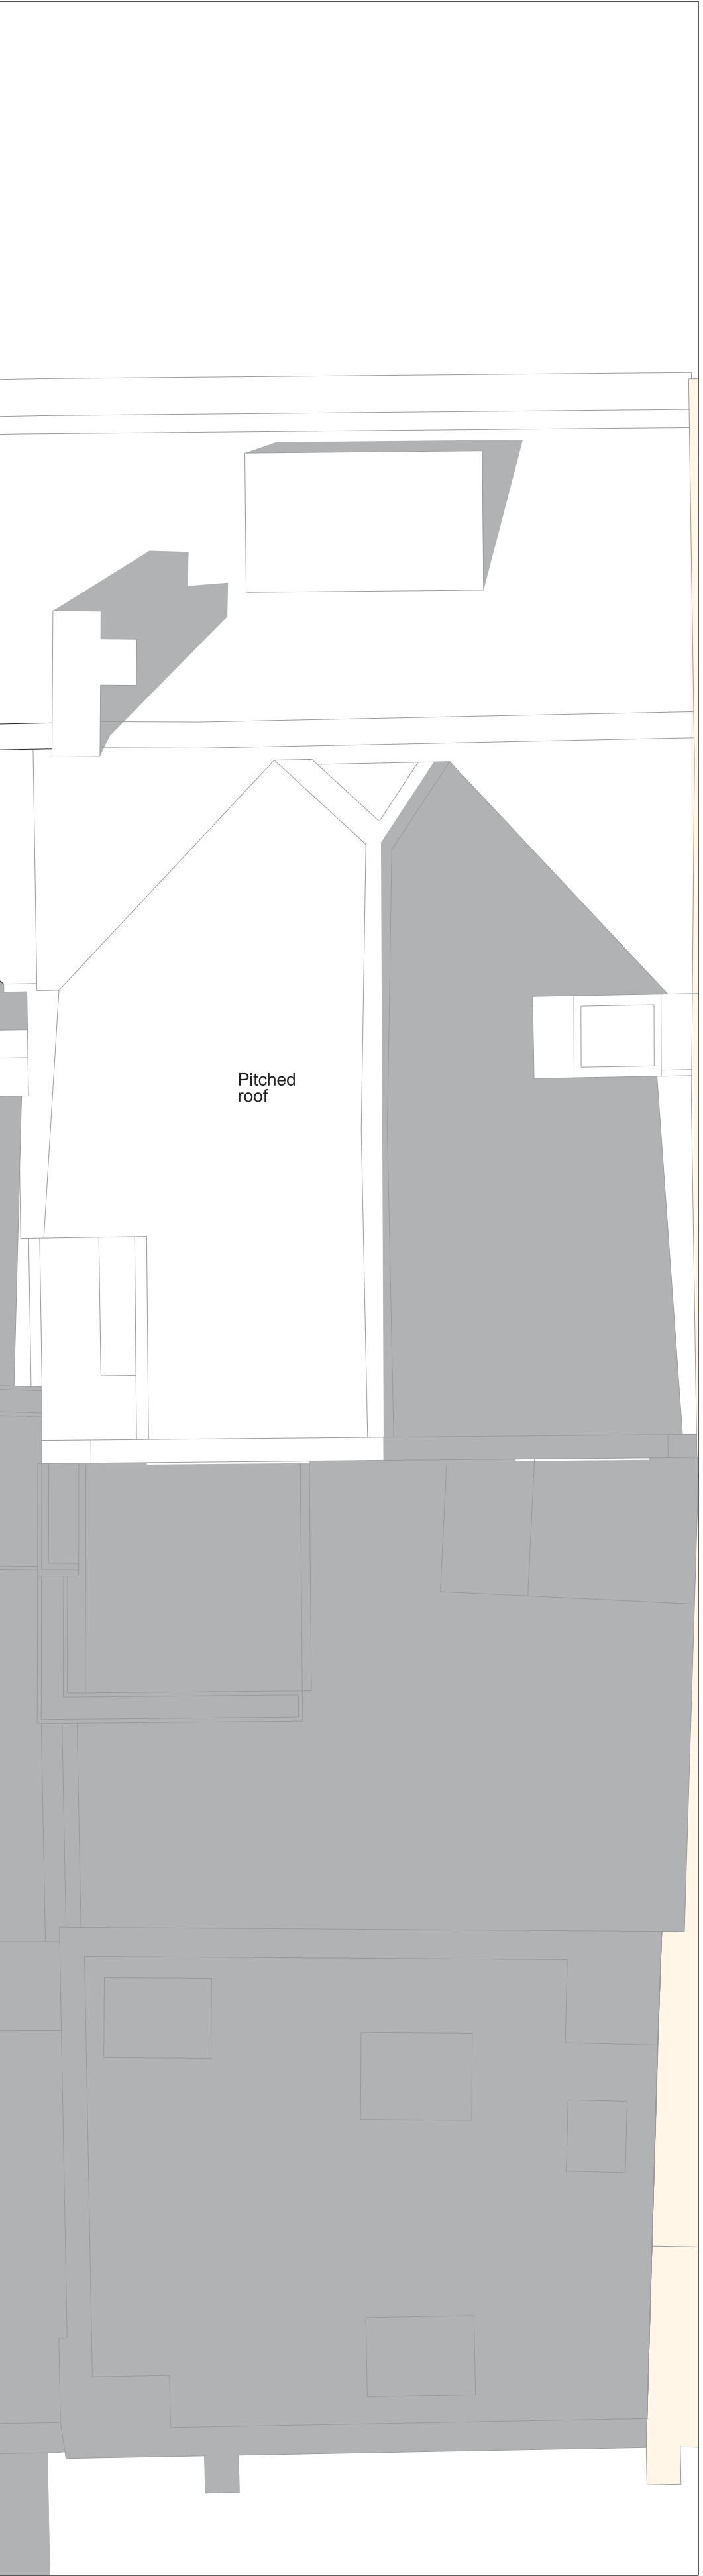
02
6D(X)102

6 Denmark Street: Existing
Roof Plan

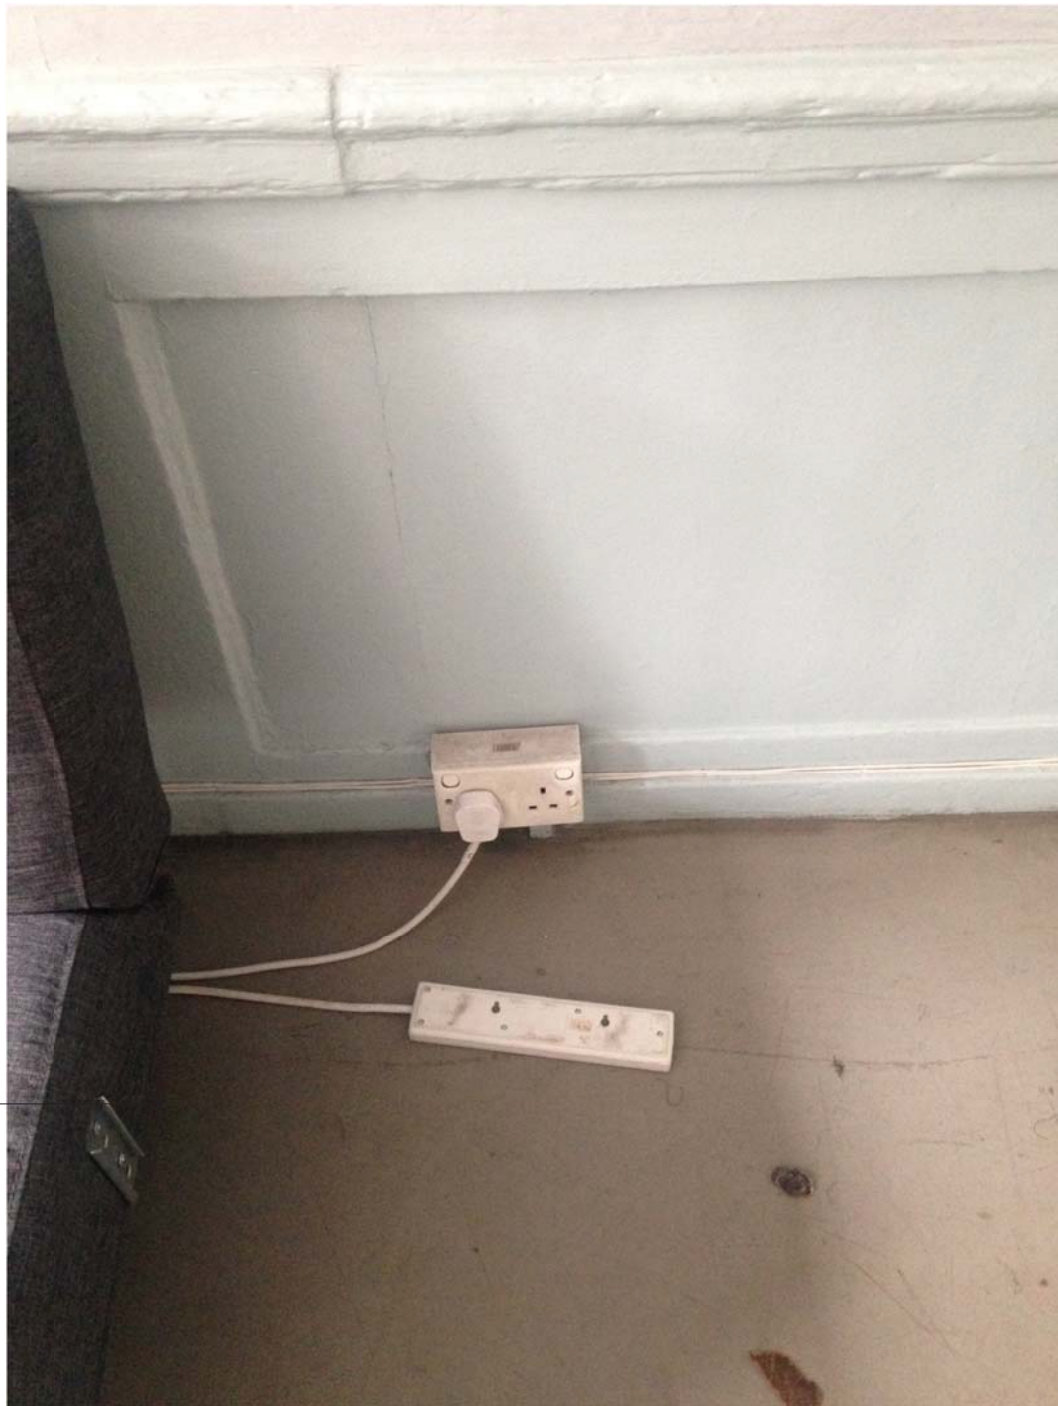
01
X_500 Condition 1 - Retained existing panelling. 1:5

Existing panelling retained in place with wiring passing behind. Small opening to be made in panel to pass through to surface mounted socket.

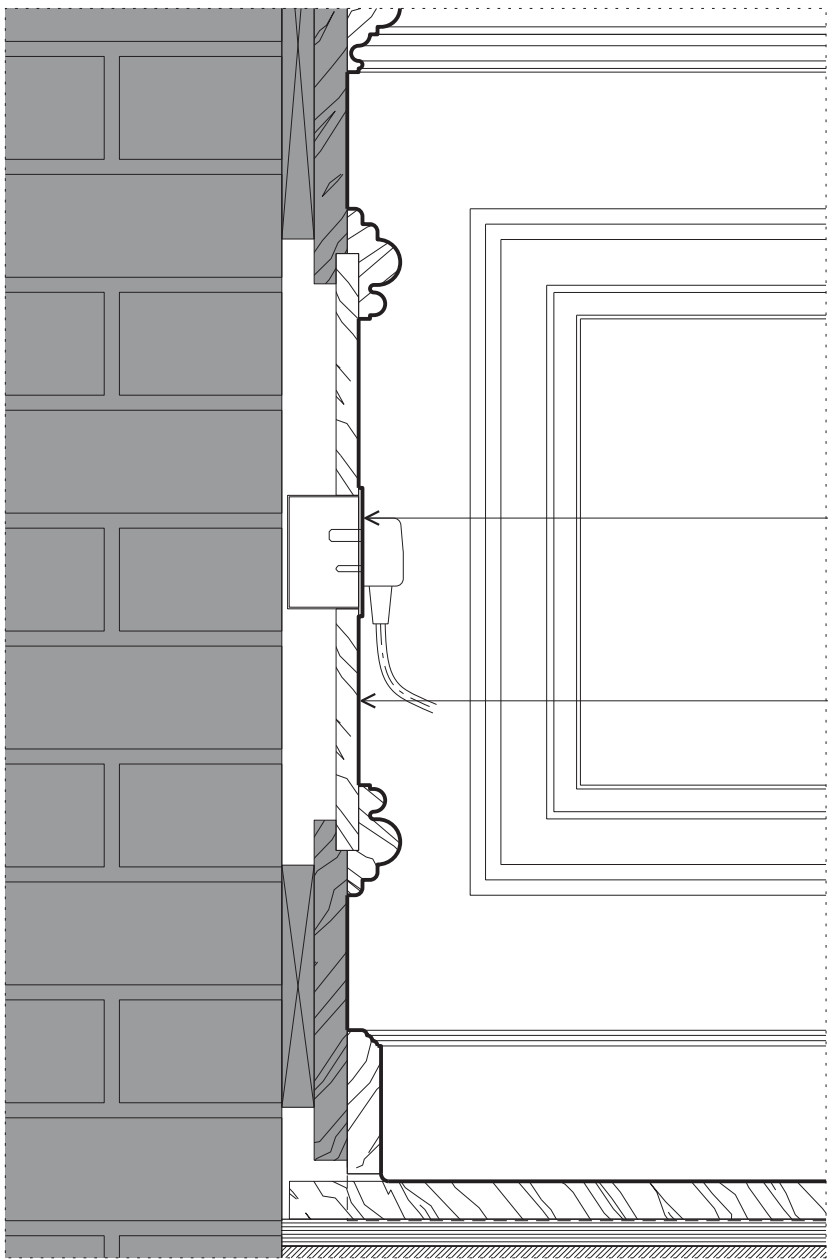
02
X_500 Power Outlet Condition 1 Recessed outlet in new/replaced panel 1:5

Power outlet to be recessed into new panel.

New timber panel in areas where original panelling is missing or to be repaired.

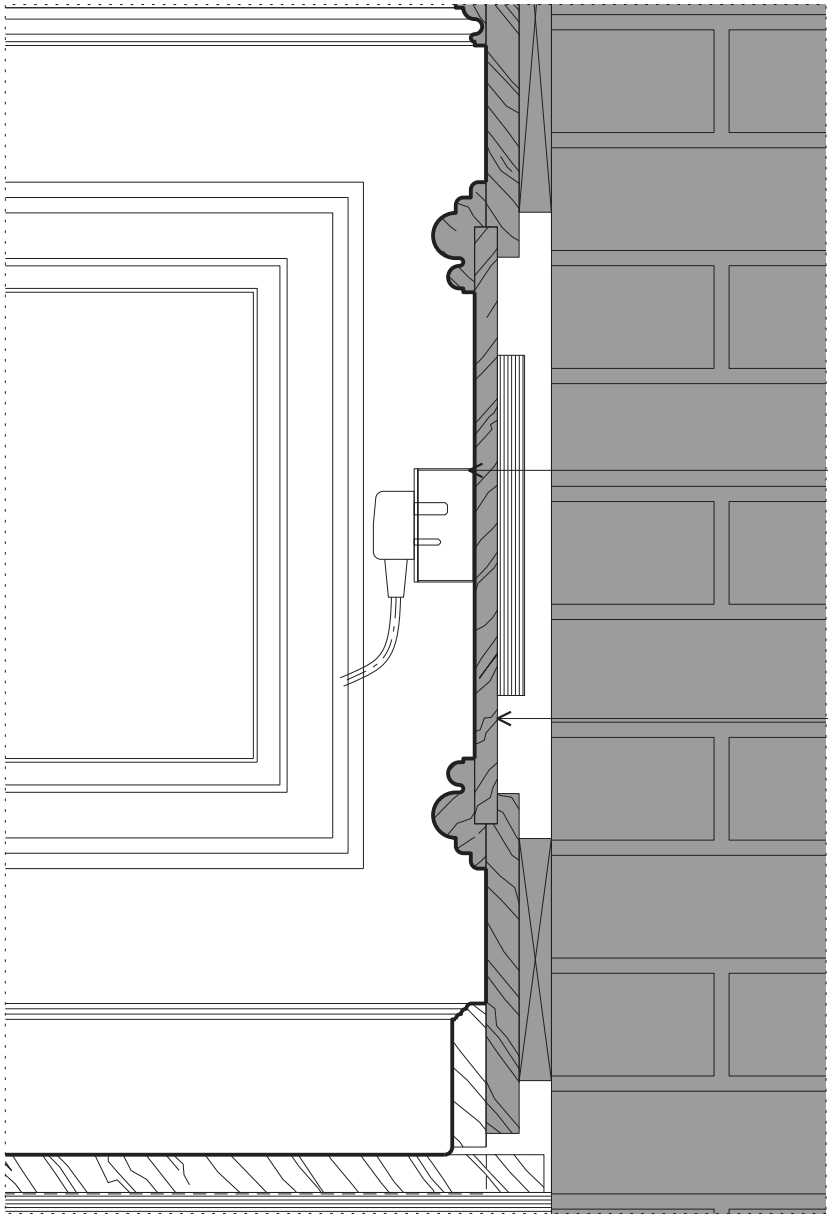
03
X_500 Power Outlet Condition 2 Surface mounted power outlet to existing panelling 1:5

Surface-mounted socket fixed to panel through to plywood patress panel affixed behind.
