St Giles - Zone 3 : 6 Denmark Street
Listed Building Application

The existing building is located on Denmark Street, London WC2H 8LS. The building is undergoing a full refurbishment in accordance with Listed Building Consent - 2012/6867/L. Ian Chalk Architects have been appointed as the architects to deliver the building on site and Cord Contracting as the Contractor.

No.6 Denmark Street forms one of a number of late 17th Century terraces along Denmark Street that were developed at the same time. ICA are appointed to refurbish nos. 6, 7, 9 & 10.

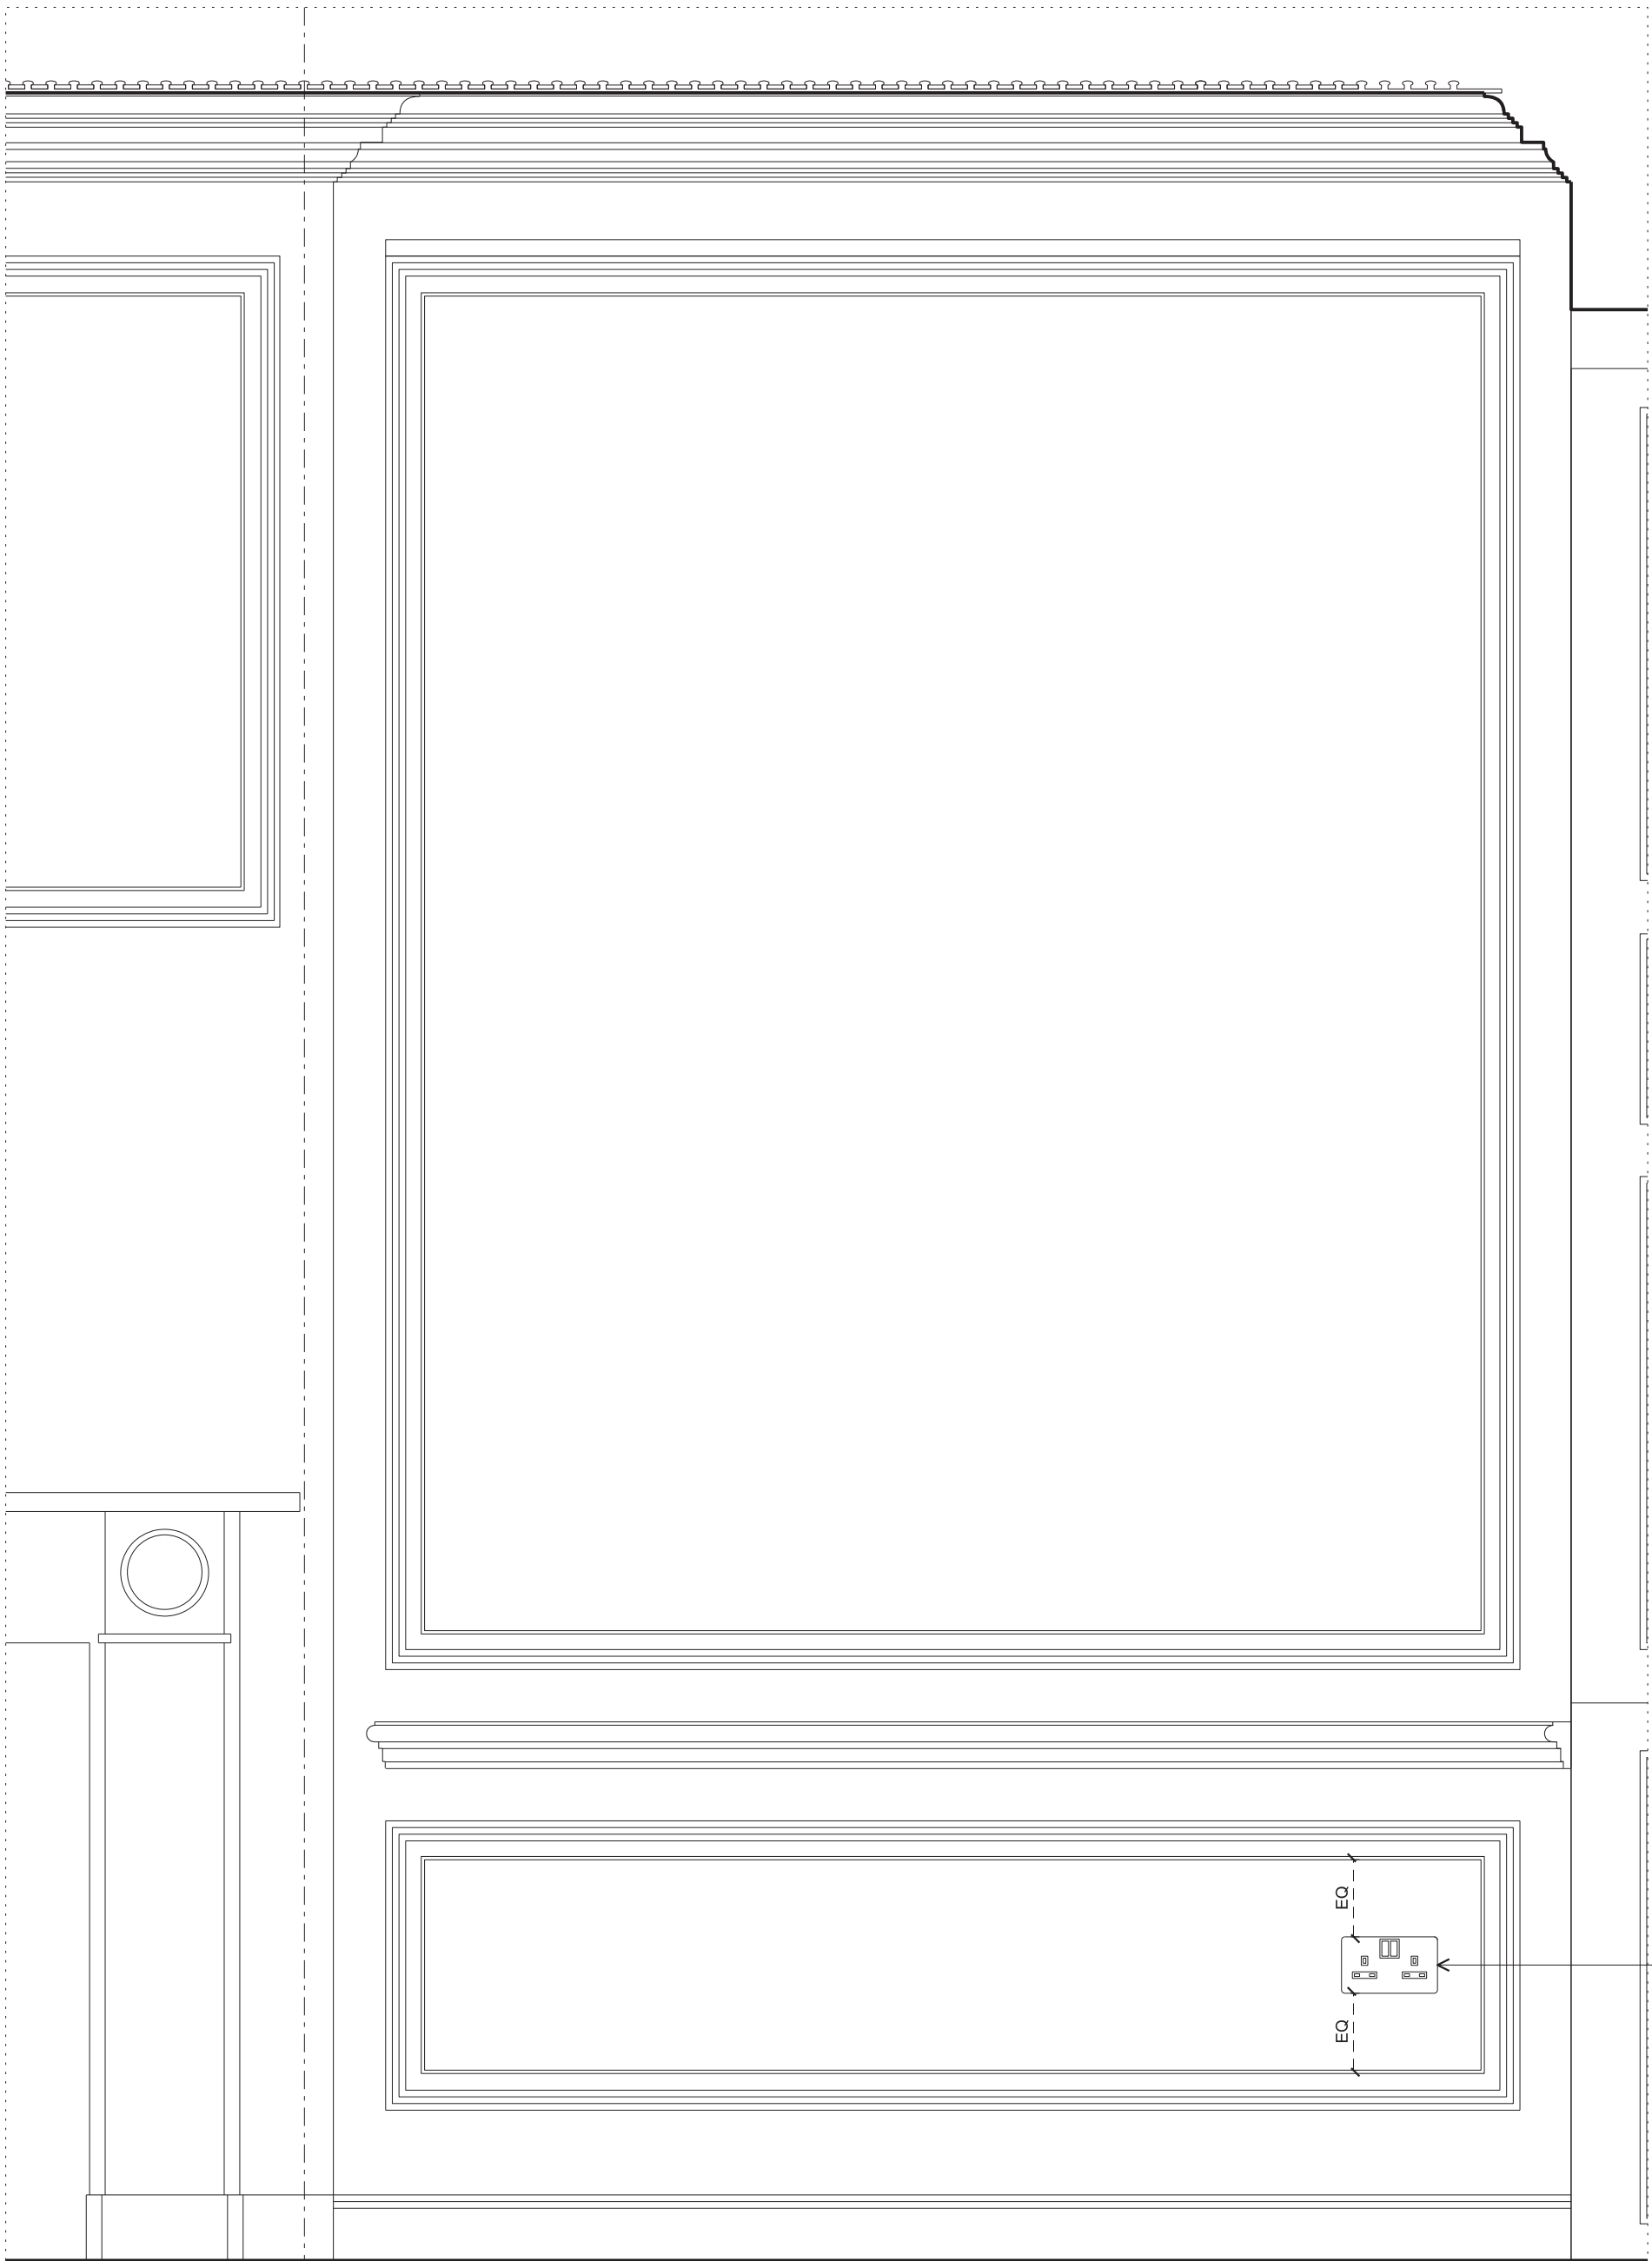
04
X_500 Power Outlet Condition 2 Elevation 1:10

Socket to align centrally in existing lower panel.

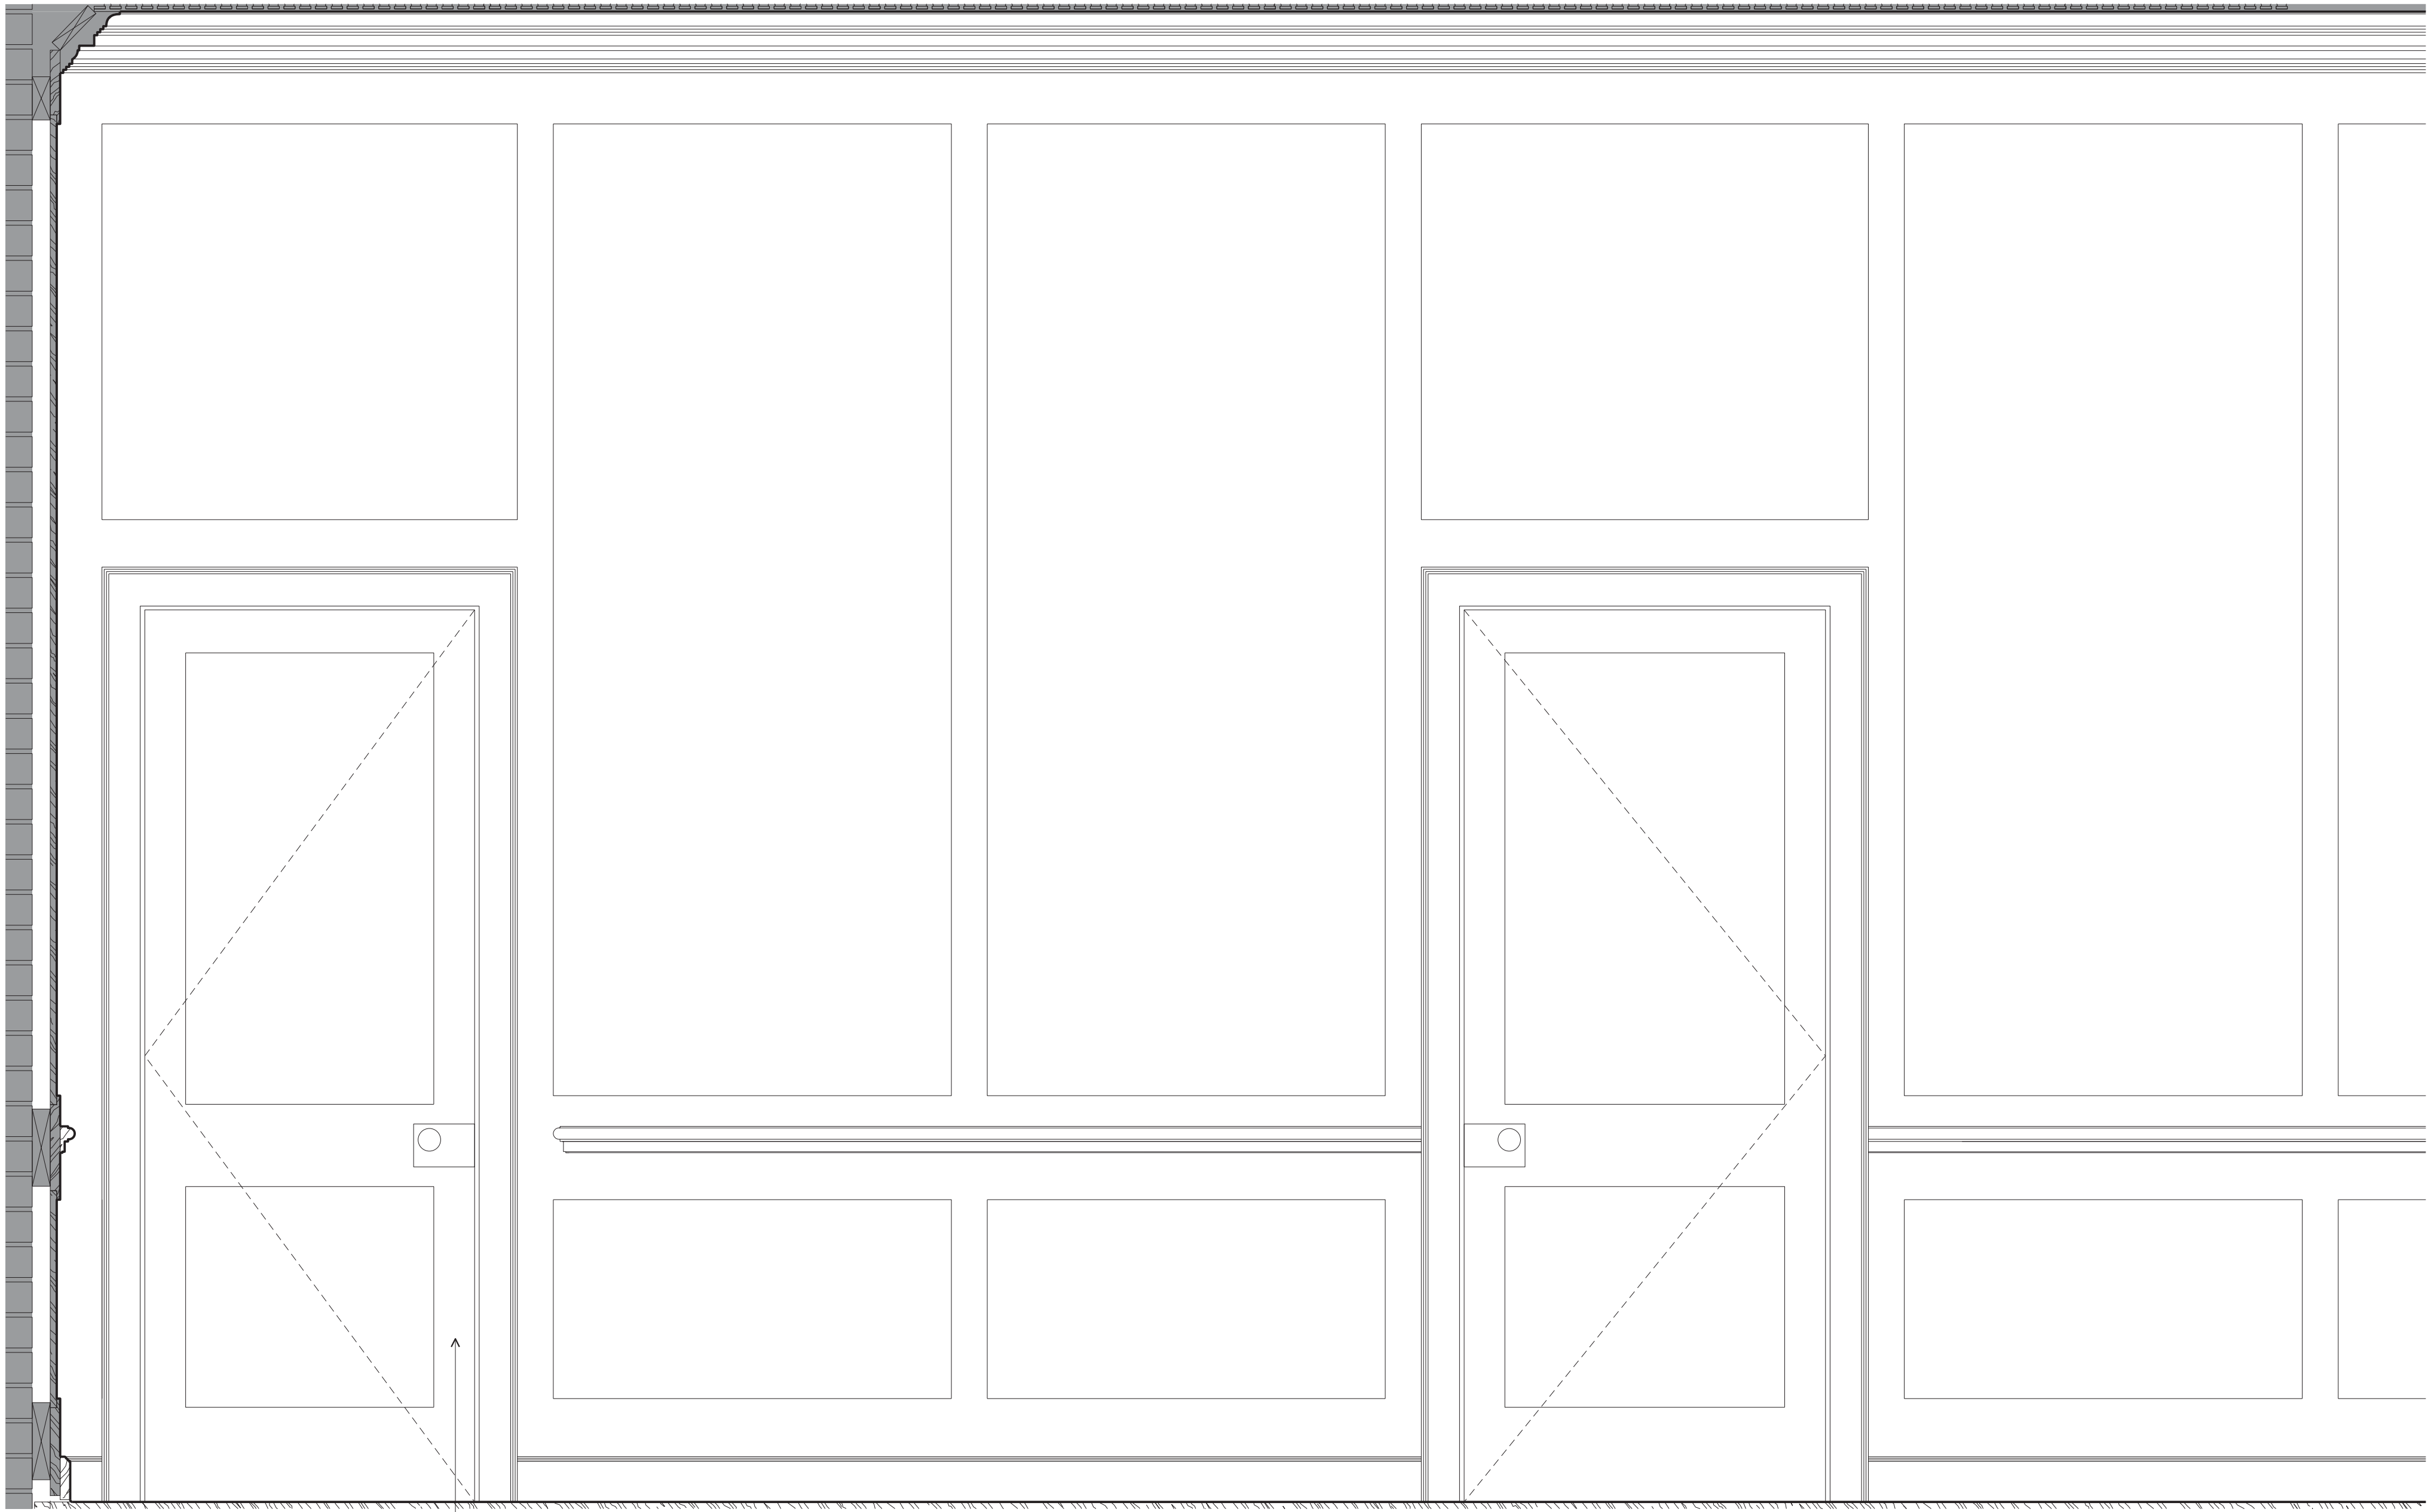
01
X_501 Proposed Door Elevation
Second Floor Rear wall 1:10

Existing openings to
be fitted with 2
panelled doors to
match existing second
floor condition

New 2 panelled solid core door in existing opening

Existing frame and architrave retained/repaired
where necessary

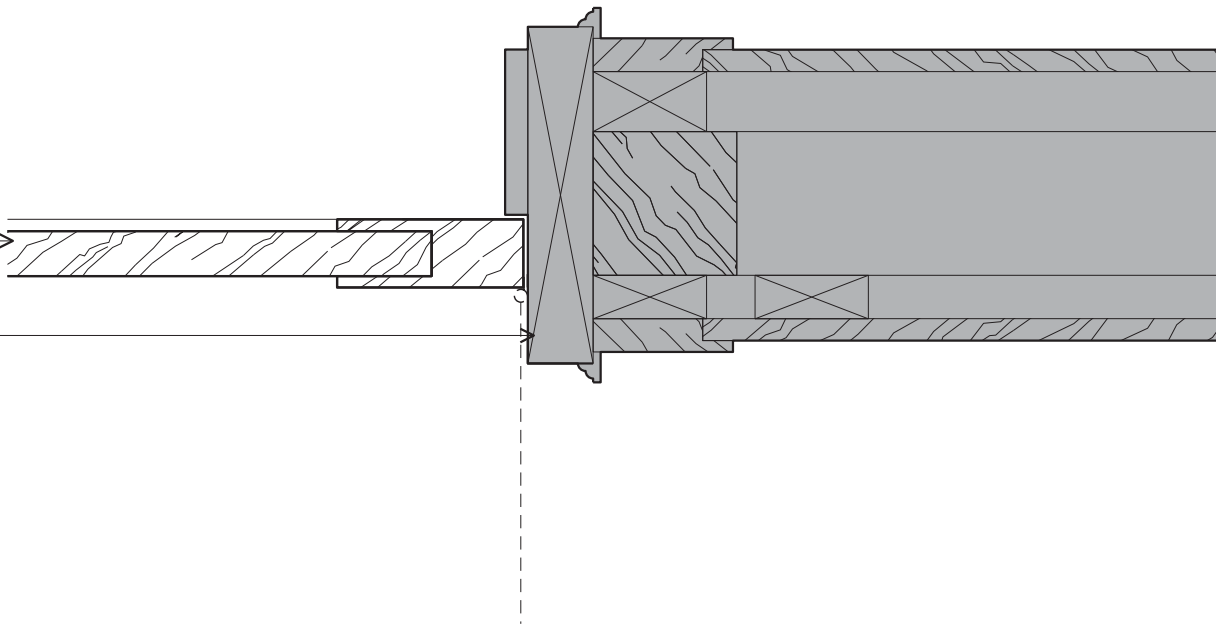
02
X_501 Proposed Typical Door Detail
Plan Detail 1:5

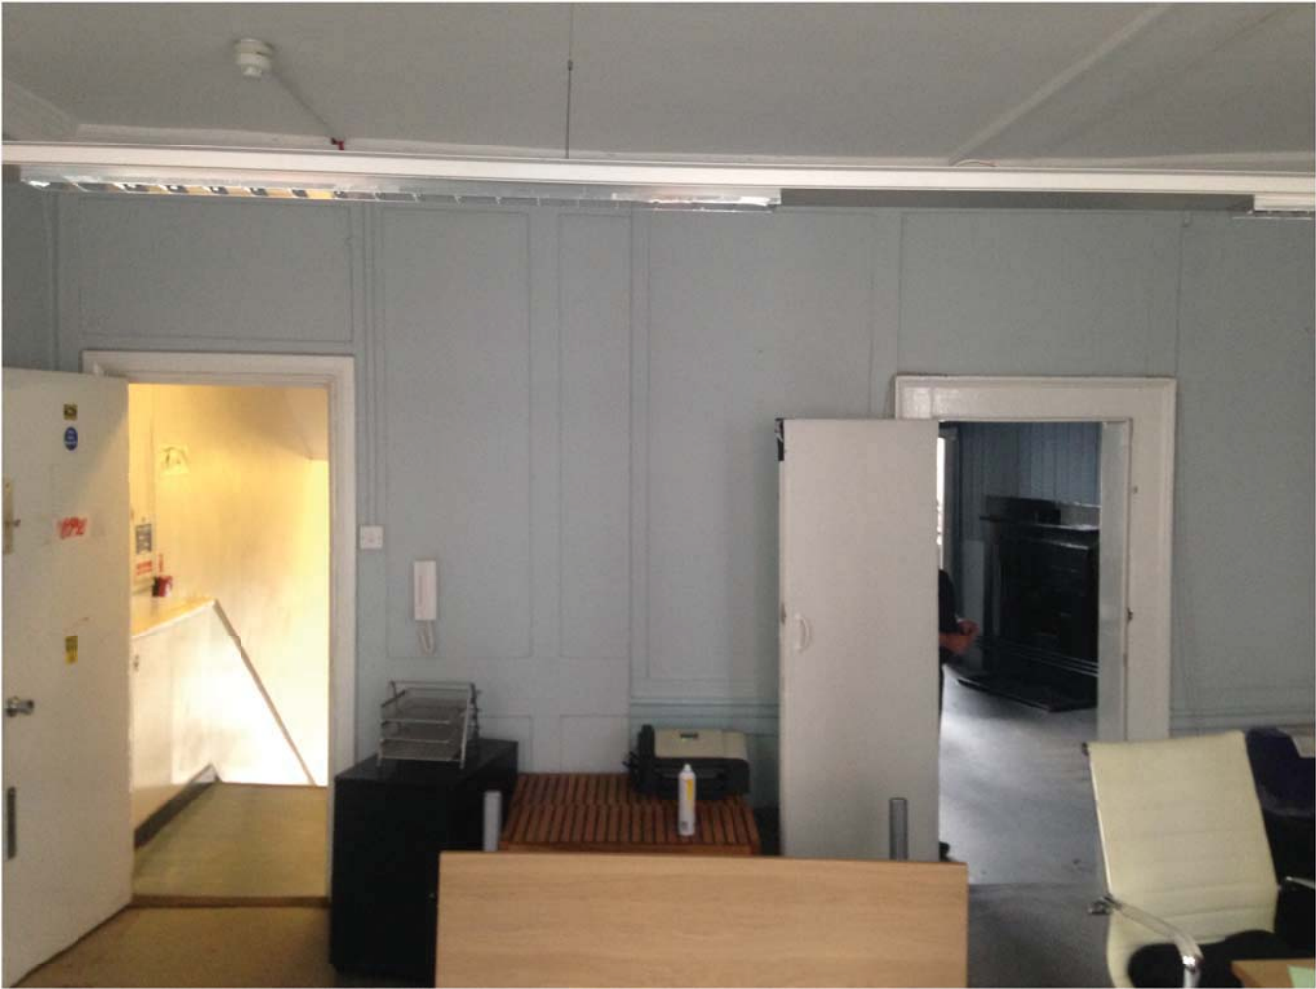
03
X_501 Existing Elevation and modified doors on second floor
Photograph

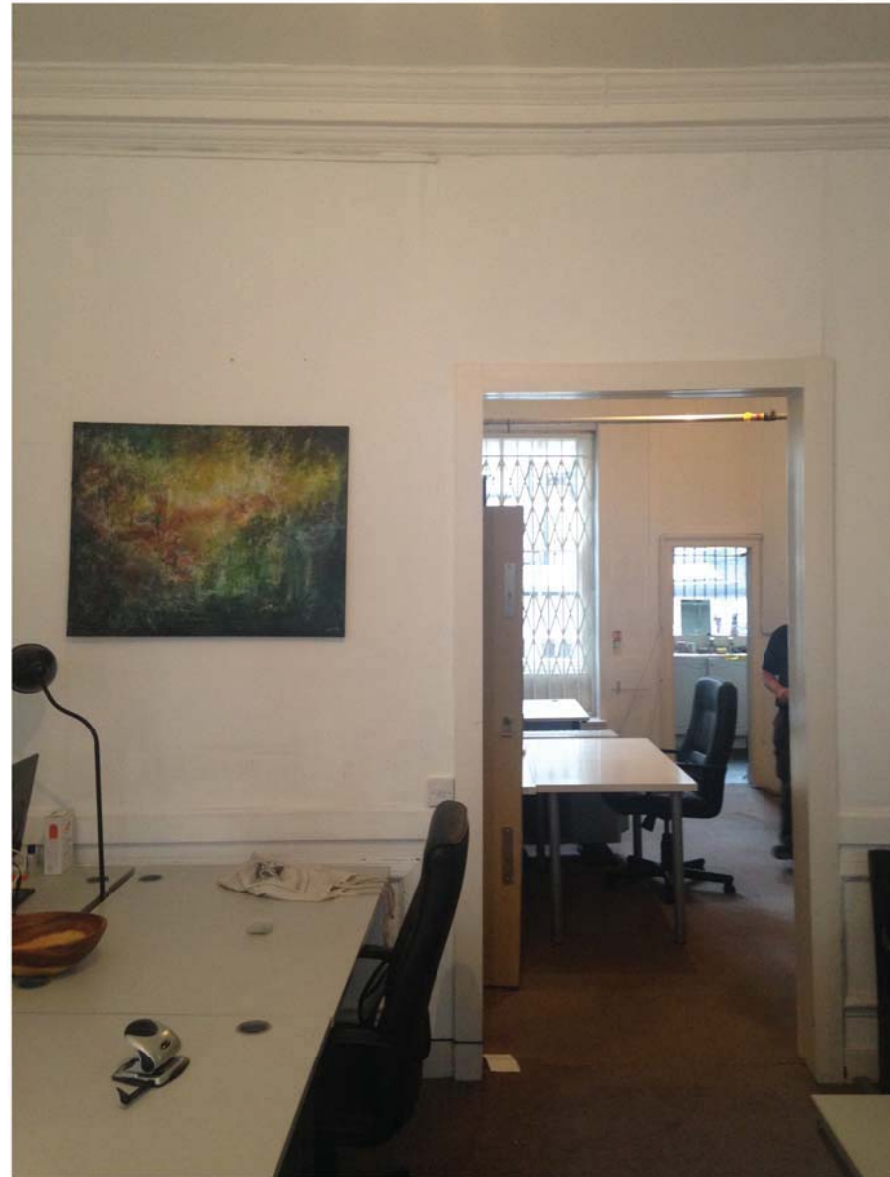
01
X_502 Existing Condition First Floor Front Room
Original Panelling and dado removed previously - to be recreated

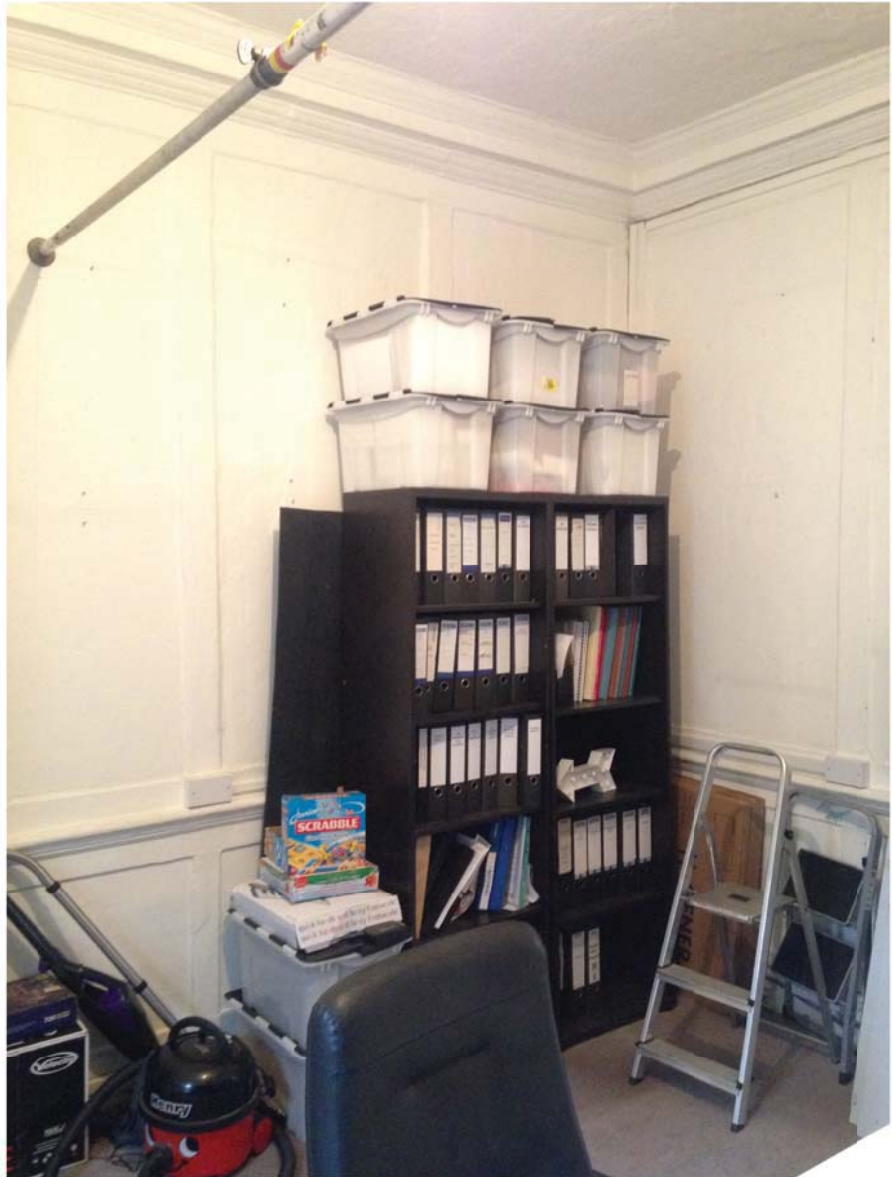
02
X_502 Existing Condition First Floor Rear Room
Original Panelling mostly intact - to be retained and repaired

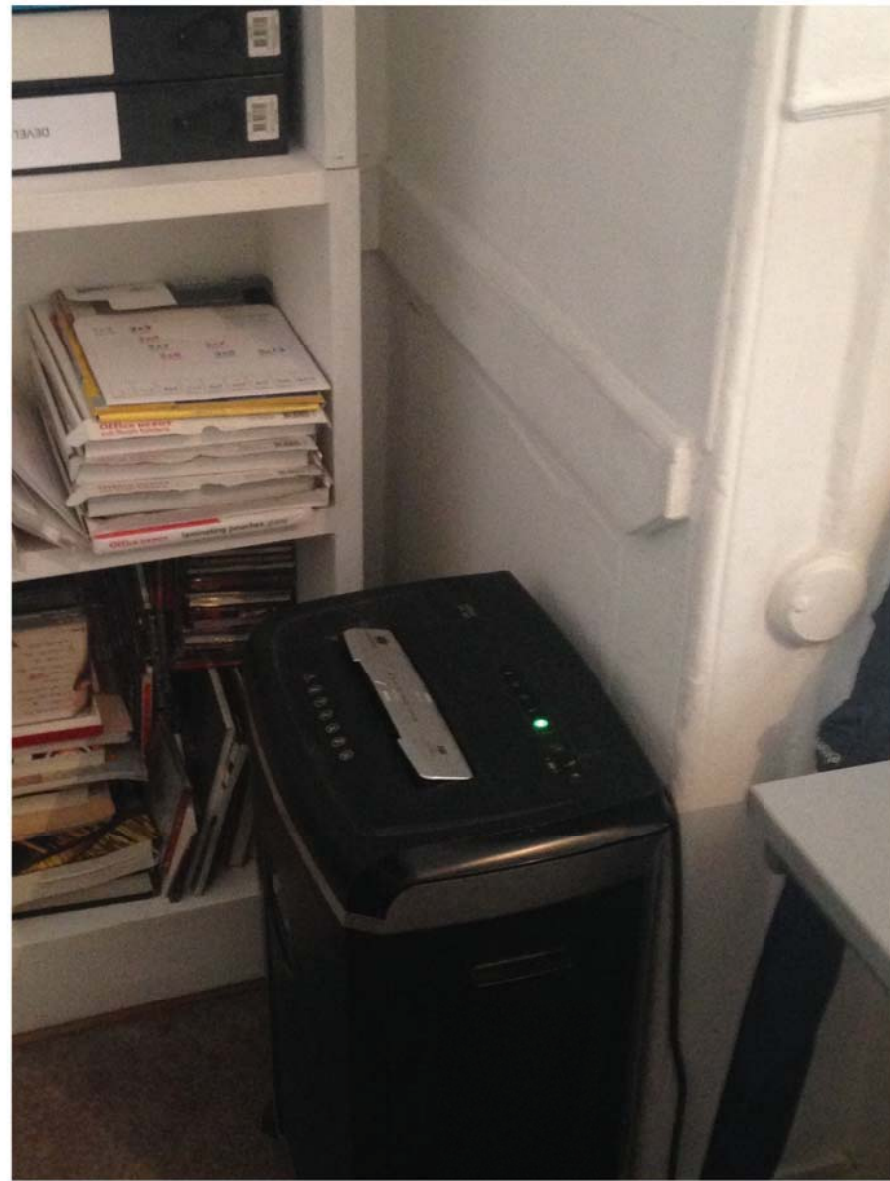
03
X_502 Existing Dado Images
Condition 1 - Front Room

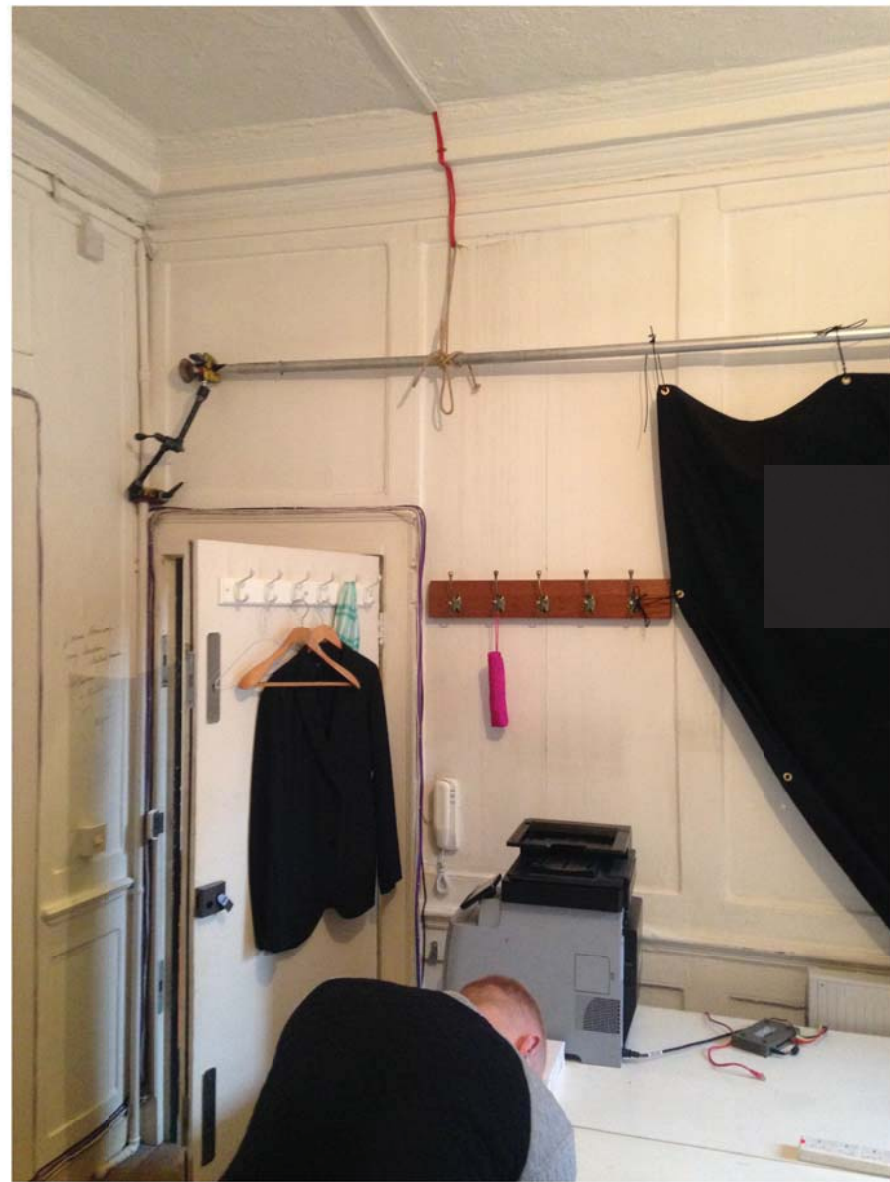
04
X_502 Existing Dado Images
Condition 2 - Rear Room. Mostly intact

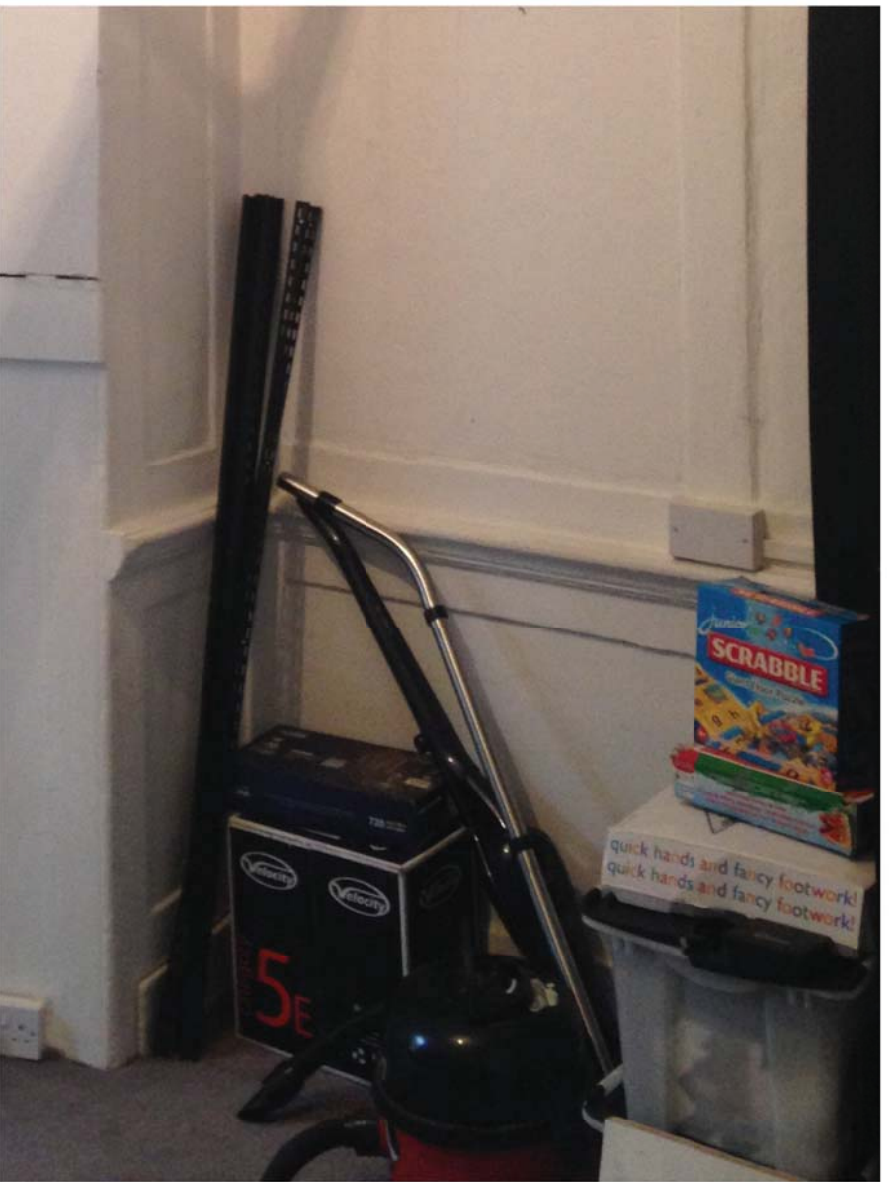
05
X_502 Existing Dado Images
Condition 2 - Rear Room

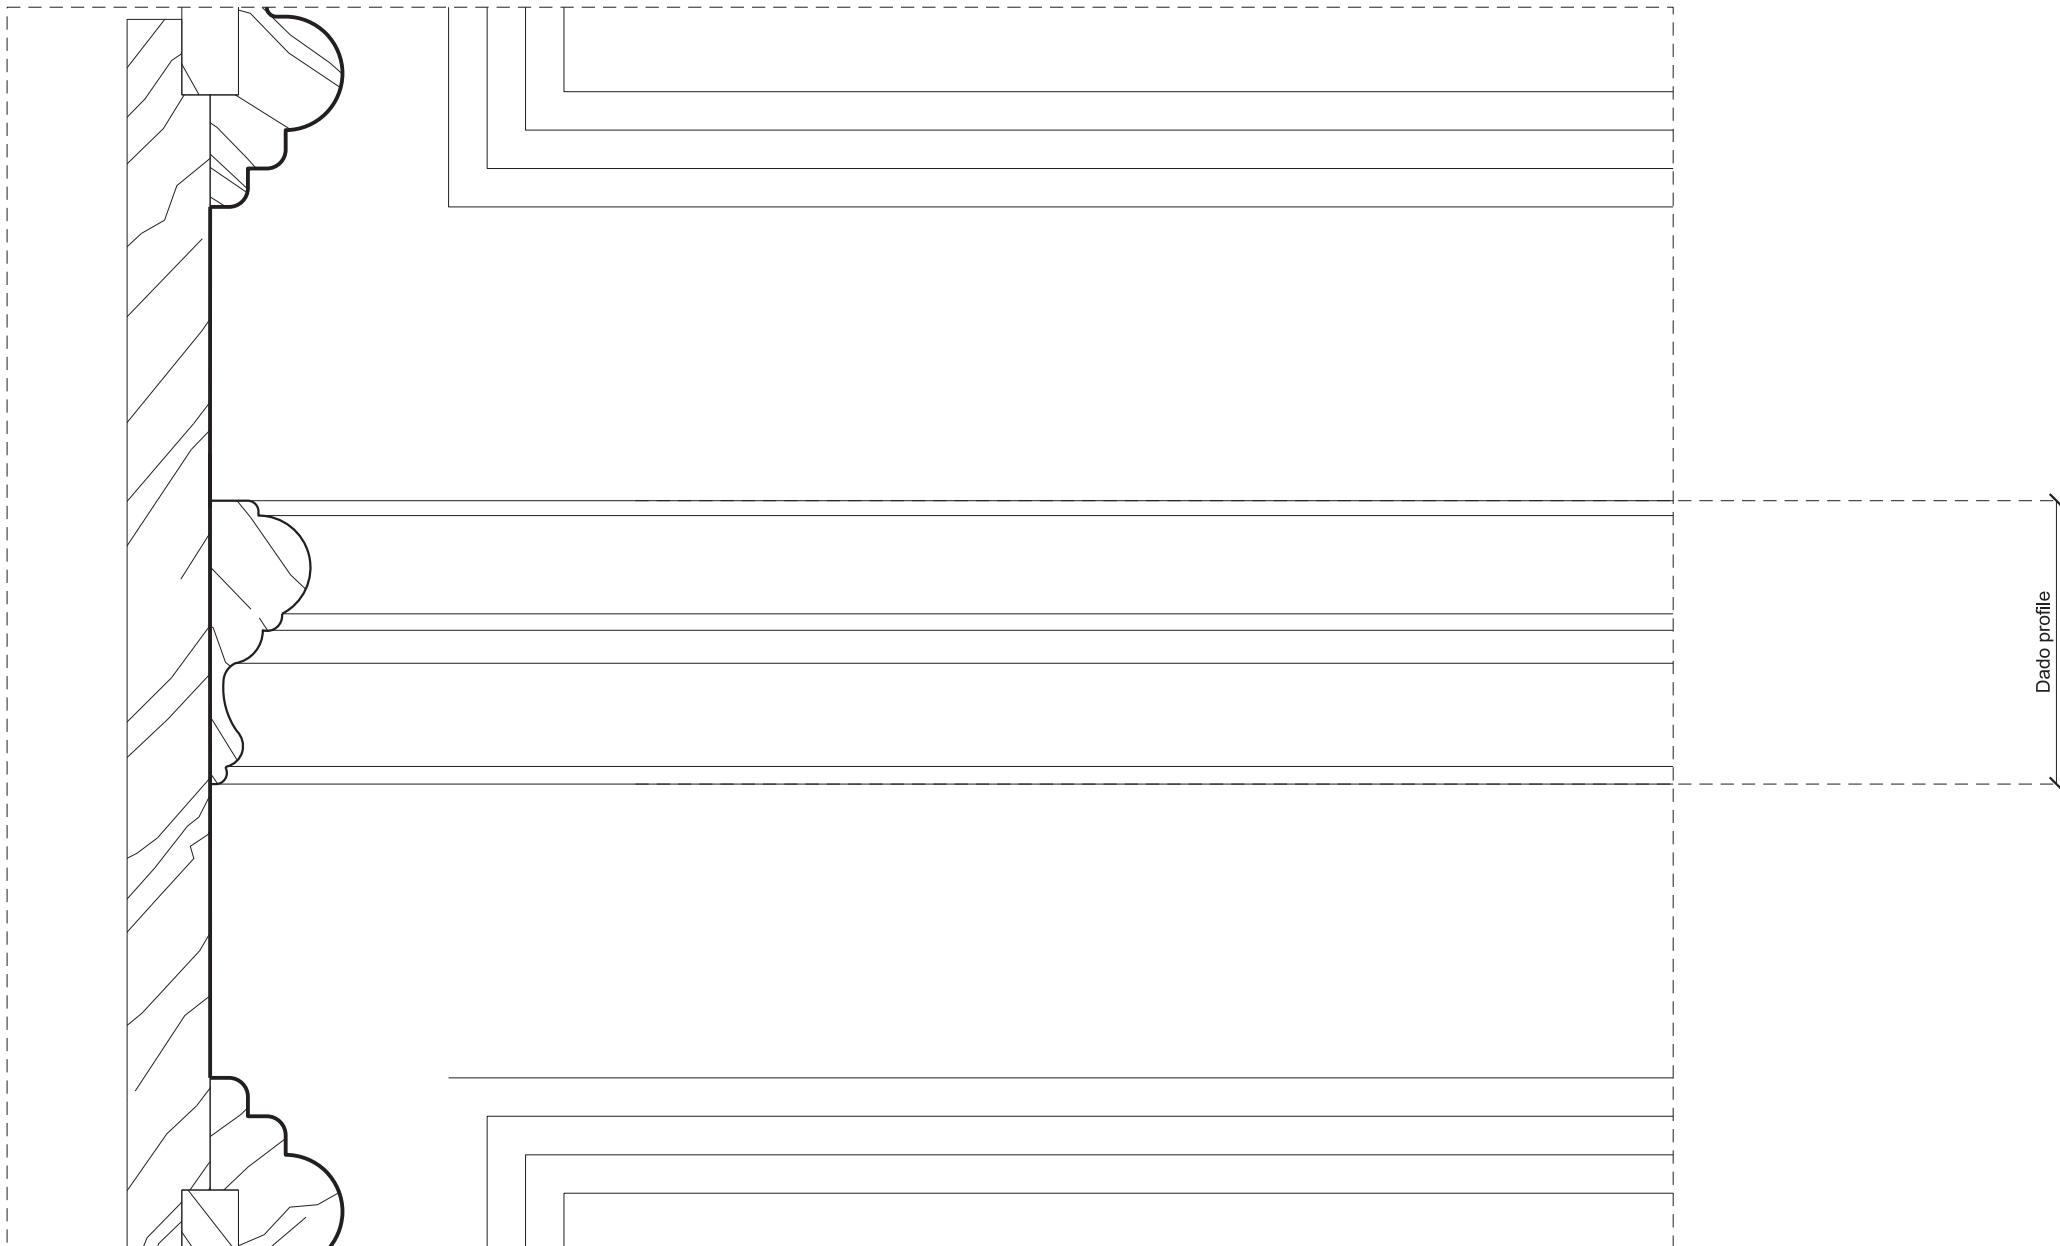
All instances of damaged or missing dado rails are to be repaired and reinstated in accordance to the details below

Front rooms have a more ornate profile to match the original, while rear rooms have simpler sections of dado

06
X_502 Existing Dado profile to be used for repair and replacement
Condition 1 - Front Room 1:5

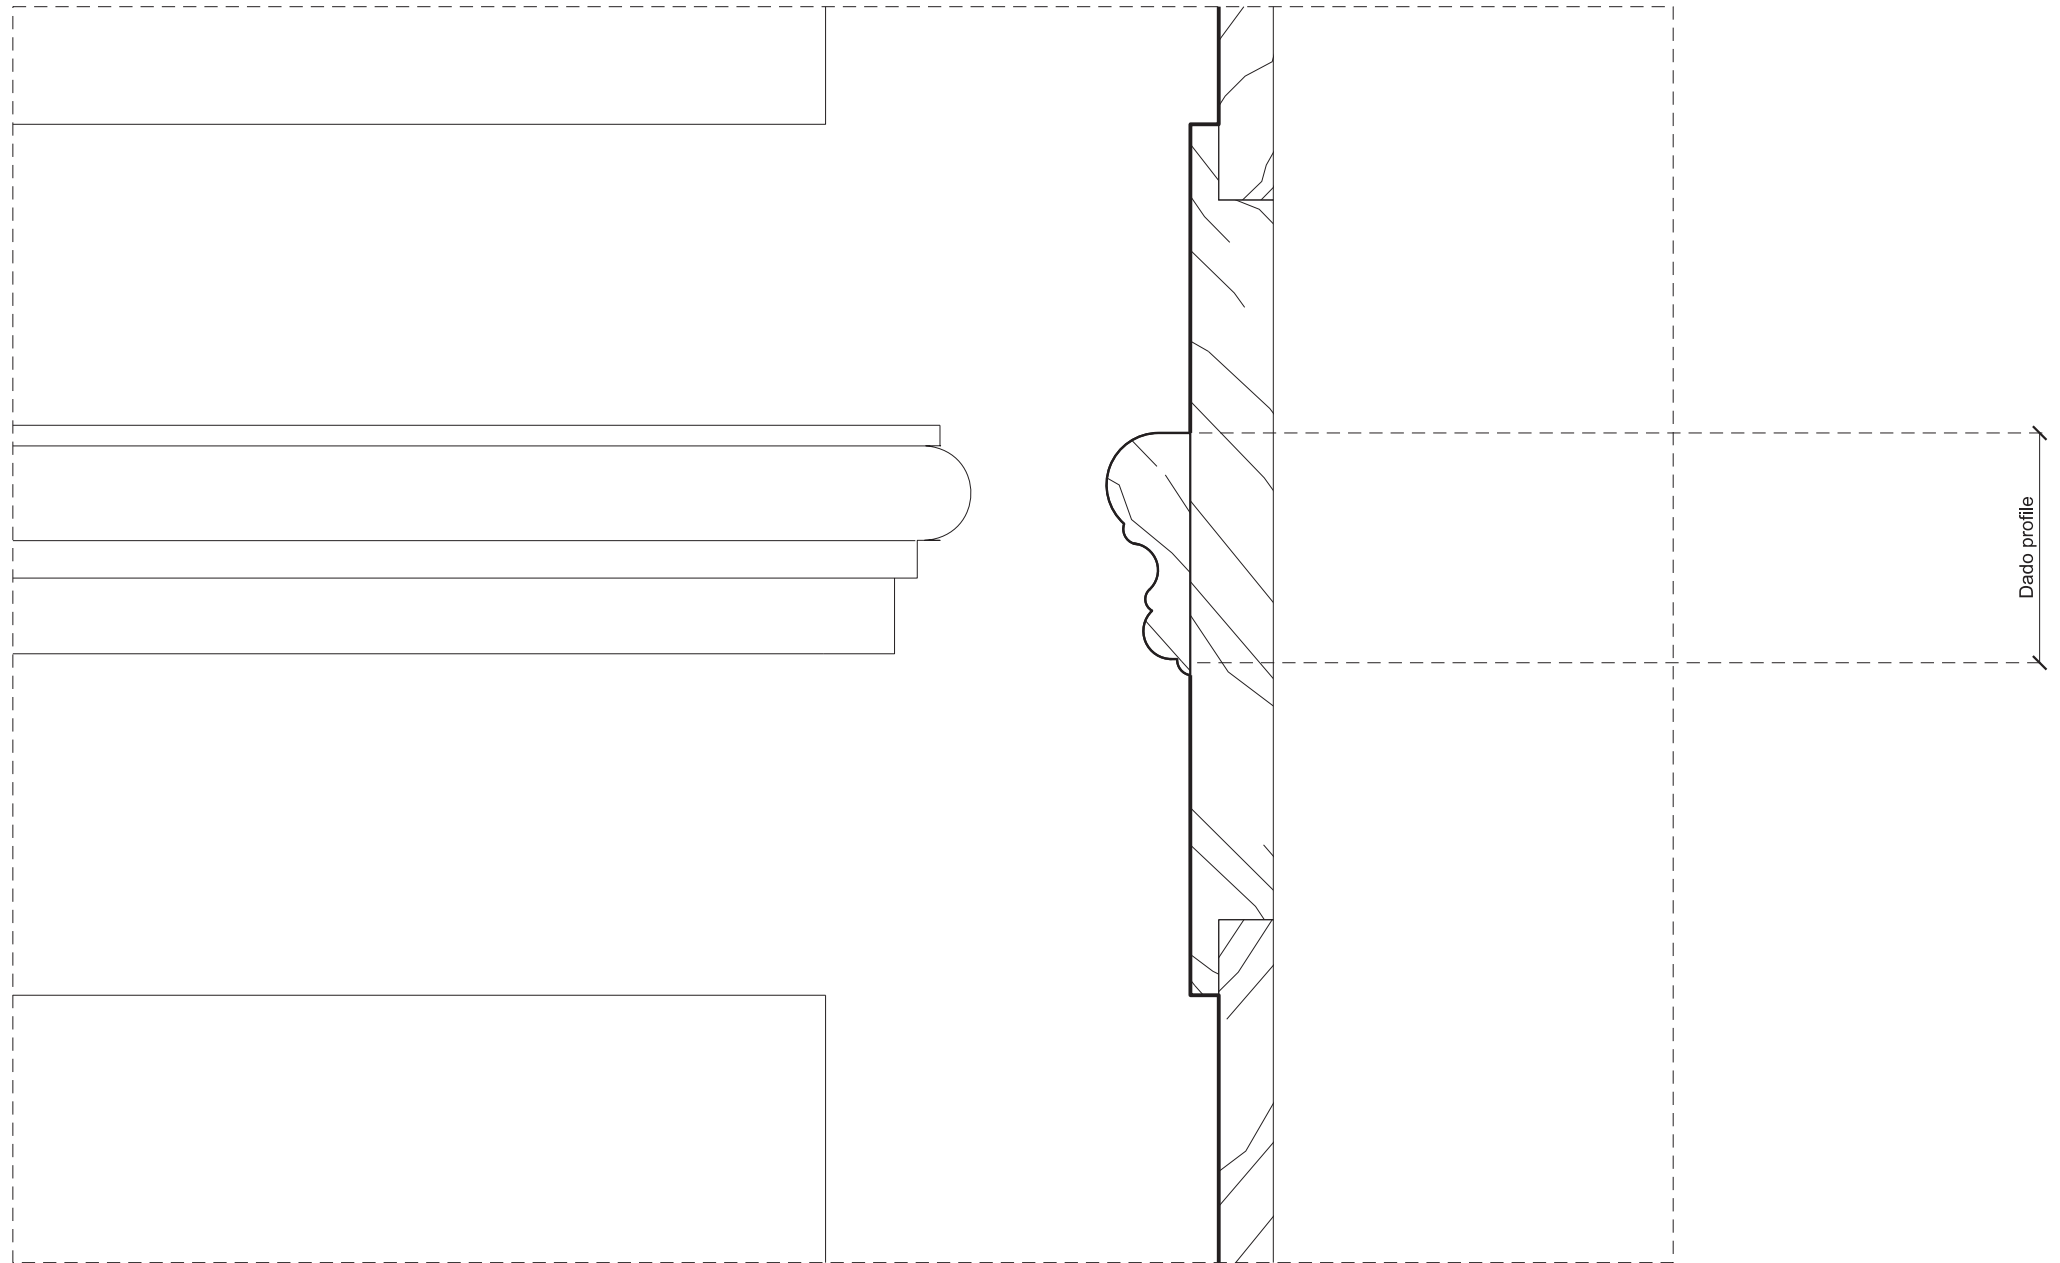
07
X_502 Existing Dado profile to be used for repair and replacement
Condition 2 - Rear Room 1:5

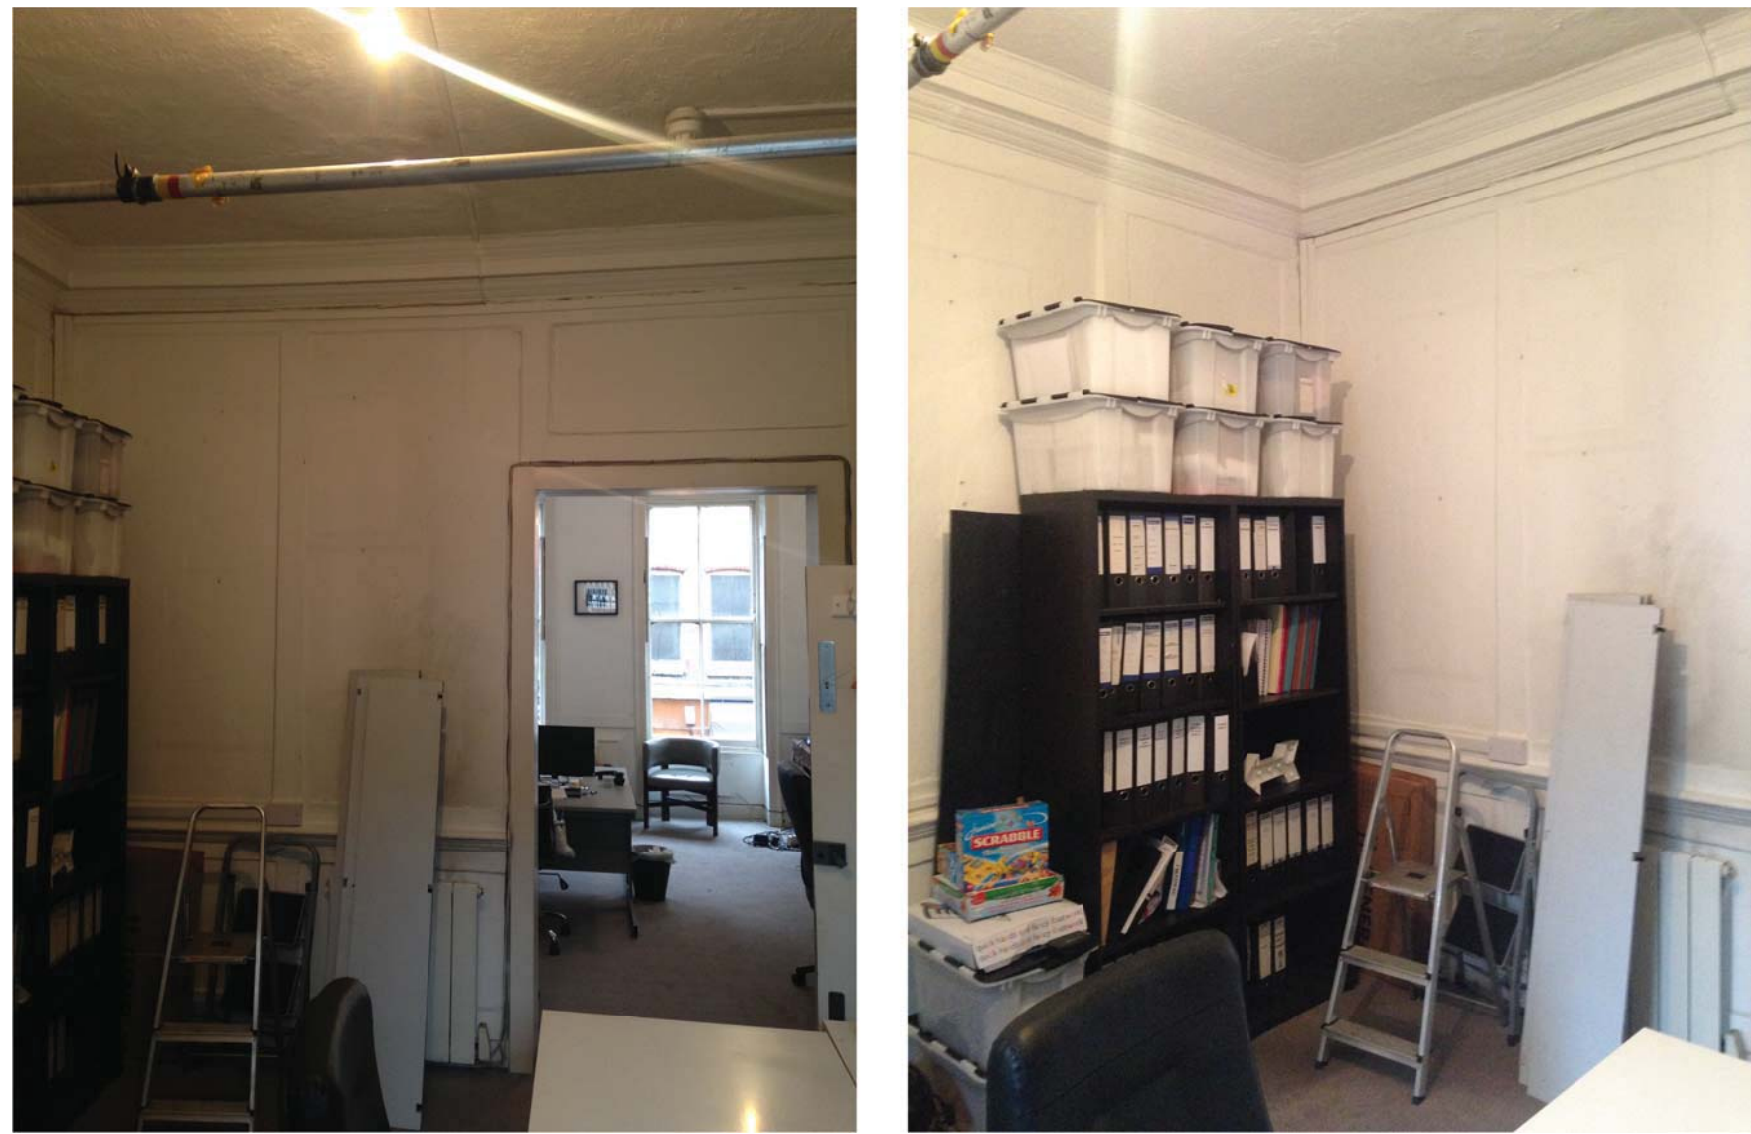
01
X_505 Existing Internal Elevation
First Floor - Spine wall, back room

New plaster
cornice - profile
to match existing

New riser with
panelling and
dado detail to
match existing.
To be scribed
into existing to
allow for later
removal

New
two-panelled
door and
reinstated
architrave to
match
existing

02
X_505 Proposed Internal Elevation
First Floor - Spine wall, back room - showing typical riser installation

Indicative location of
vertical services distribution

Existing
frame to be
left exposed
to allow for
legibility of
existing
panels.
New riser
panelling to
be inset
and scribed
into existing

03
X_505 Proposed Typical Riser to Spine Wall
Plan Detail

Drainage and ventilation to transfer in new spine wall riser. See 1401_6D(X)505 for details
