St Giles - Zone 3 : 6 Denmark Street
Listed Building Application

The existing building is located on Denmark Street, London WC2H 8LS. The building is undergoing a full refurbishment in accordance with Listed Building Consent - 2012/6867/L. Ian Chalk Architects have been appointed as the architects to deliver the building on site and Cord Contracting as the Contractor.

No.6 Denmark Street forms one of a number of late 17th Century terraces along Denmark Street that were developed at the same time. ICA are appointed to refurbish nos. 6, 7, 9 & 10.

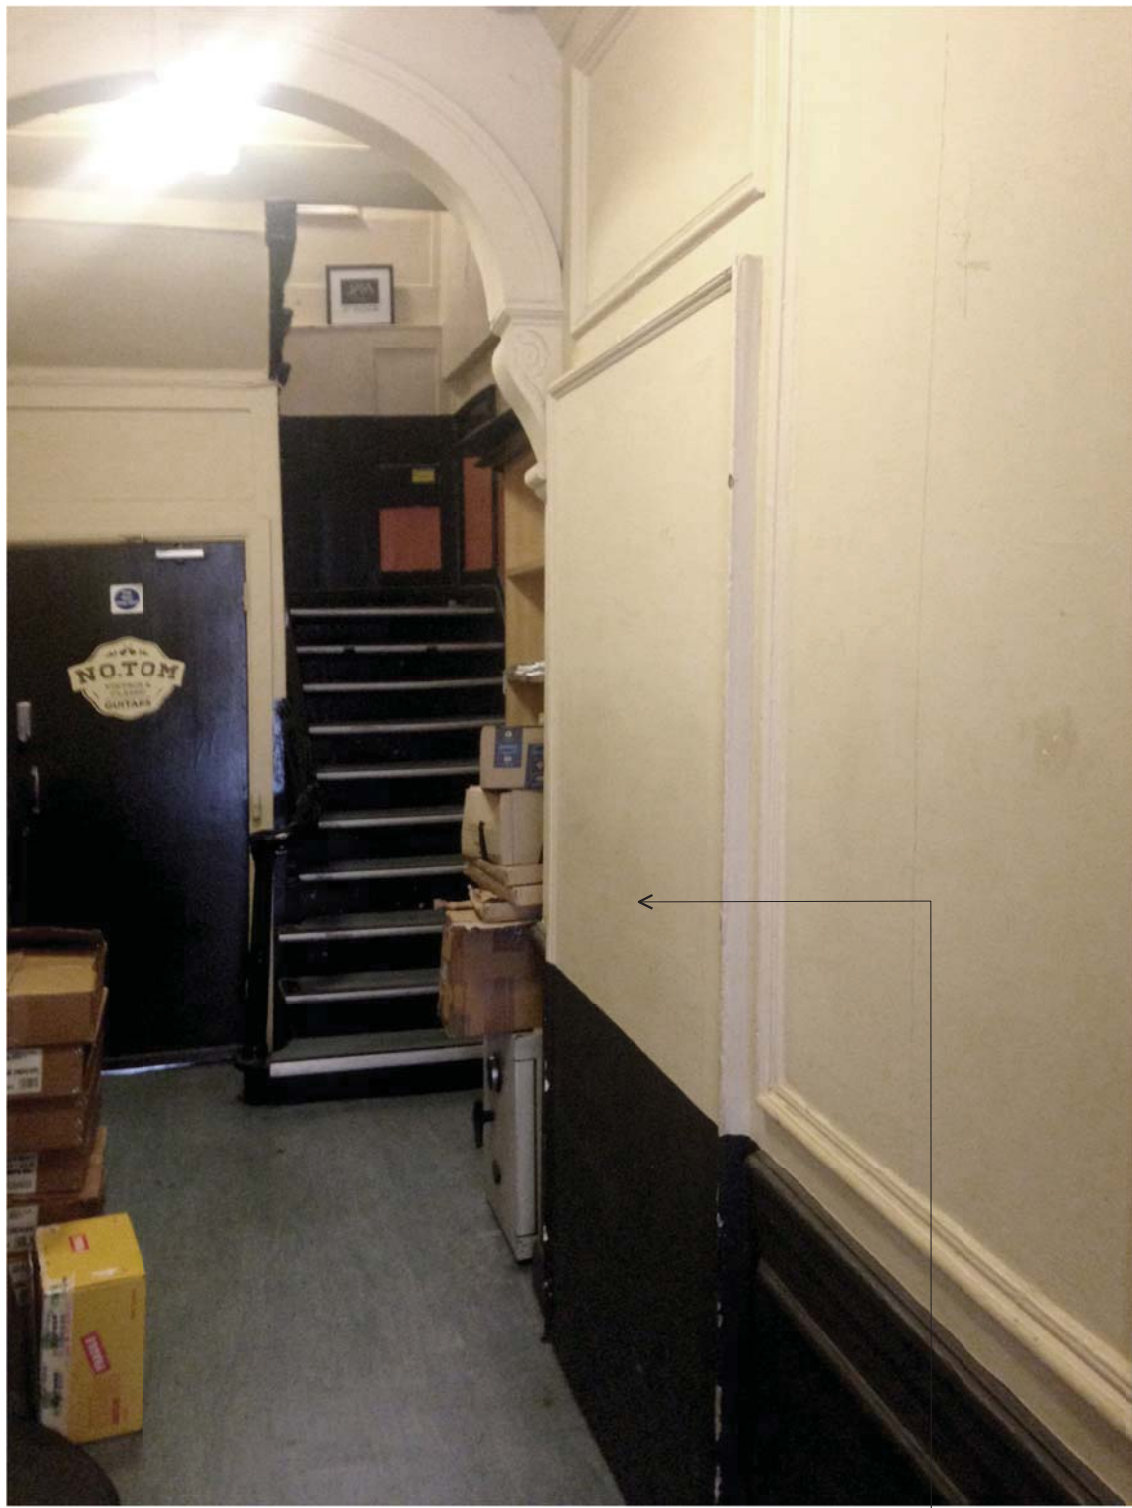
01
X_507
Existing Internal View
Ground Floor Hallway - Showing closed-up connecting door
and recently revealed panelling

Location of former
connecting door -
now closed off due
to retail unit

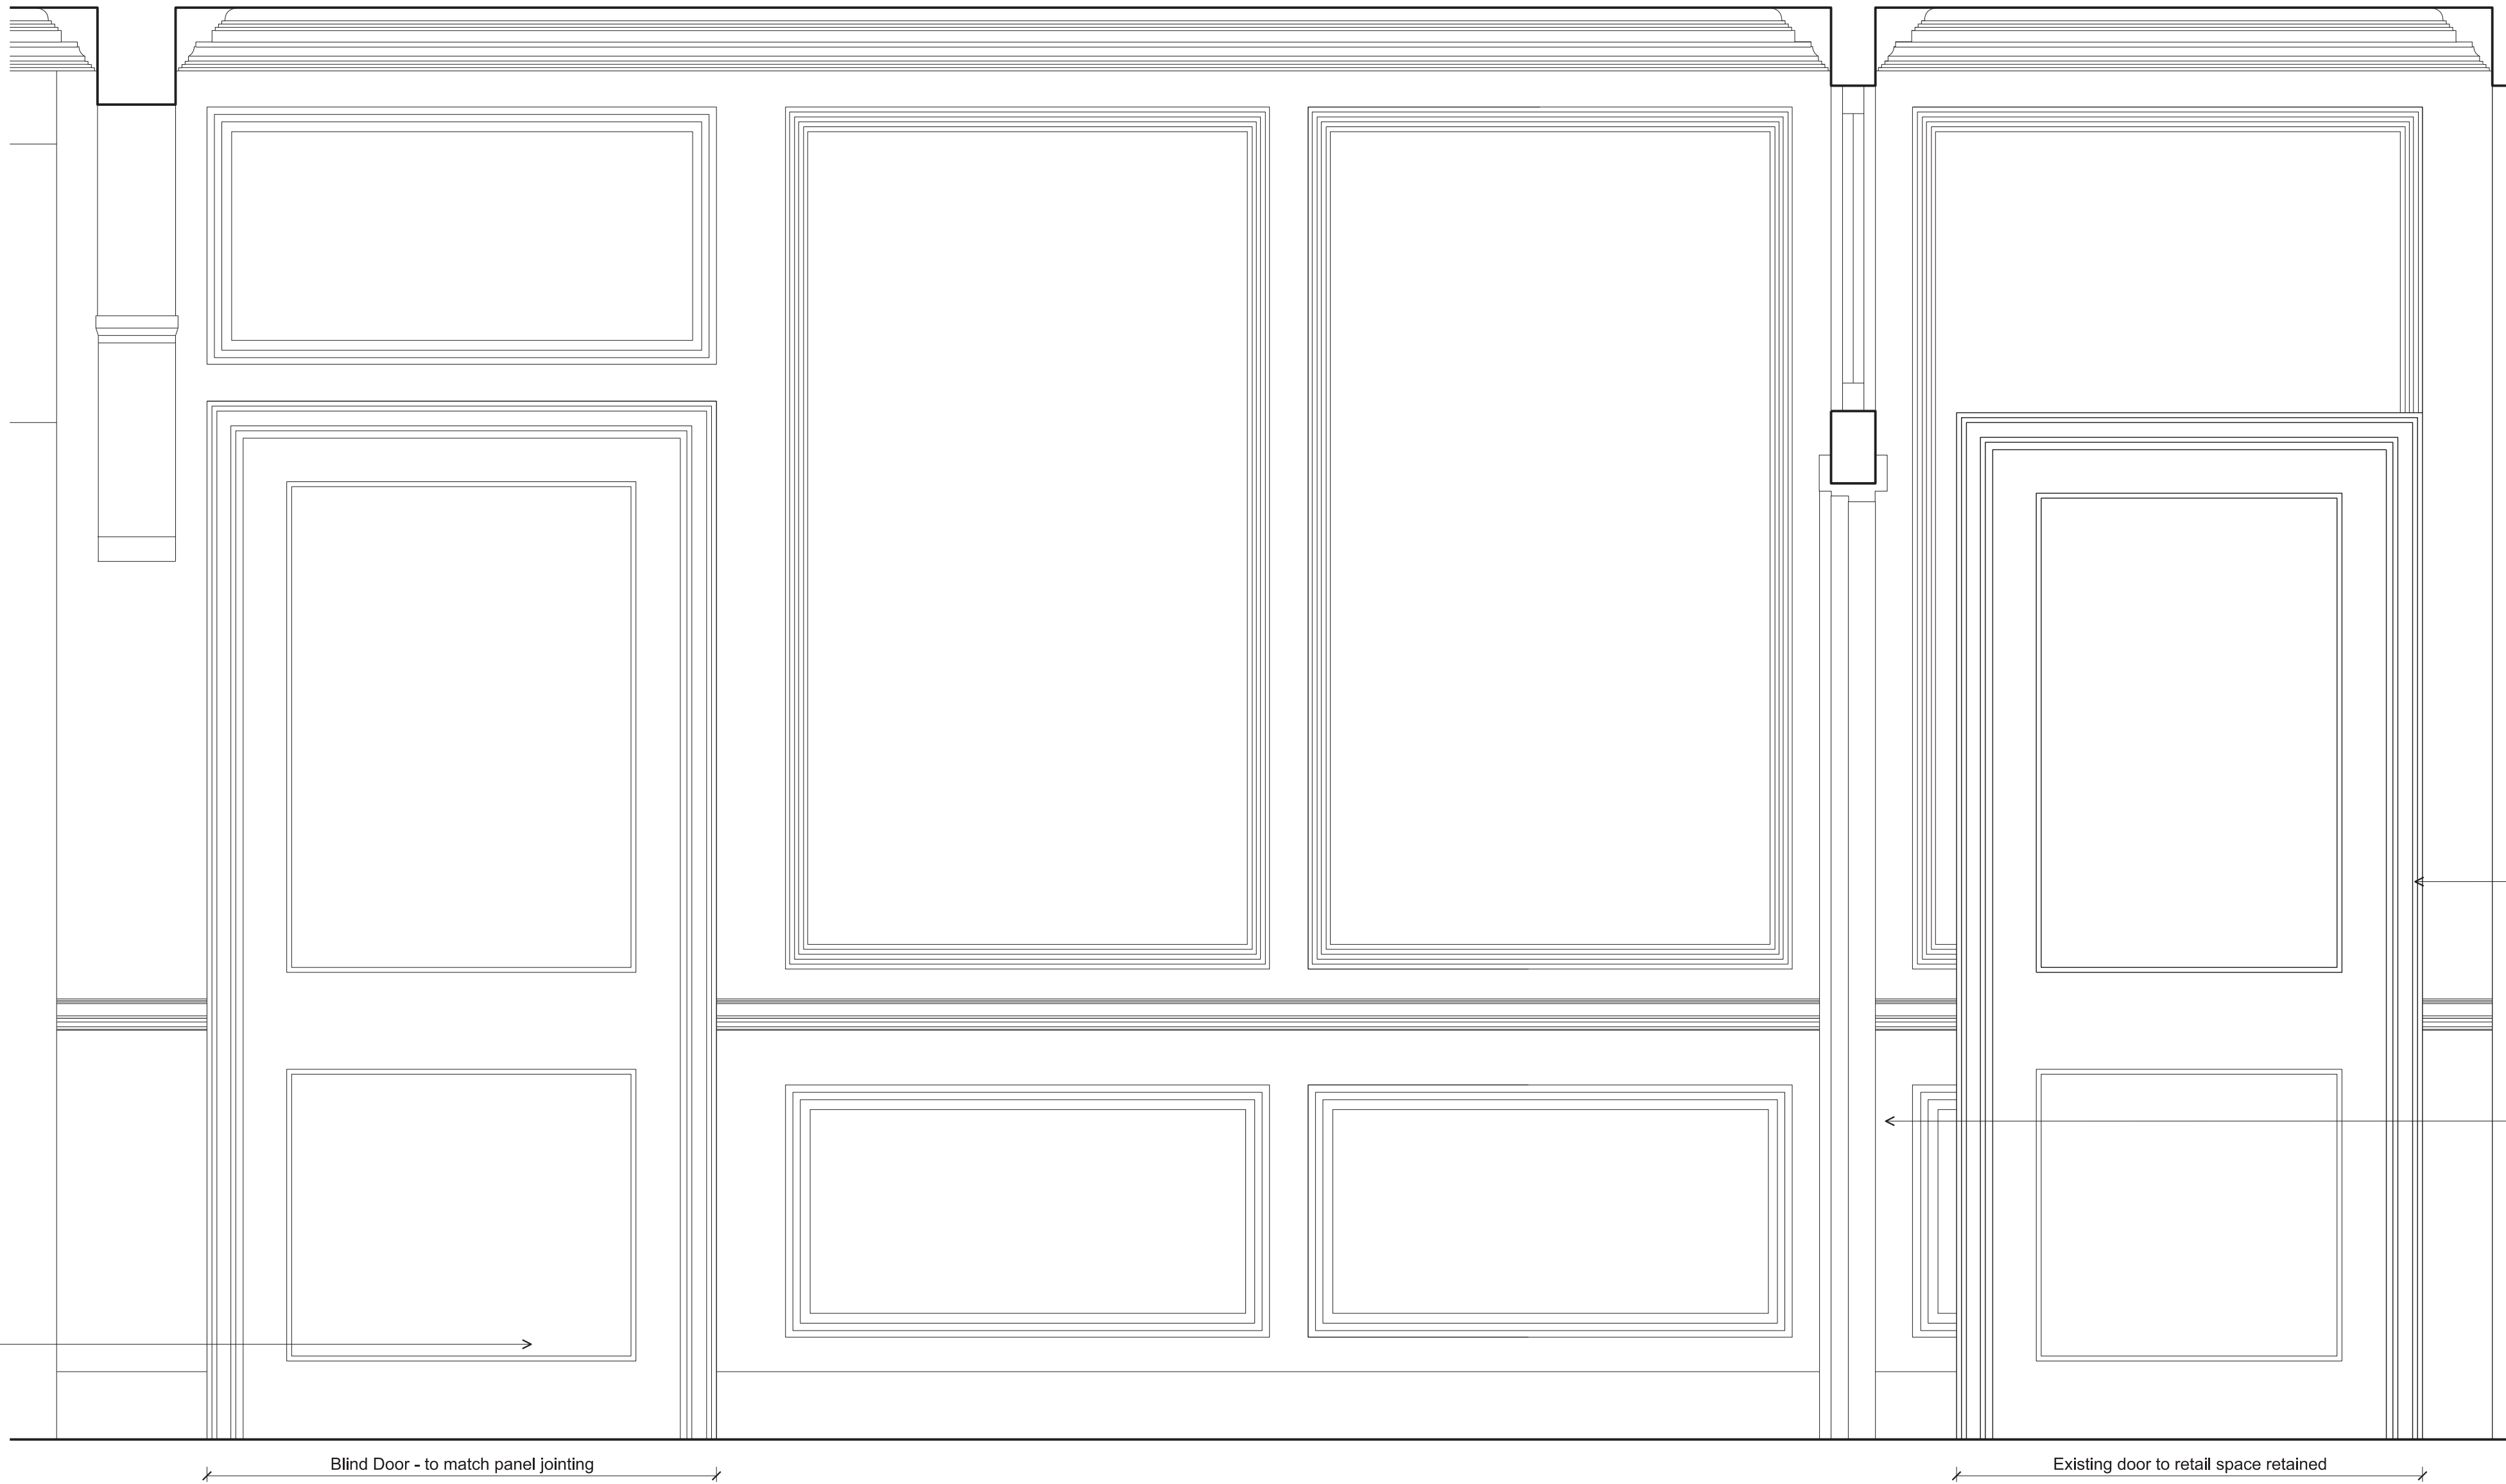
New two-panel blind door -
located in position of former
connecting door

02
X_507
Proposed Internal Elevation
Ground Floor Hallway - Showing new blind door

Existing
panelling with
reinstated dado
detail

Repositioned
entrance hall
door with
fanlight above

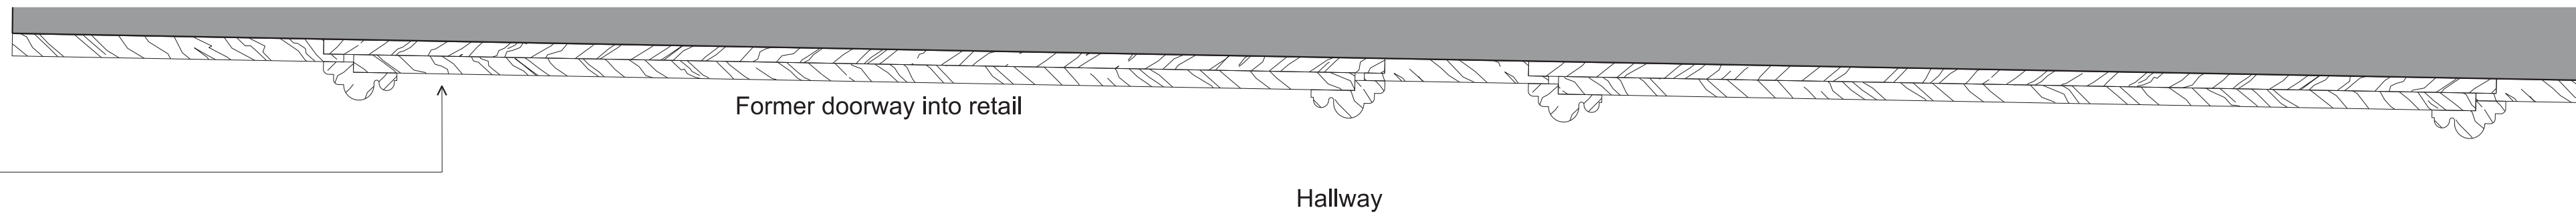
Blind door to be introduced where former
door opening has been infilled

03
X_507
Proposed Panels to Hallway
Plan Detail

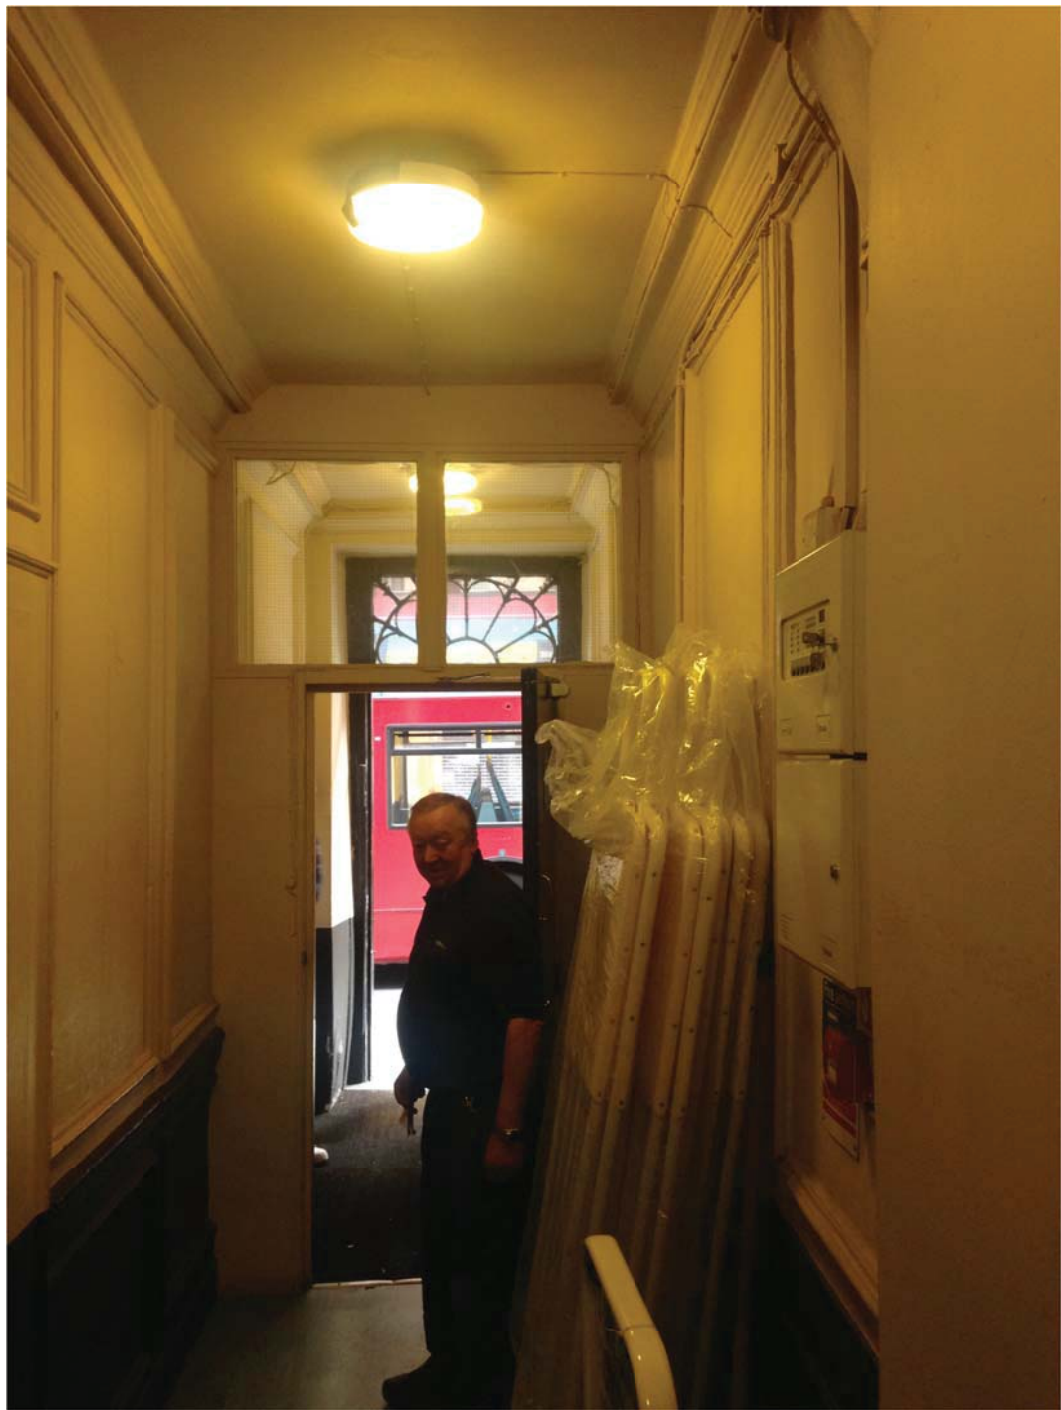
01
X_508
Existing Internal View
Ground Floor Hallway - Showing closed-up connecting door
and recently revealed panelling

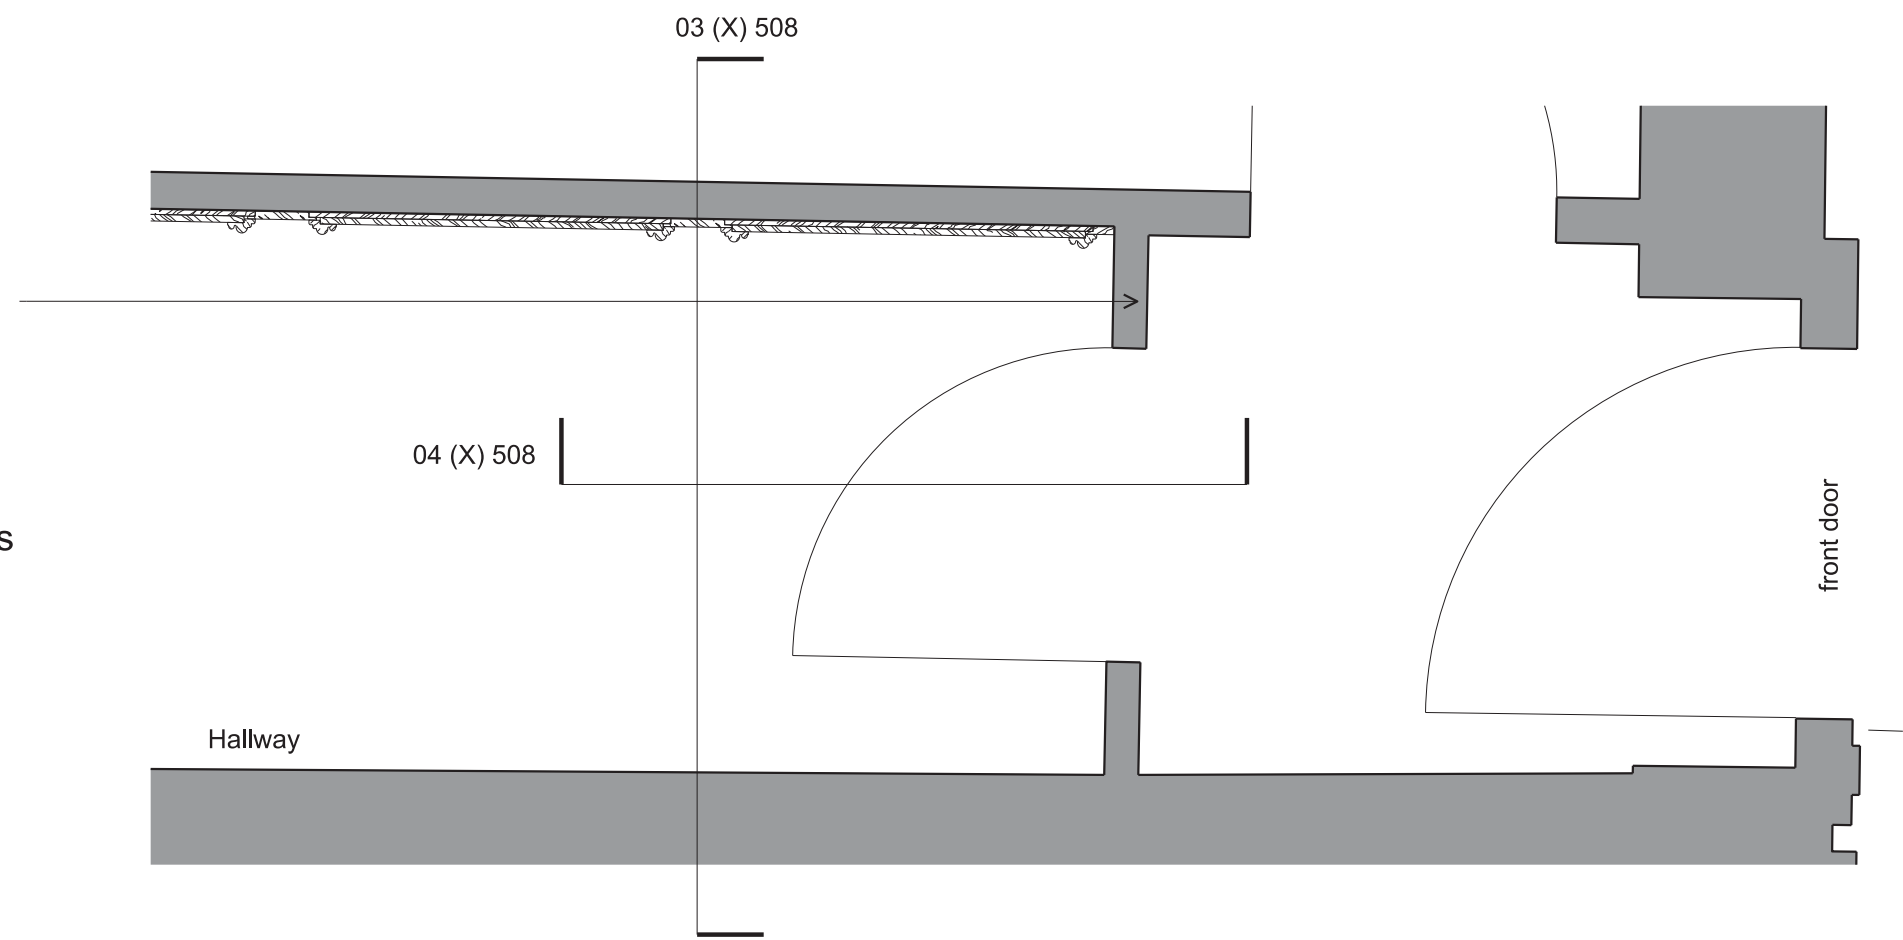
02
X_508
Proposed Cupboard Hallway
Plan Detail

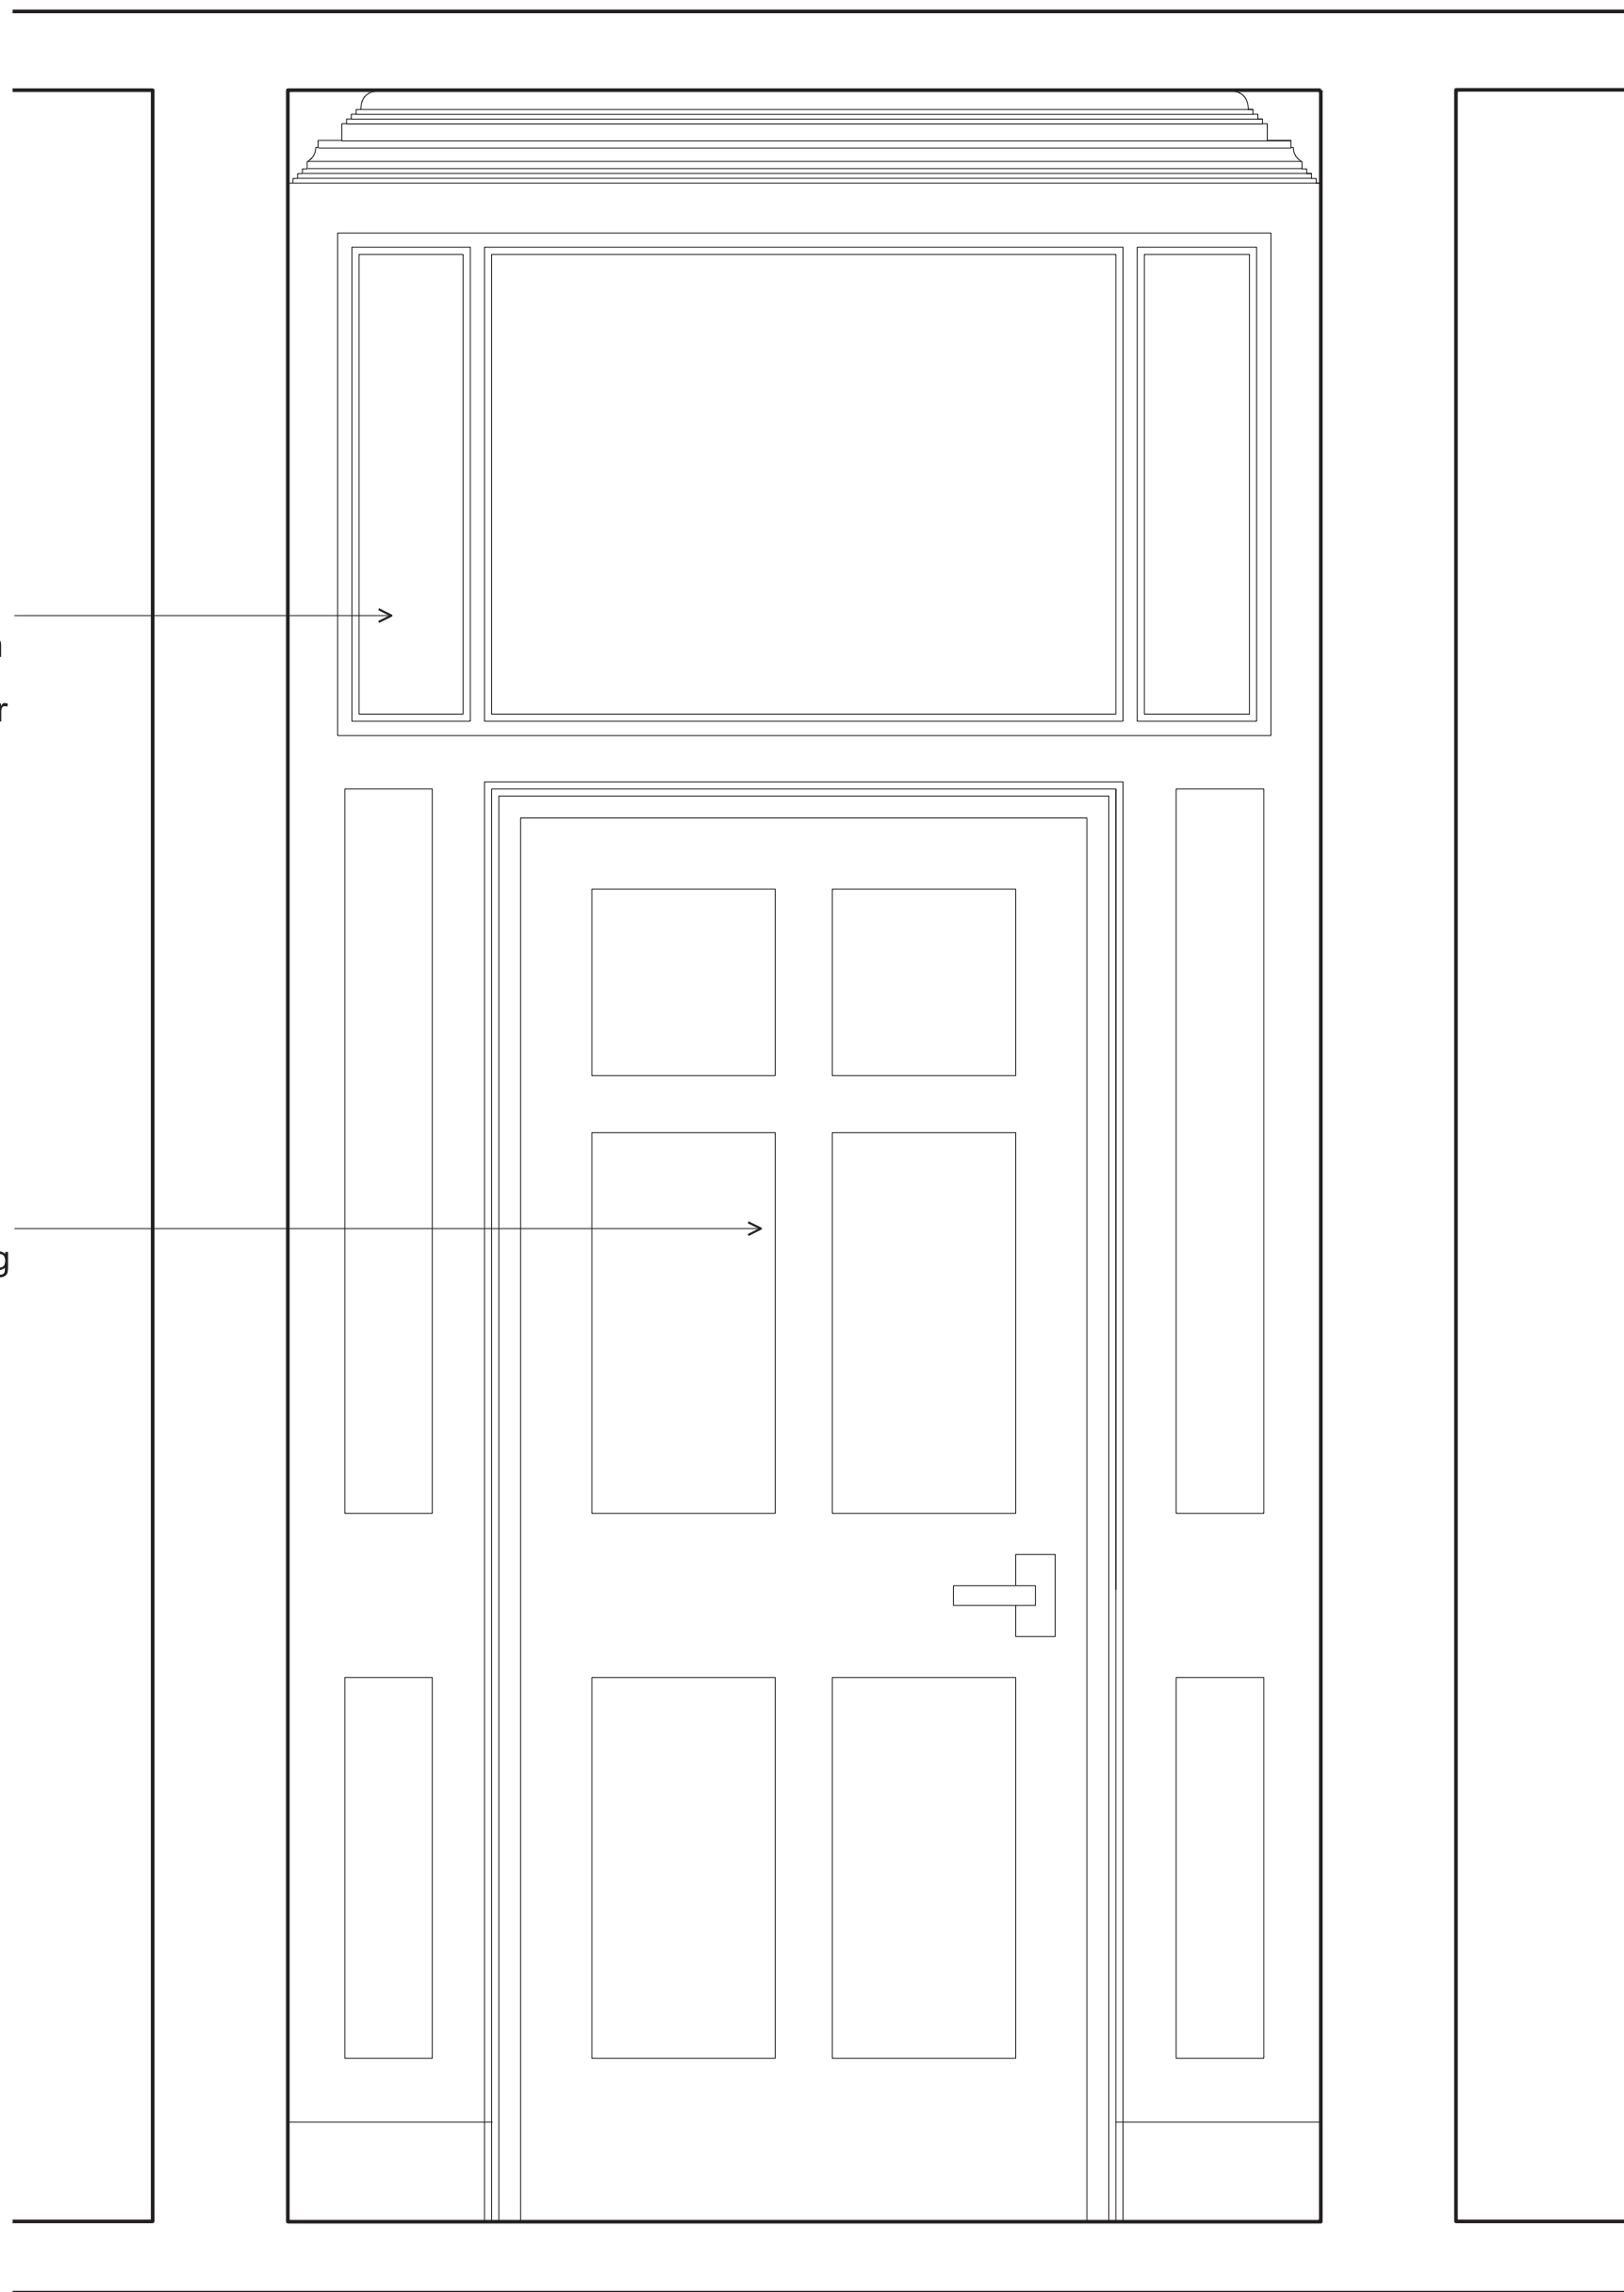
New doorway to be of a
tripartite arrangement with
narrow sidelights and
glazed fanlight above door

New 6-panel door to
match style of existing
hallway

04
X_508
Proposed Internal Elevation
Ground Floor Hallway - Showing new doorway and panelling
