| project name 7 Denmark Street | | | |
| sketch title Proposed Structural Details | | | date 20/11/2017 |
| project no 879 | sketch no 03-XX-LB-S-0001.4 | rev 01 | by RK |

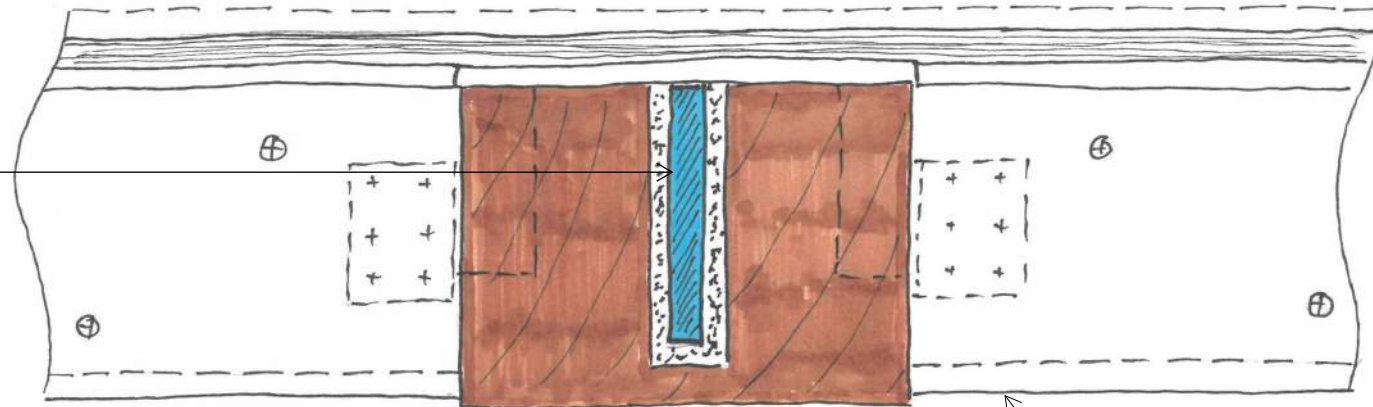
Detail 4: Section of Front Floor Beam To Be Strengthened, 1:10

Steel strengthening plate
to be resin bonded into
slot cut into existing
timber floor beam

Existing joists to be
strengthened with 200x50
C24 timber joists - bolted
together at 400mm
staggered c/c

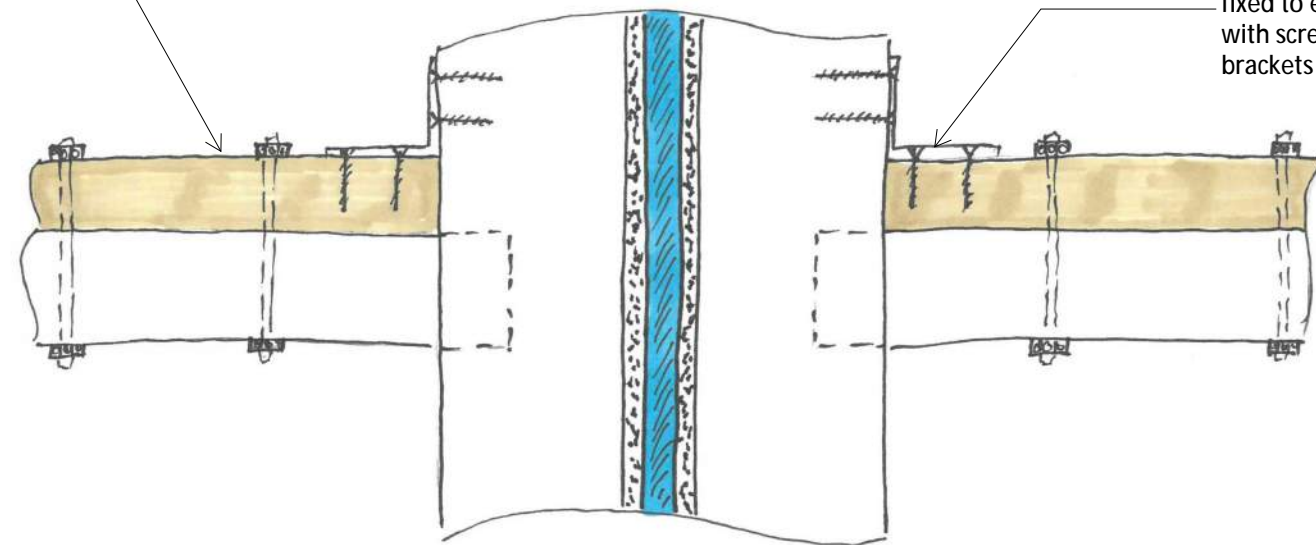
**Detail 5: Plan of Front Floor Beam To Be Strengthened, 1:10
Option A**

Incoming floor joists

New timber joists to be
fixed to existing floor beam
with screw fixed angle
brackets

- The existing timber floor beam can not be justified for the required residential loadings to current standards and requires strengthening
- This solution offers the least impact to the existing floor joists

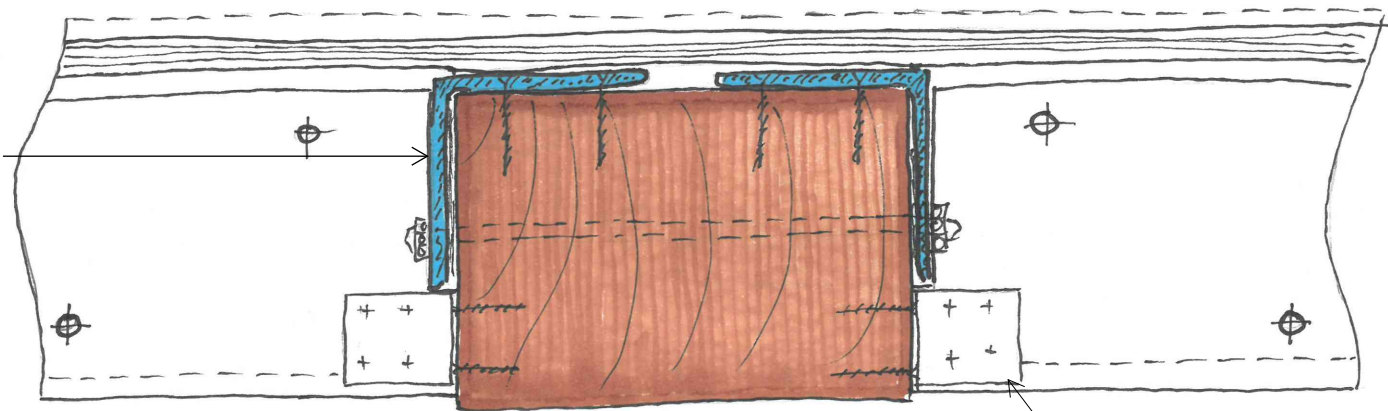
Detail 7: Section of Front Floor Beam To Be Strengthened, 1:10

Steel angles to be fixed to existing timber floor beam with through bolts and screw to top of beam

Existing joists to be strengthened with 200x50 C24 timber joists - bolted together at 400mm staggered c/c

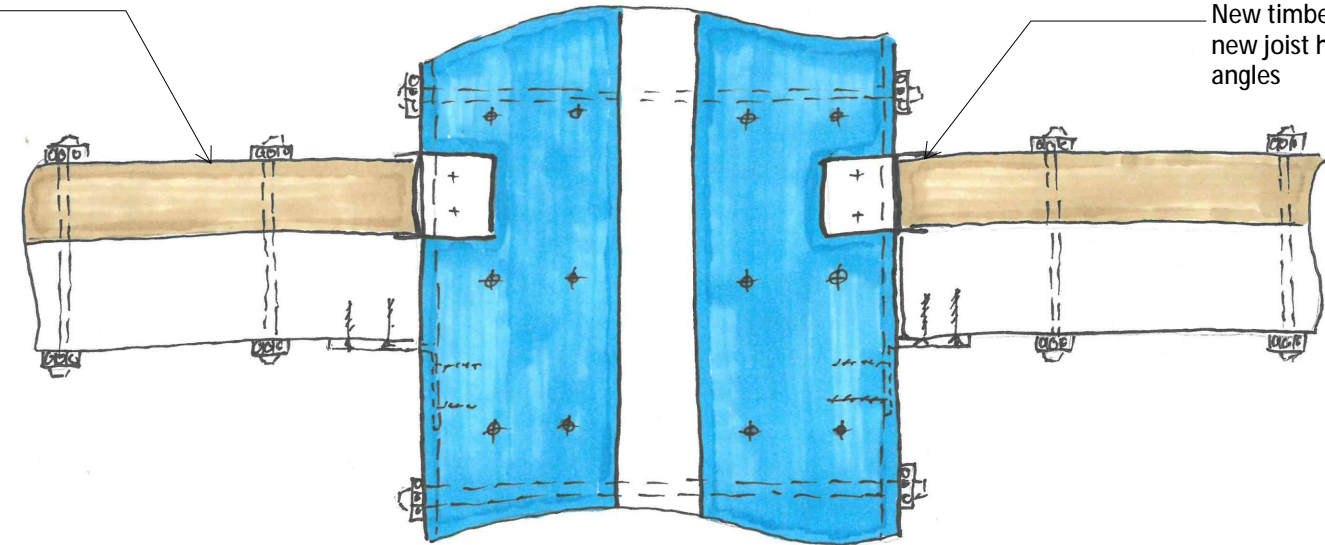
Detail 8: Plan of Front Floor Beam To Be Strengthened, 1:10 Option B

Incoming floor joists to be fixed to existing timber floor beam with screw fixed brackets to allow for the existing bearing to be cut back to allow for strengthening steel angles to be installed

New timber joists to be supported on new joist hangers fixed to top of steel angles

- The existing timber floor beam can not be justified for the required residential loadings to current standards and requires strengthening
- The proposed solution offers the least impact to the existing floor beam

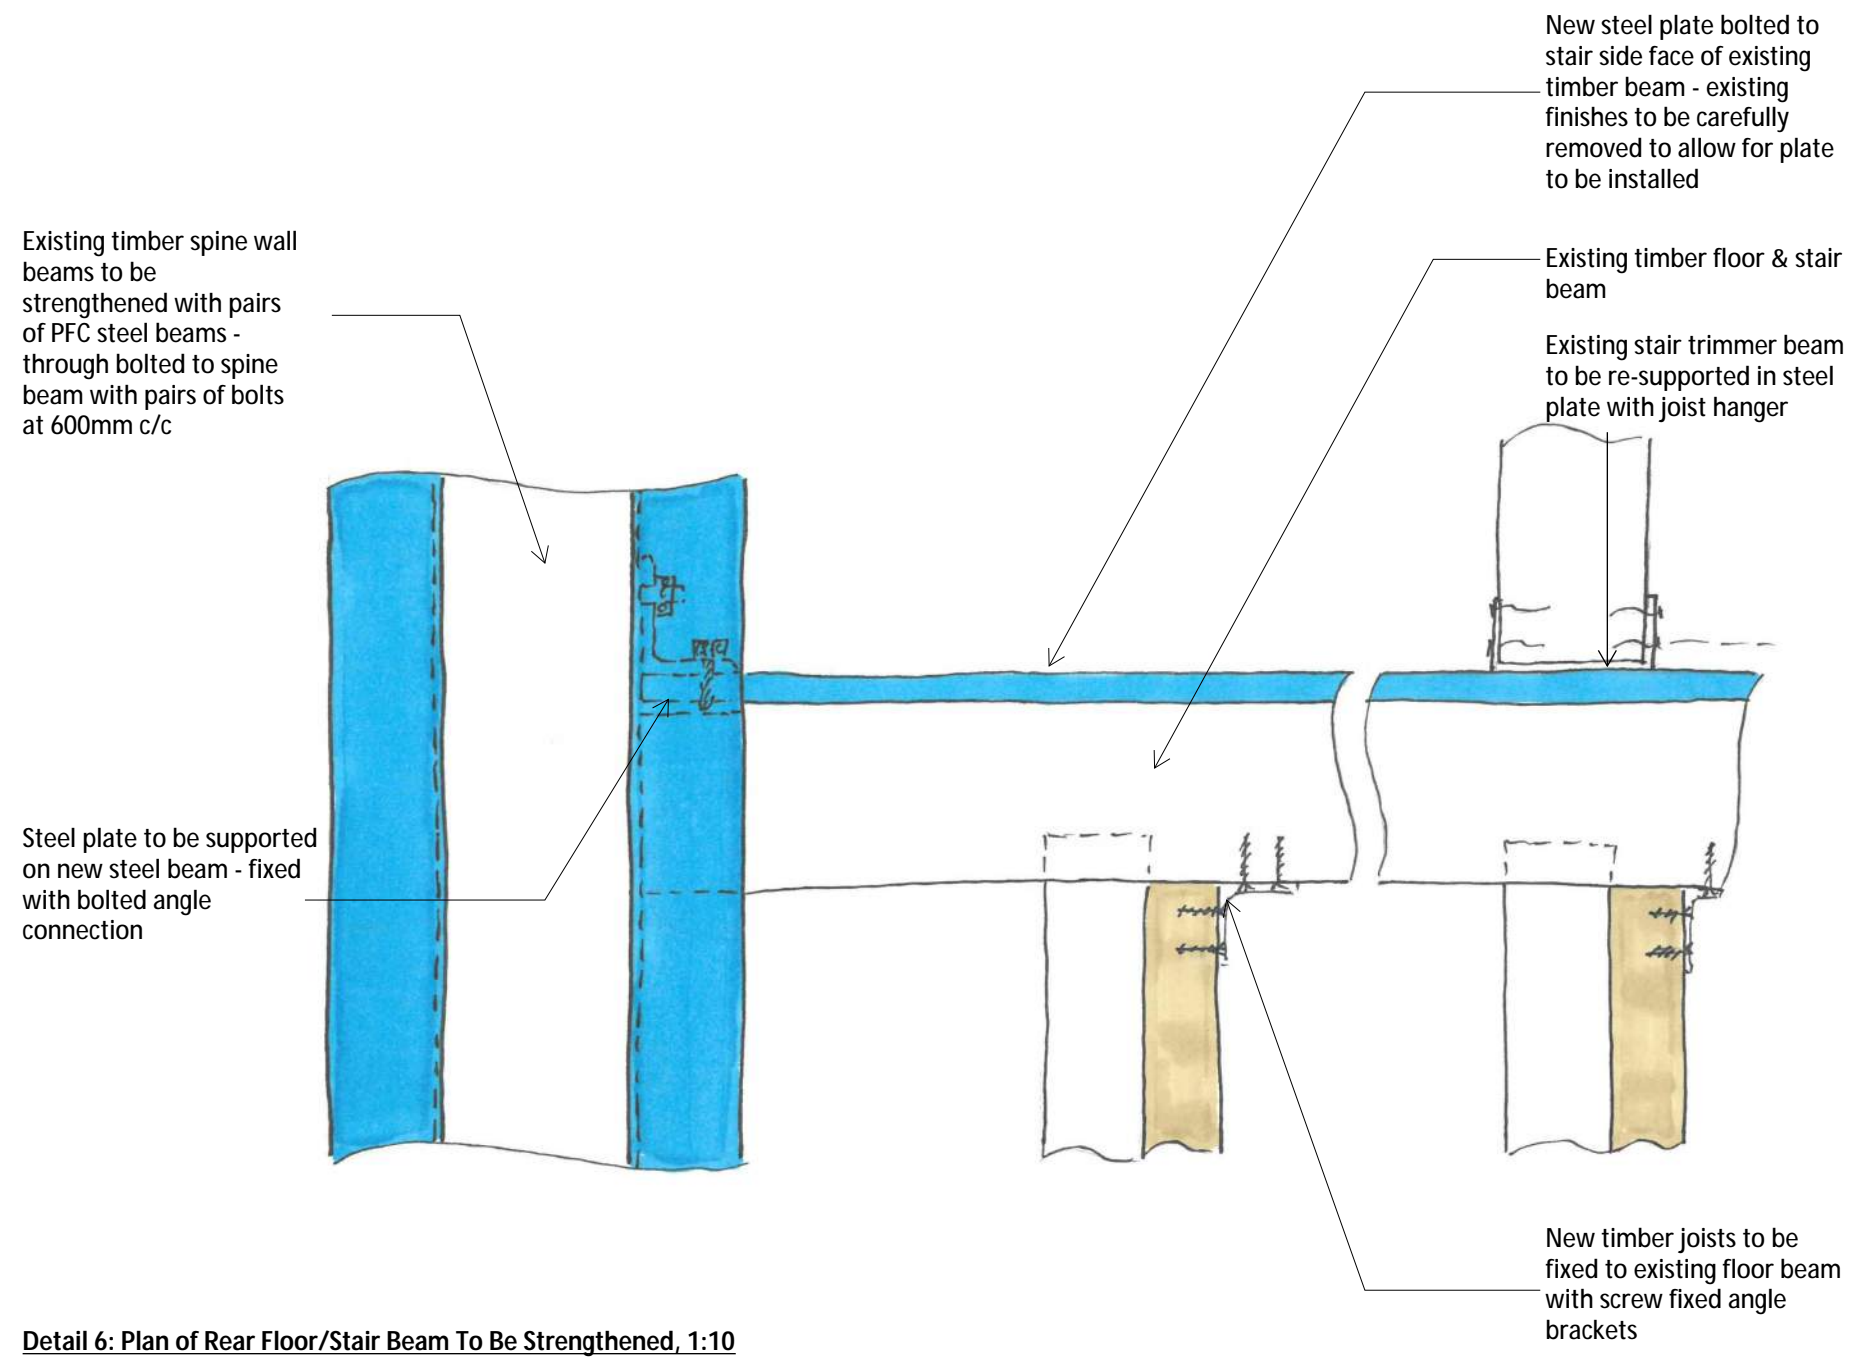
- The existing timber floor beam can not be justified for the required residential loadings to current standards and requires strengthening
- The staircase shows signs of settlement due to the movement of the stair wall and the supporting beam line needs to be stabilised at each level
- The proposed solution offers the least impact to the existing floor structure as the floor joists will not require cutting back and re-supporting

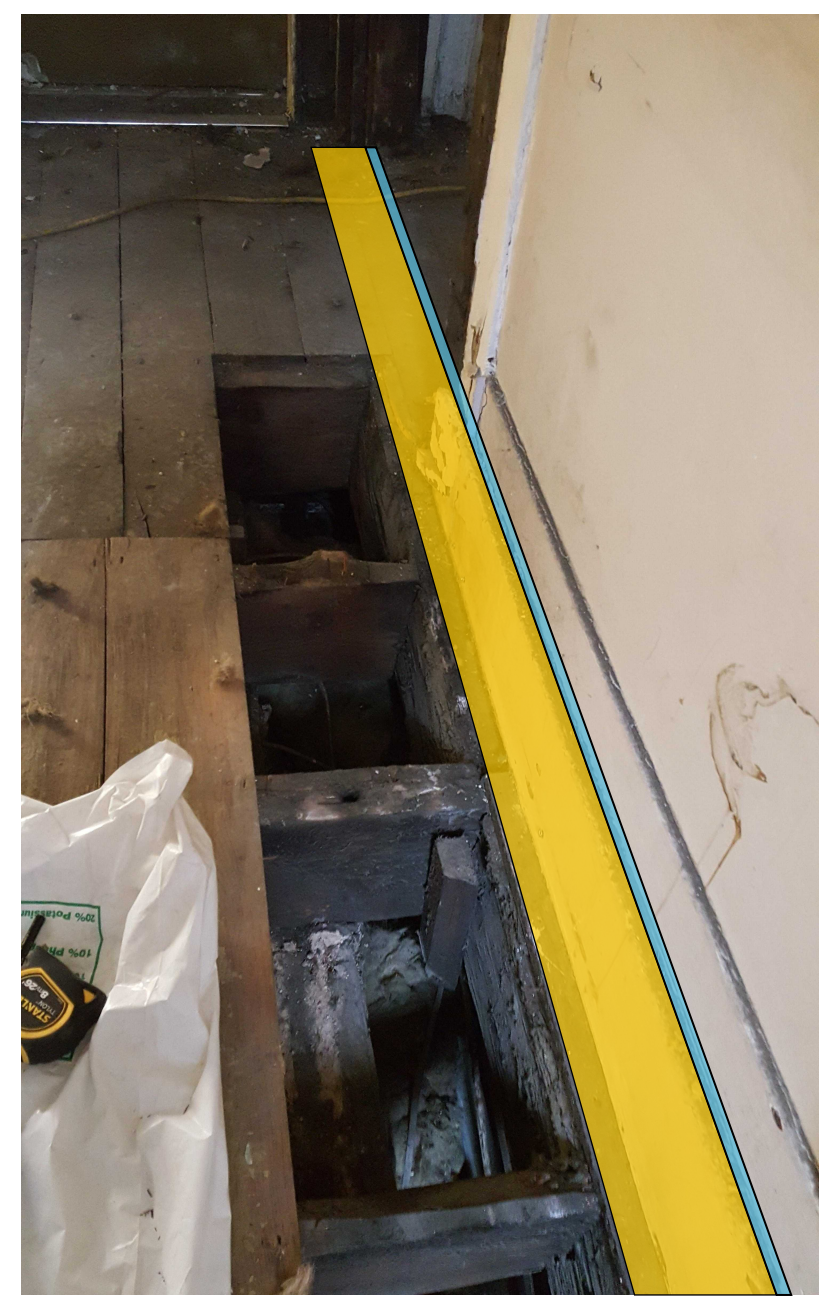
Figure 5, Rear Floor Beam To Be Strengthened (Indicative)
Note: Strengthening to opposite side of wall shown
