Our ref. G1701/18A10/AK1

Planning Application 2016/1639/P - 23 Crossfield Road NW3 4NU

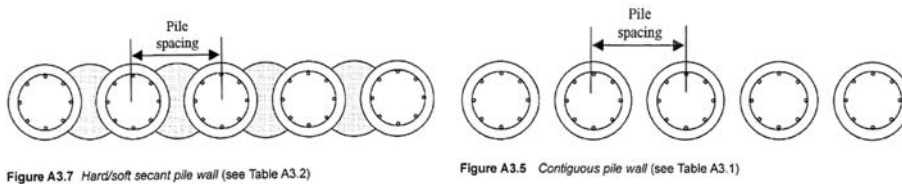
In December, a revised design was submitted. This allowed for larger piles and the use of a secant rather than contiguous pile arrangement. The

difference between the two is most easily explained by the following illustrations copied from the former CIRIA C580 guidance.

Figure A3.7 Hard/soft secant pile wall (see Table A3.2)

Figure A3.5 Contiguous pile wall (see Table A3.1)

But no account has been taken by GEA of installation movement and, as I pointed out in November, the movement caused by insertion of a secant wall is likely to be about twice as much as that due to a contiguous pile arrangement. Also, water pressure on the wall arising from ground movement has been specifically and quite wrongly excluded from the retaining wall analysis, and a decimal point error within the computer input has caused the top temporary strut to be calculated to have 10 times the resistance to movement that it would really exert. The analysis is not satisfactory.
