INTRODUCTION

This short document from Willow Cottages residents [date 19 March 2018] is a measured and considered response to the recently submitted GEA authored BIA Audit Response document dated 24 January 2018.

The GEA BIA Audit Response is a formal reply to the additional queries raised in Campbell Reith's BIA Audit Report dated December 2017. It should be noted that to date the applicant under planning application 2016/7146/P [Proposed Basement works at 31 Willoughby Road NW3] has been afforded three opportunities to respond appropriately to the numerous and legitimate queries relating to the proposed works and their impacts on Listed Willow Cottages [LWC] and Listed Willow Cottages rear retaining boundary wall [LRRBW].

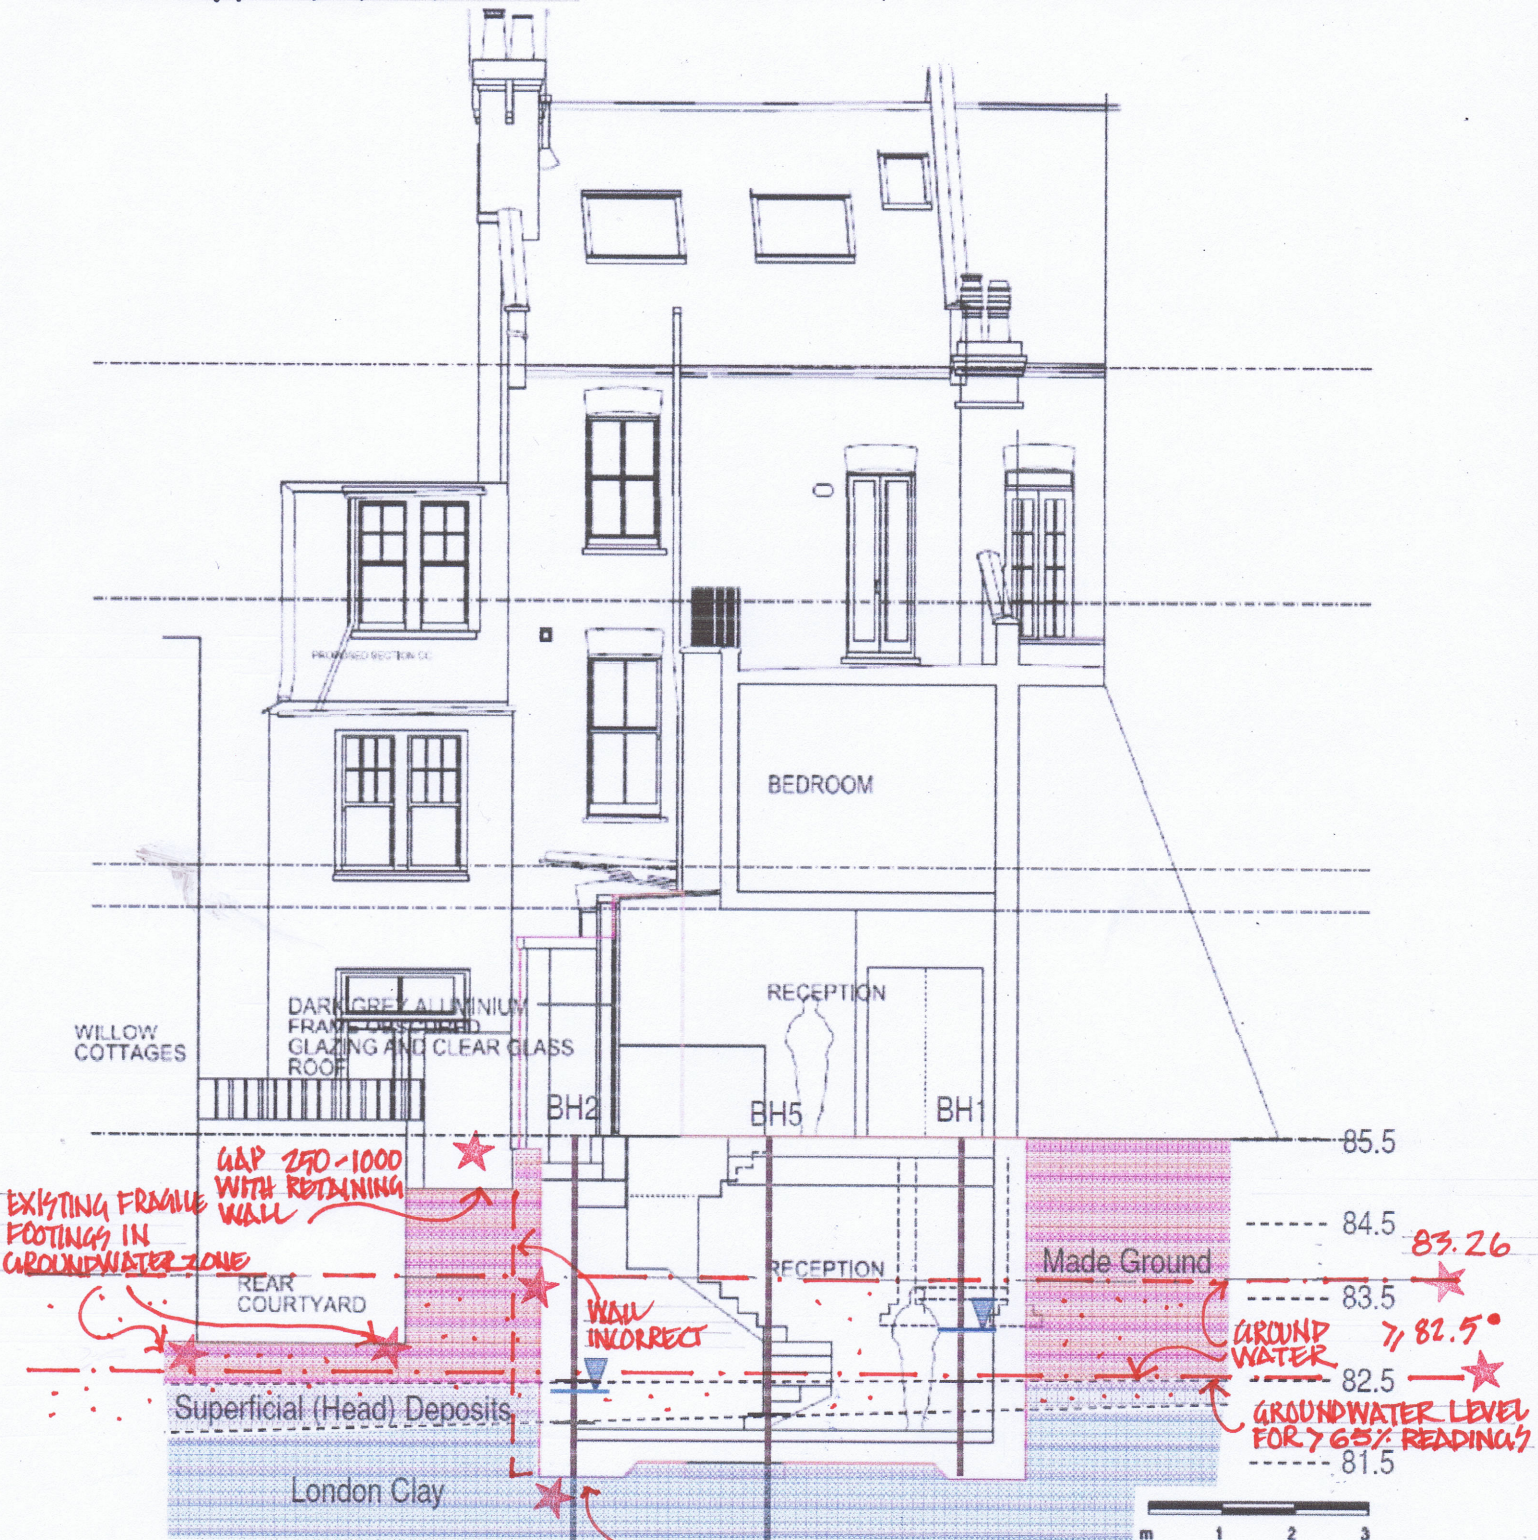
PROPOSED SECTION C-C - WITH COMMENTS RELATIVE TO WILLOW COTTAGES

REAL EXCAVATION DEPTH NOT SHOWN

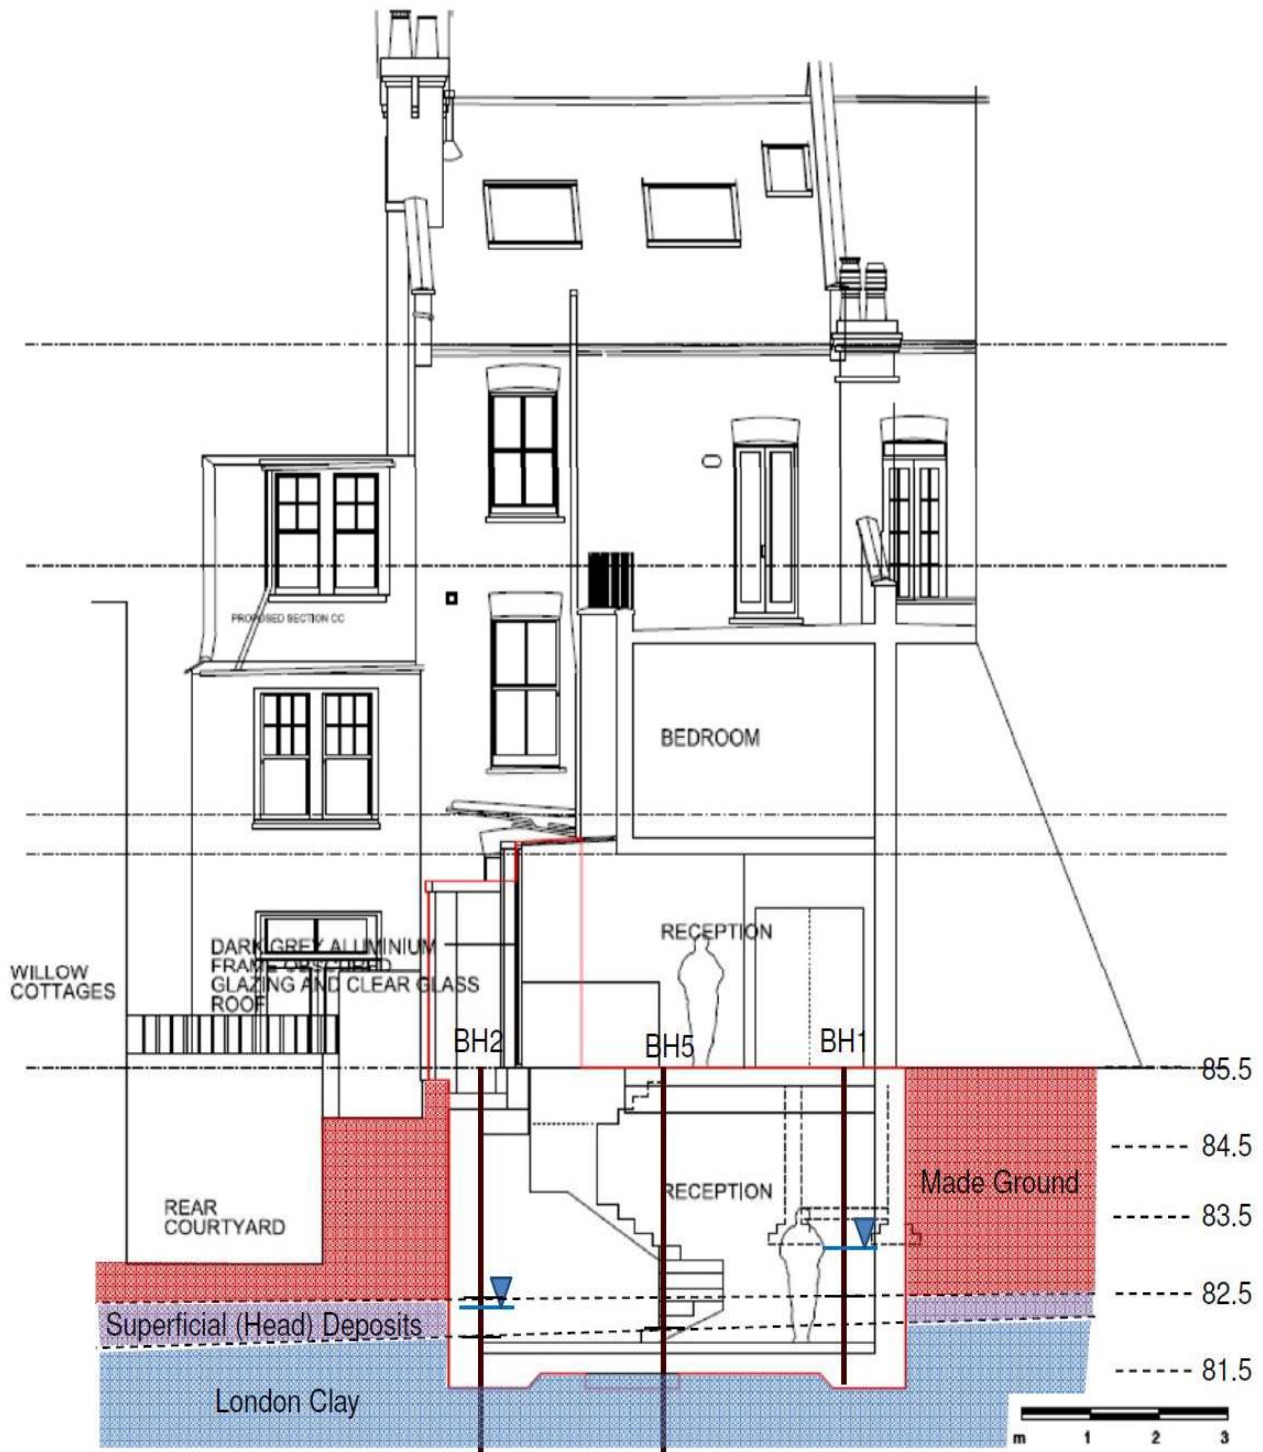
Borehole No	Standpipe depth (m bgl) [m OD]	Depth to groundwater (m bgl) [m OD]					
		02/02/2016	23/02/2016	14/12/2016	05/07/2017	11/07/2017*	19/12/2017
1	3.1 [82.45]	2.55 [83.00]	2.34 [83.21]	Not monitored	2.46 [83.09]	3.00 [82.55]	2.29 [83.26]
2	4.00 [81.50]	3.00 [82.50]	3.04 [82.46]	Not monitored	3.17 [82.33]	3.20 [82.30]	3.04 [82.46]
3	3.00 [82.40]	2.75 [82.65]	2.70 [82.70]	2.75 [82.65]	2.85 [82.55]	2.80 [82.60]	2.66 [82.74]
4	5.00 [80.40]	2.75 [82.65]	2.76 [82.64]	2.75 [82.65]	2.88 [82.52]	2.89 [82.51]	2.83 [82.57]

*Water levels within BH1 not fully recovered from rising head test undertaken on 5th July 2017.

These readings confirm that there is permanent flowing groundwater at the shallow bearing foundation levels of Listed Willow Cottages and the Listed rear boundary retaining wall. As mentioned in our earlier submitted critiques, Listed Willow Cottages and the listed retaining wall have shallow Victorian footings on currently stable memory-based load bearing and compacted ground. The proposed works will cause serious long term destabilisation to the now stable and well-established loadbearing soil profile to both listed constructions [achieved over 150 years]. Furthermore, the measured ground water profile shows

there to be substantial water within the 'Made Ground' zone that will obviously be re-directed by the proposed basement works onto the fragile listed retaining wall and the listed Willow Cottage terrace. This will remove the fines within the soil, reduce bearing capacity and cause disparate movement and damage to Willow Cottages.

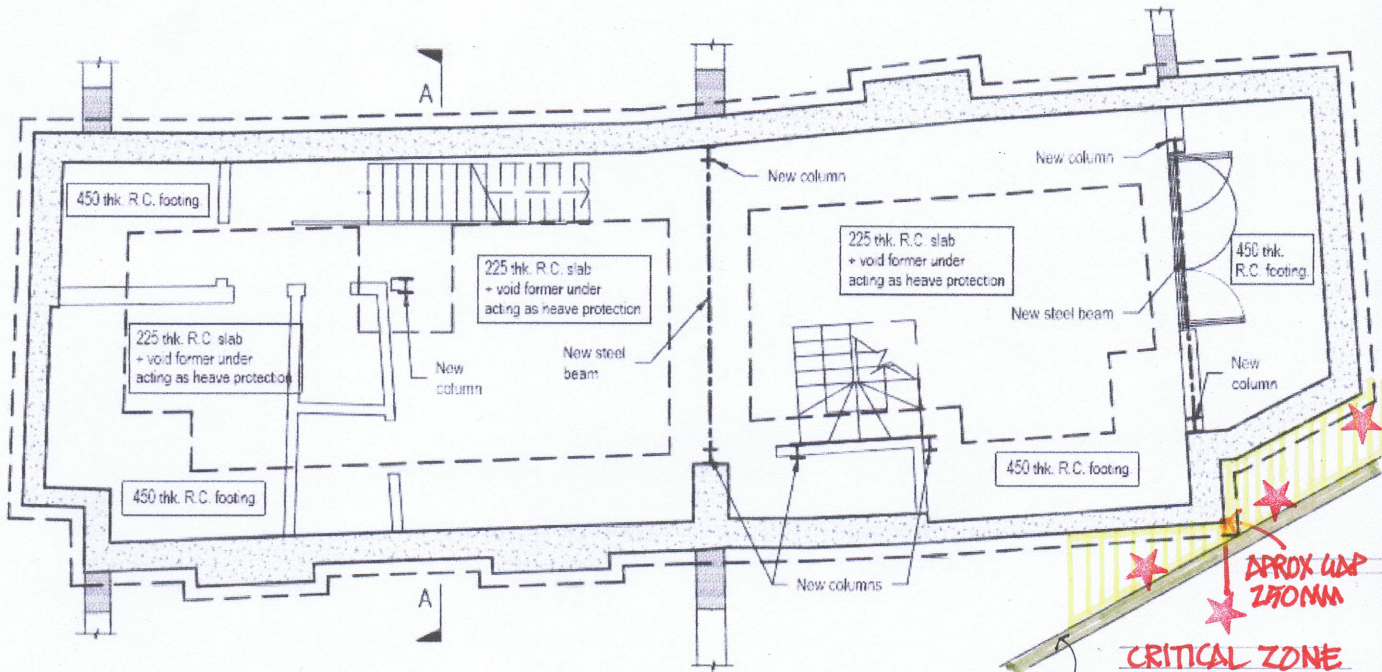
EXTRACT DRAWING 4186-SMOZE

Stage 4:

- Four pads / strips / fit steels / cast R.C. walls
- Remove sacrificial pins
- Cast slab
- After concrete has cured and achieved design strength carefully trim back projections & remove temporary works
- Install partition walls & finishes: insulation, waterproofing etc. - refer to Architects details

2. The combined summary drawings, including drawing 4186-SM02E and summary groundwater tables which all show their relationships to Listed Willow Cottages, ominously underplay and even ignore the real relationships and obvious impacts of

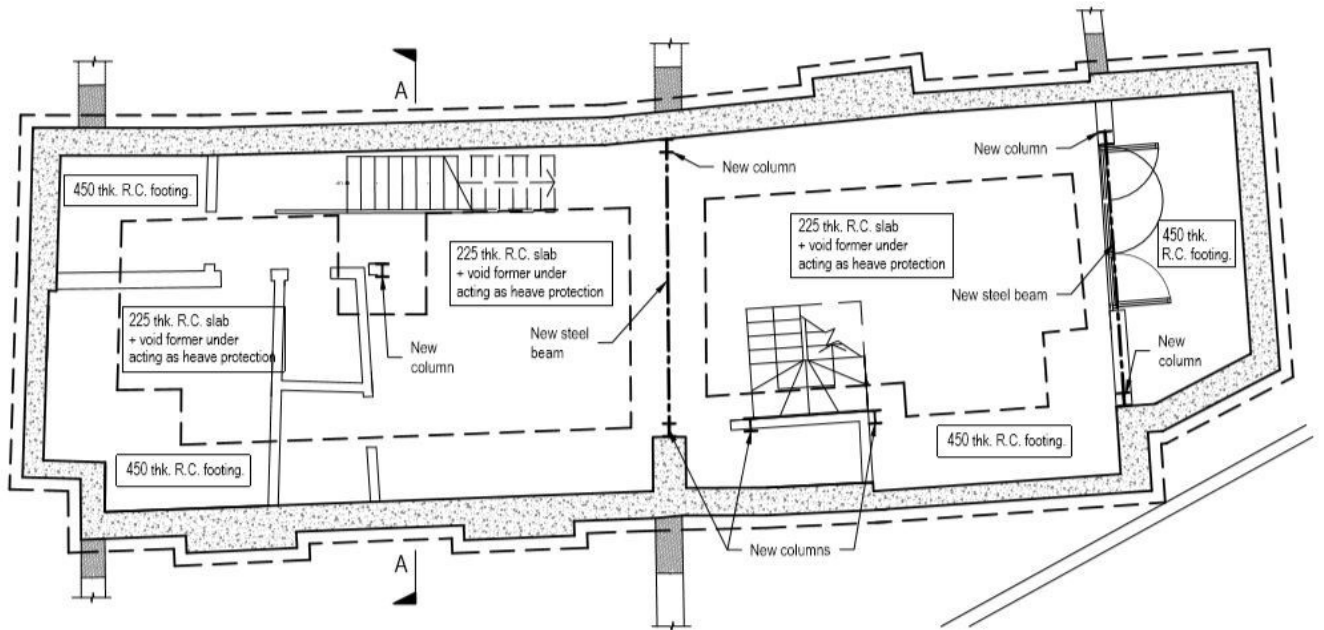
Stage 4:

- a. Pour pads / strips / fit steels / cast R.C. walls.
- b. Remove sacrificial pins.
- c. Cast slab.
- d. After concrete has cured and achieved design strength carefully trim back projections & remove temporary works.
- e. Install partition walls & finishes: insulation, waterproofing etc.- refer to Architects details.
