Garden House, Structural Report and Basement Impact Assessment

Issue 06

Project Number:	16168
Report Issue Date:	08/12/2017
Report Issue Status	For Planning
Prepared by:	Luci Rutledge MEng CEng MIStructE
Checked by:	Duncan Walters BSc MSc CEng MIStructE

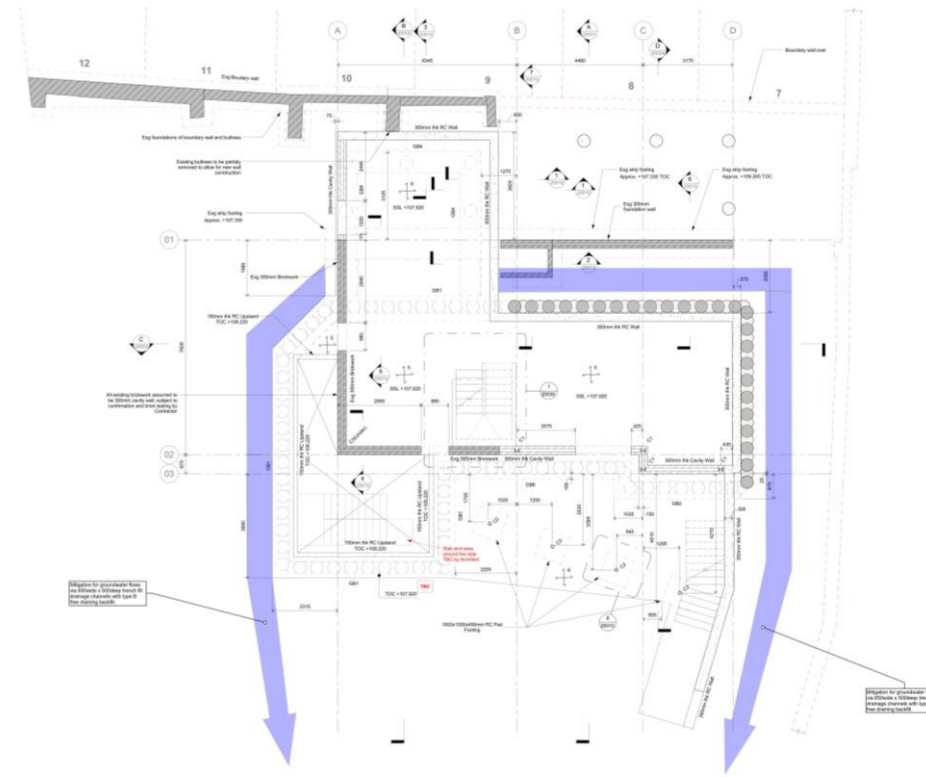
The proposed location of the trenches is shown on the adjacent sketches, positioned outboard of the pile capping beams. At 650mm wide x 500mm deep, they match that of the measured existing ground water level, thus providing an overflow to release any increase in the groundwater level.

Figure 22 Proposed Drainage Channels in plan and section surrounding the excavation leading towards the east of the site

As a precautionary measure, mitigation will be implemented in the form of drainage channels cut into the landscape to match the depth of the measured ground water level. This will ensure that the existing groundwater level is retained at the status quo rather than reducing or raising the existing level which could have more onerous impacts to the surrounding environment.
