British Museum
 Perimeter Properties Refurbishment

P2007246	
DRAWING TITLE 1-1A Montague Street Proposed Side Elevation 1A MS	SCALE 1:50@A1
DRAWING NO. (15)AE003	DATE April'17
REVISION D

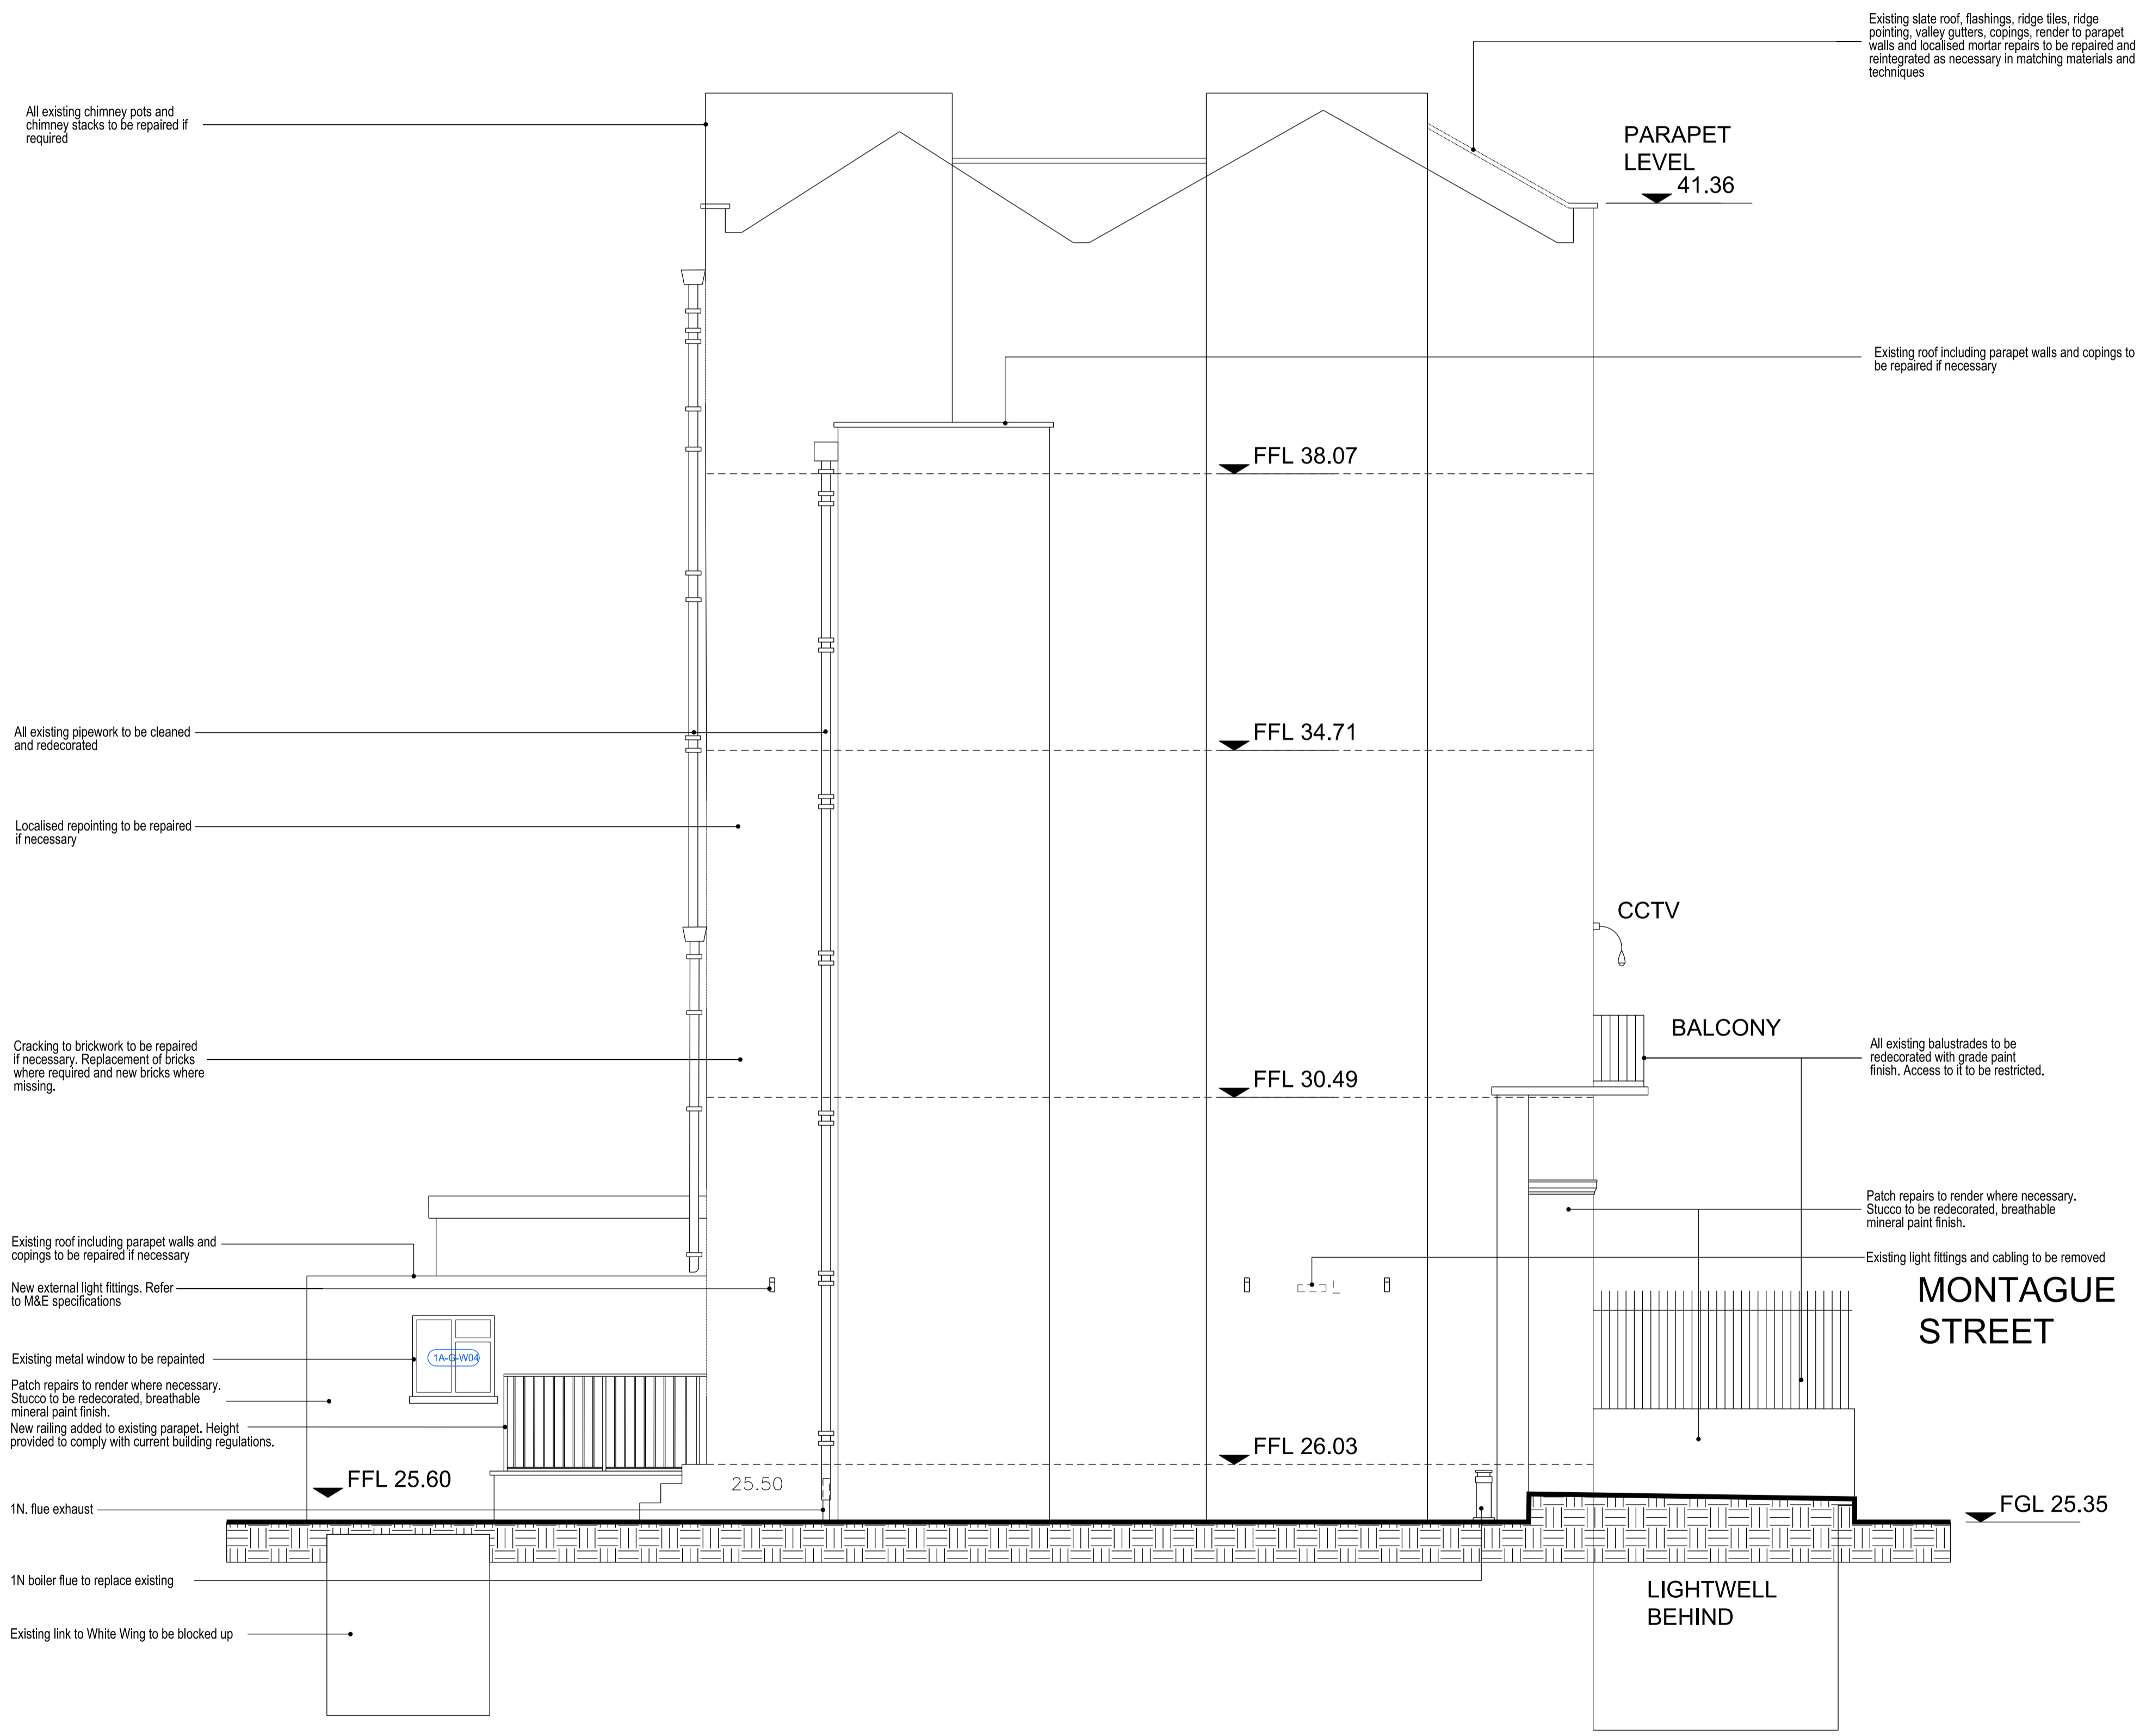
All existing chimney pots and chimney stacks to be repaired if required

Existing slate roof, flashings, ridge tiles, ridge pointing, valley gutters, copings, render to parapet walls and localised mortar repairs to be repaired and reintegrated as necessary in matching materials and techniques

Existing roof including parapet walls and copings to be repaired if necessary

All existing pipework to be cleaned and redecorated

Localised repointing to be repaired if necessary

Cracking to brickwork to be repaired if necessary. Replacement of bricks where required and new bricks where missing.

All existing balustrades to be redecorated with grade paint finish. Access to it to be restricted.

Patch repairs to render where necessary. Stucco to be redecorated, breathable mineral paint finish.

New external light fittings. Refer to M&E specifications

Existing light fittings and cabling to be removed

Existing metal window to be repainted

1N boiler flue to replace existing
