PROPOSED ROOF PLAN

CLIENT <b>Venoru Ltd</b>	
PROJECT <b>49 Marchmont Street, WC1N 2AN</b>	
DRAWING PROPOSED ROOF PLAN FOR PLANNING PURPOSES ONLY NOT FOR CONSTRUCTION	
DRG. No <b>15</b>	REVISION <b>D</b>
SCALE <b>1:50 @ A3 PAPER</b>	DATE <b>4 April 2018</b>

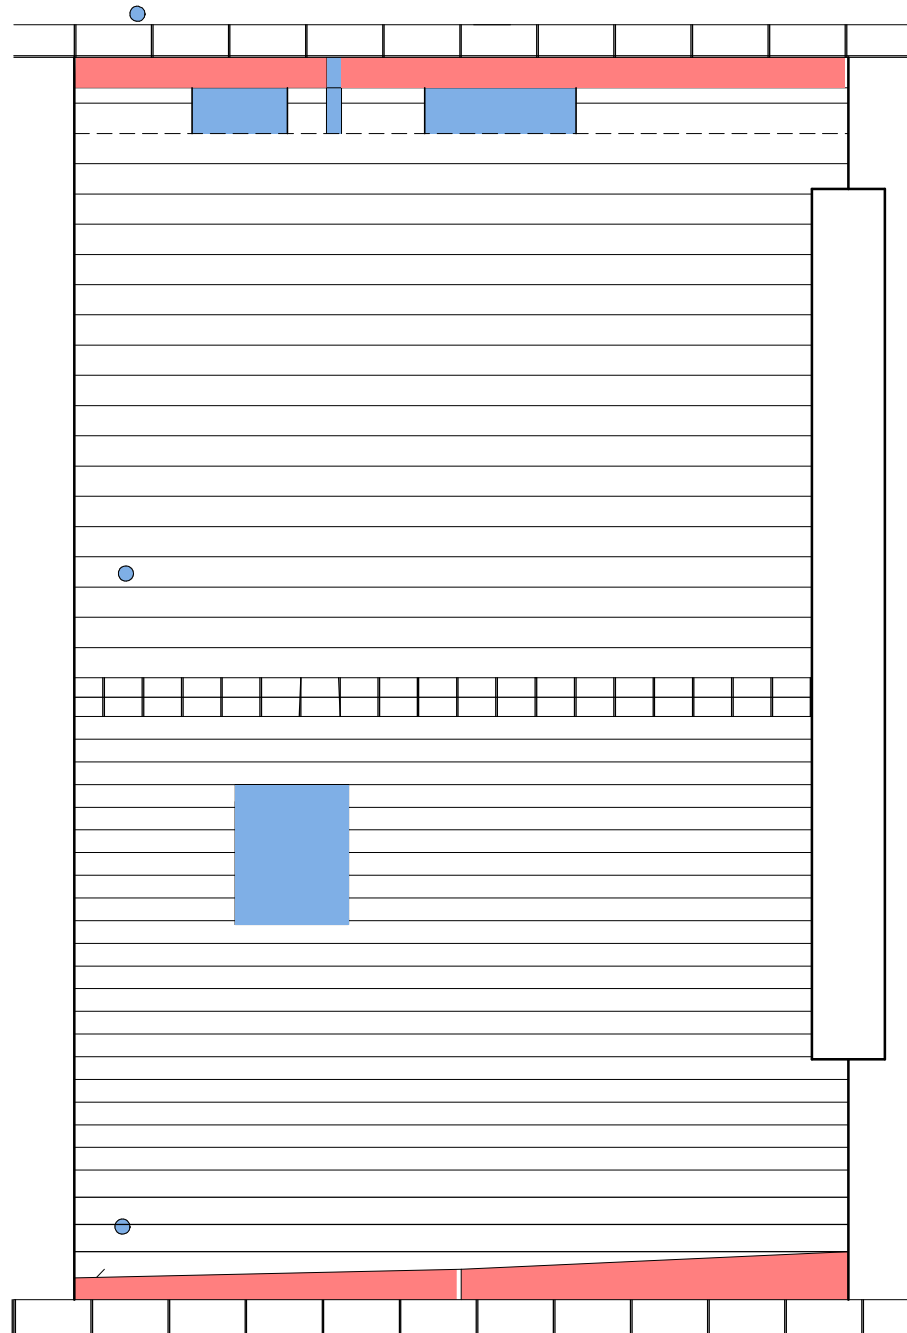
lead hatch RETAINED

existing slates reused  
new slates to match - sample submitted

parapet stones examined for stability and made good  
gutter repaired - new sprocketed eaves and new lead gutter laid to adequate falls

dormers repaired and new lead weatherings fitted to dormer roof and mansard

gutter repaired - new sprocketed eaves and new lead gutter laid to adequate falls

PARAPET stones examined for condition and rebbed as required

timber elements of roof to be repaired as described here and on drawing 14  
- rafters checked for integrity and repaired as required

roof membrane has been patched over time and there are missing areas and areas of continuous water ingress

parapet gutters to be rebuilt with improved falls - see drawing 14

a new breathable membrane is required fixed over the rafters throughout - carefully weathered at parapets to kerb the severe water ingress

dormers lead roofs to be repaired

new lead weatherings to all junctions between roof and masonry to be repaired and areas where missing to be fitted with new
