## 01: PROPOSED GROUND FLOOR PLAN

## 02: ELEVATION OF TIMBER PANEL WALL FROM COMMON HALLWAY

04: PROPOSED PANEL WALL DETAILED SECTION

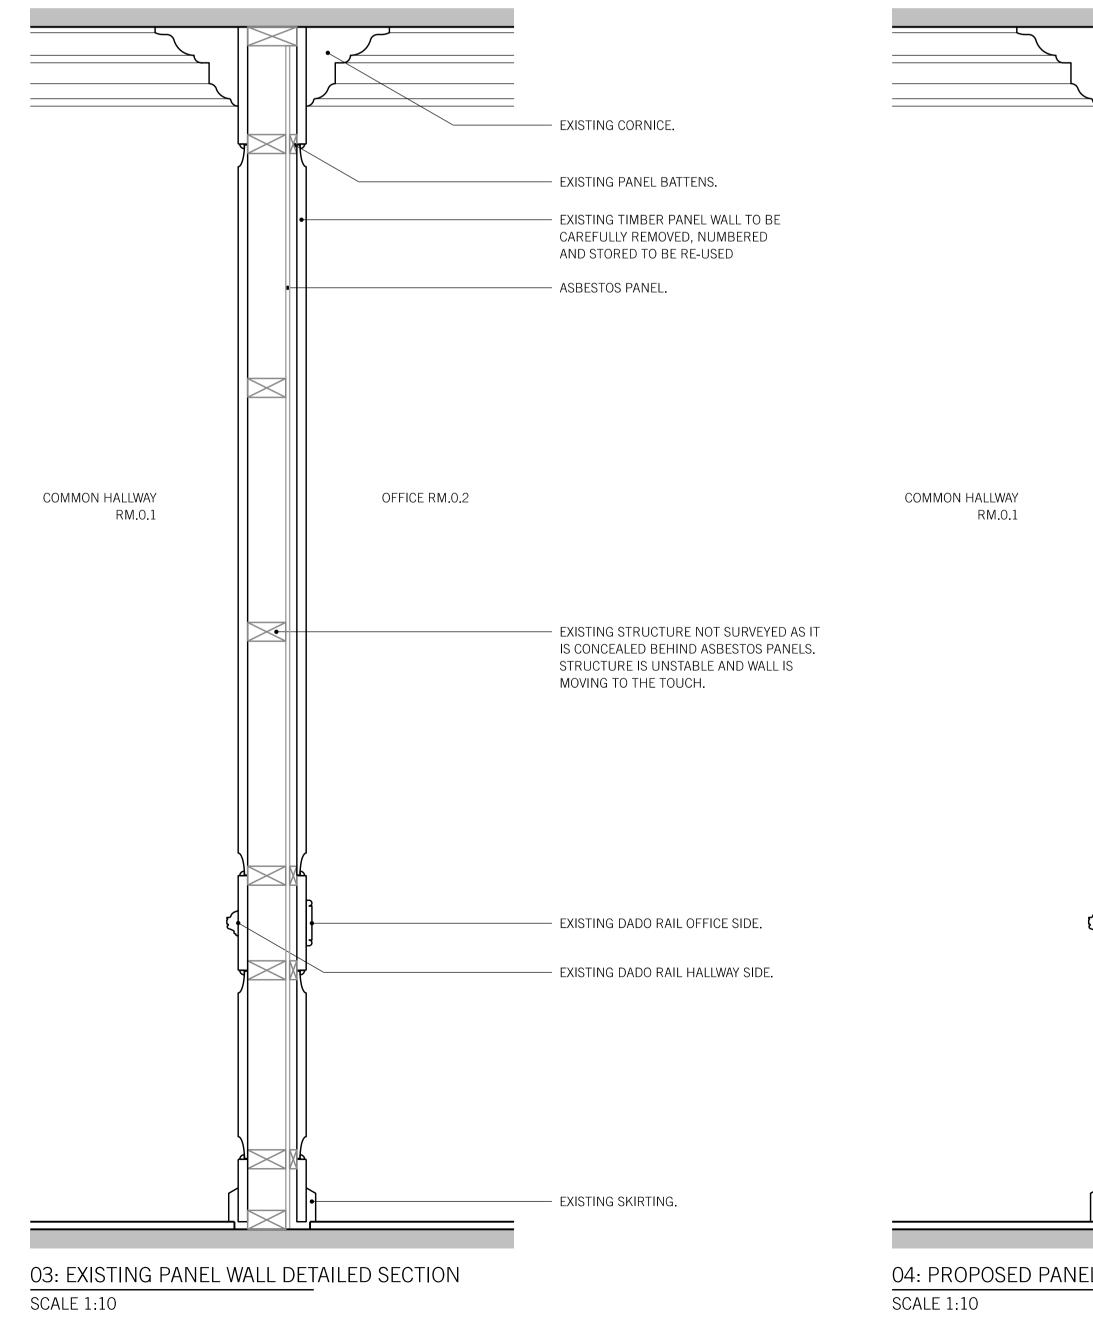
INTUMESCENT PAINT TO CORNICE AS - INTUMESCENT PAINT TO CORNICE AS \_\_\_\_\_ PER DRAWING 177A-710-06 PER DRAWING 177A-710-06 - INTUMESCENT SILICONE EXISTING CORNICE MAINTAINED AND REPAIRED. THICKNESS OF WALL IS ANTICIPATED TO STAY AS EXISTING, HOWEVER IF THE EXISTING PANEL CAREFULLY CUT TO STRUCTURE NEEDS TO BE REINFORCED AVOID DAMAGE TO CORNICE BUT TO AND INCREASED TO STABILISE THE ALLOW ACCESS AND SECURE WALL AND INTRODUCE THE NECESSARY STRUCTURE. FIRE RESISTANCE, THIS WILL BE PANEL CUT LINE TO BE CAREFULLY ACCOMODATED BY OVERLAPPING THE REINSTATED AND SEALED WITH CORNICE IN RM.0.2 BY APPROXIMATELY INTUMESCENT SILICONE. 15MM. 05: PROPOSED WALL HEAD ALTERNATIVE ARRANGEMENT - EXISTING TIMBER PANEL WALL TO BE REINSTATED AND REPAIRED WHERE SCALE 1:10 NECESSARY. - THE EXISTING TIMBER FRAME STRUCTURE OF THE WALL WILL BE ASSESSED FOR VIABILITY AND REPAIRED TO MAKE THE WALL STRUCTURALLY SOUND. AS THE EXISTING WALL HAS SOME MOVEMENT, IT IS ANTICIPATED THAT PARTS OF THE STRUCTURE WILL BE REPLACED. OFFICE RM.0.2 IF POSSIBLE, THE STRUCTURE WILL BE REPAIRED WITHOUT NEEDING TO TAKE DOWN THE TIMBER PANELLING ON THE COMMON HALLWAY SIDE. 15MM FIRELINE PLASTERBOARD INSTALLED TO TIMBER FRAME. FULL FILL STUD WALL WITH FIRE BATT INSULATION FRICTION FITTED TIGHT TO ALL EDGES. EXISTING TIMBER PANEL ON COMMON HALLWAYSIDE OF WALL TO BE MAINTAINED AS EXISTING. IF IT IS NOT POSSIBLE TO STABILISE THE STRUCTURE WITHOUT THE TOTAL DISASSEMBLY OF THE WALL THEN THE SAME APPROACH SHALL BE ADOPTED ON THIS SIDE TO ENSURE THE CAREFUL STABILISATION AND FIRE PROTECTION. - EXISTING DADO RAIL OFFICE SIDE REINSTATED. EXISTING DADO RAIL HALLWAY SIDE MAINTAINED. - EXISTING SKIRTING.  $\mathbf{i}$
