**17/27399-2**  
**April 2018**

**SOUTH LODGE, HEATHSIDE,  
HAMPSTEAD, LONDON, NW3 1BL**

**BASEMENT IMPACT ASSESSMENT**

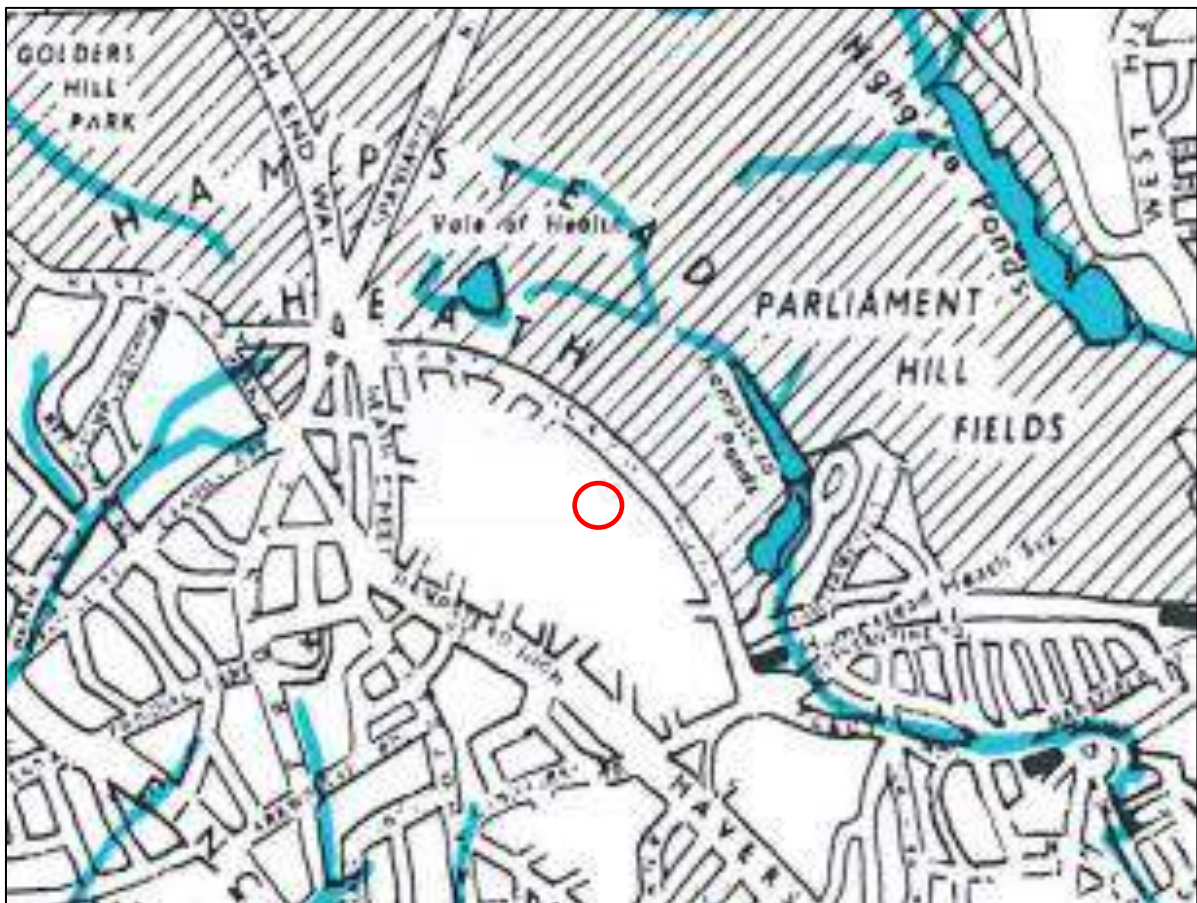
Figure 4. Location of site (circled) relative to the 'Lost Rivers' of London (Source: Barton, 1992)

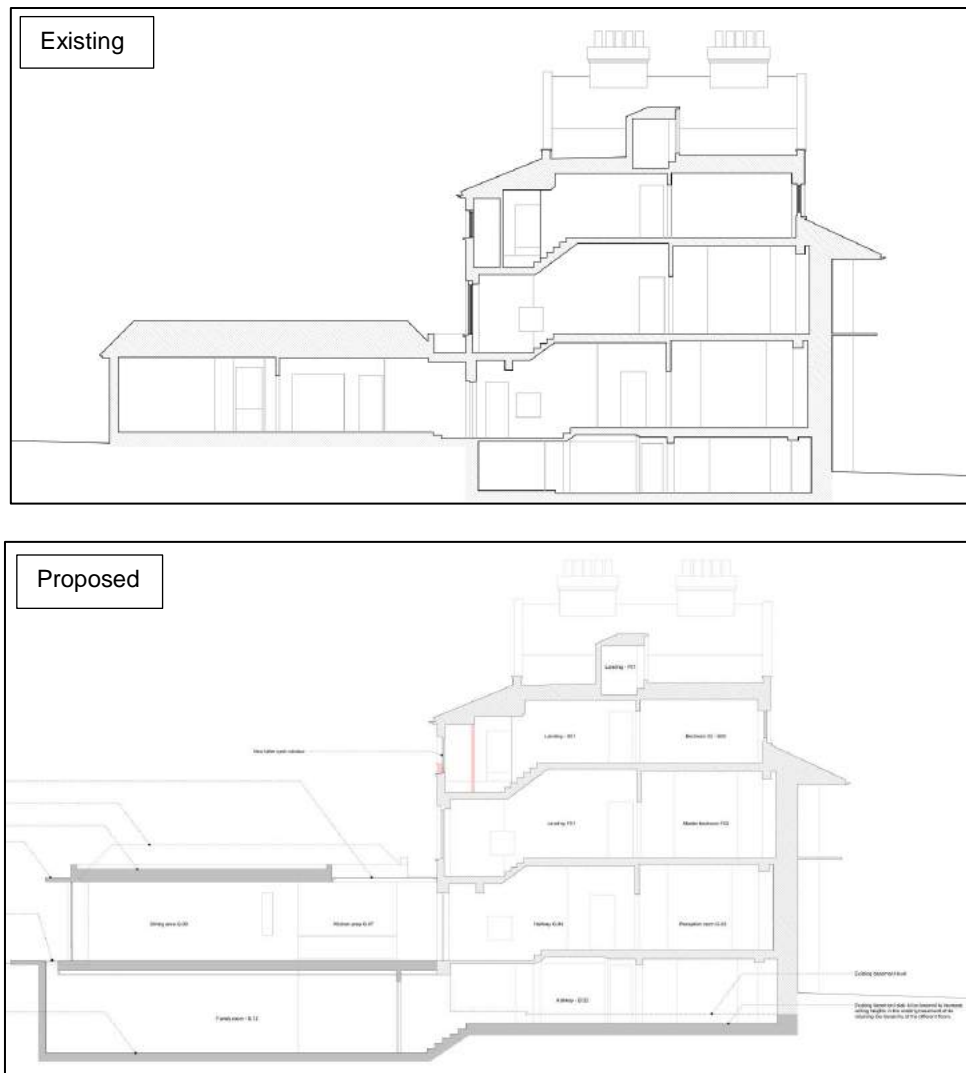
**Figure 8. Sections of the proposed North and South Elevations of the property.**

The Finished Floor Level (FFL) of the proposed new basement steps down from 92.85m AOD below the footprint of the original property (which equates to an approx. 0.90m excavation) to 92.00m AOD below the existing rear extension (a 3.50m excavation).

Sections showing the proposed developments are detailed in Figure 8 below.

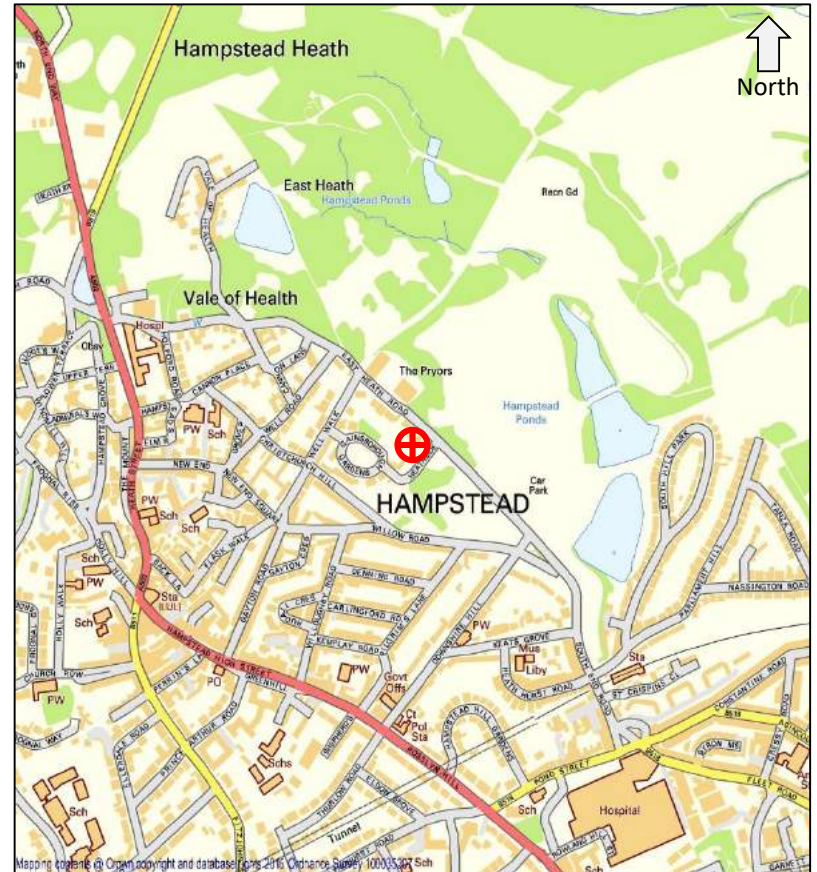
<b><u>FAIRHURST</u></b>	Ground Movement Assessment		
	Site Location Plan		
South Lodge, Heathside, NW3 1BL	Date: April 2018	Initials: JT	Figure: 1

Fairhurst have been commissioned by Site Analytical Services Limited (SASL) to complete a Ground Movement Assessment (GMA) in connection with a proposed residential development at South Lodge, Heathside, Hampstead at approximate postcode NW3 1BL. The location of the site is detailed on Figure 1. The purpose of this assessment is to determine what effects the proposed permanent construction may have upon nearby structures.

The site is located at South Lodge, Heathside, Hampstead, NW3 1BL (National Grid Ref: 526895, 186040). A site location plan is included in this report as Figure 1.

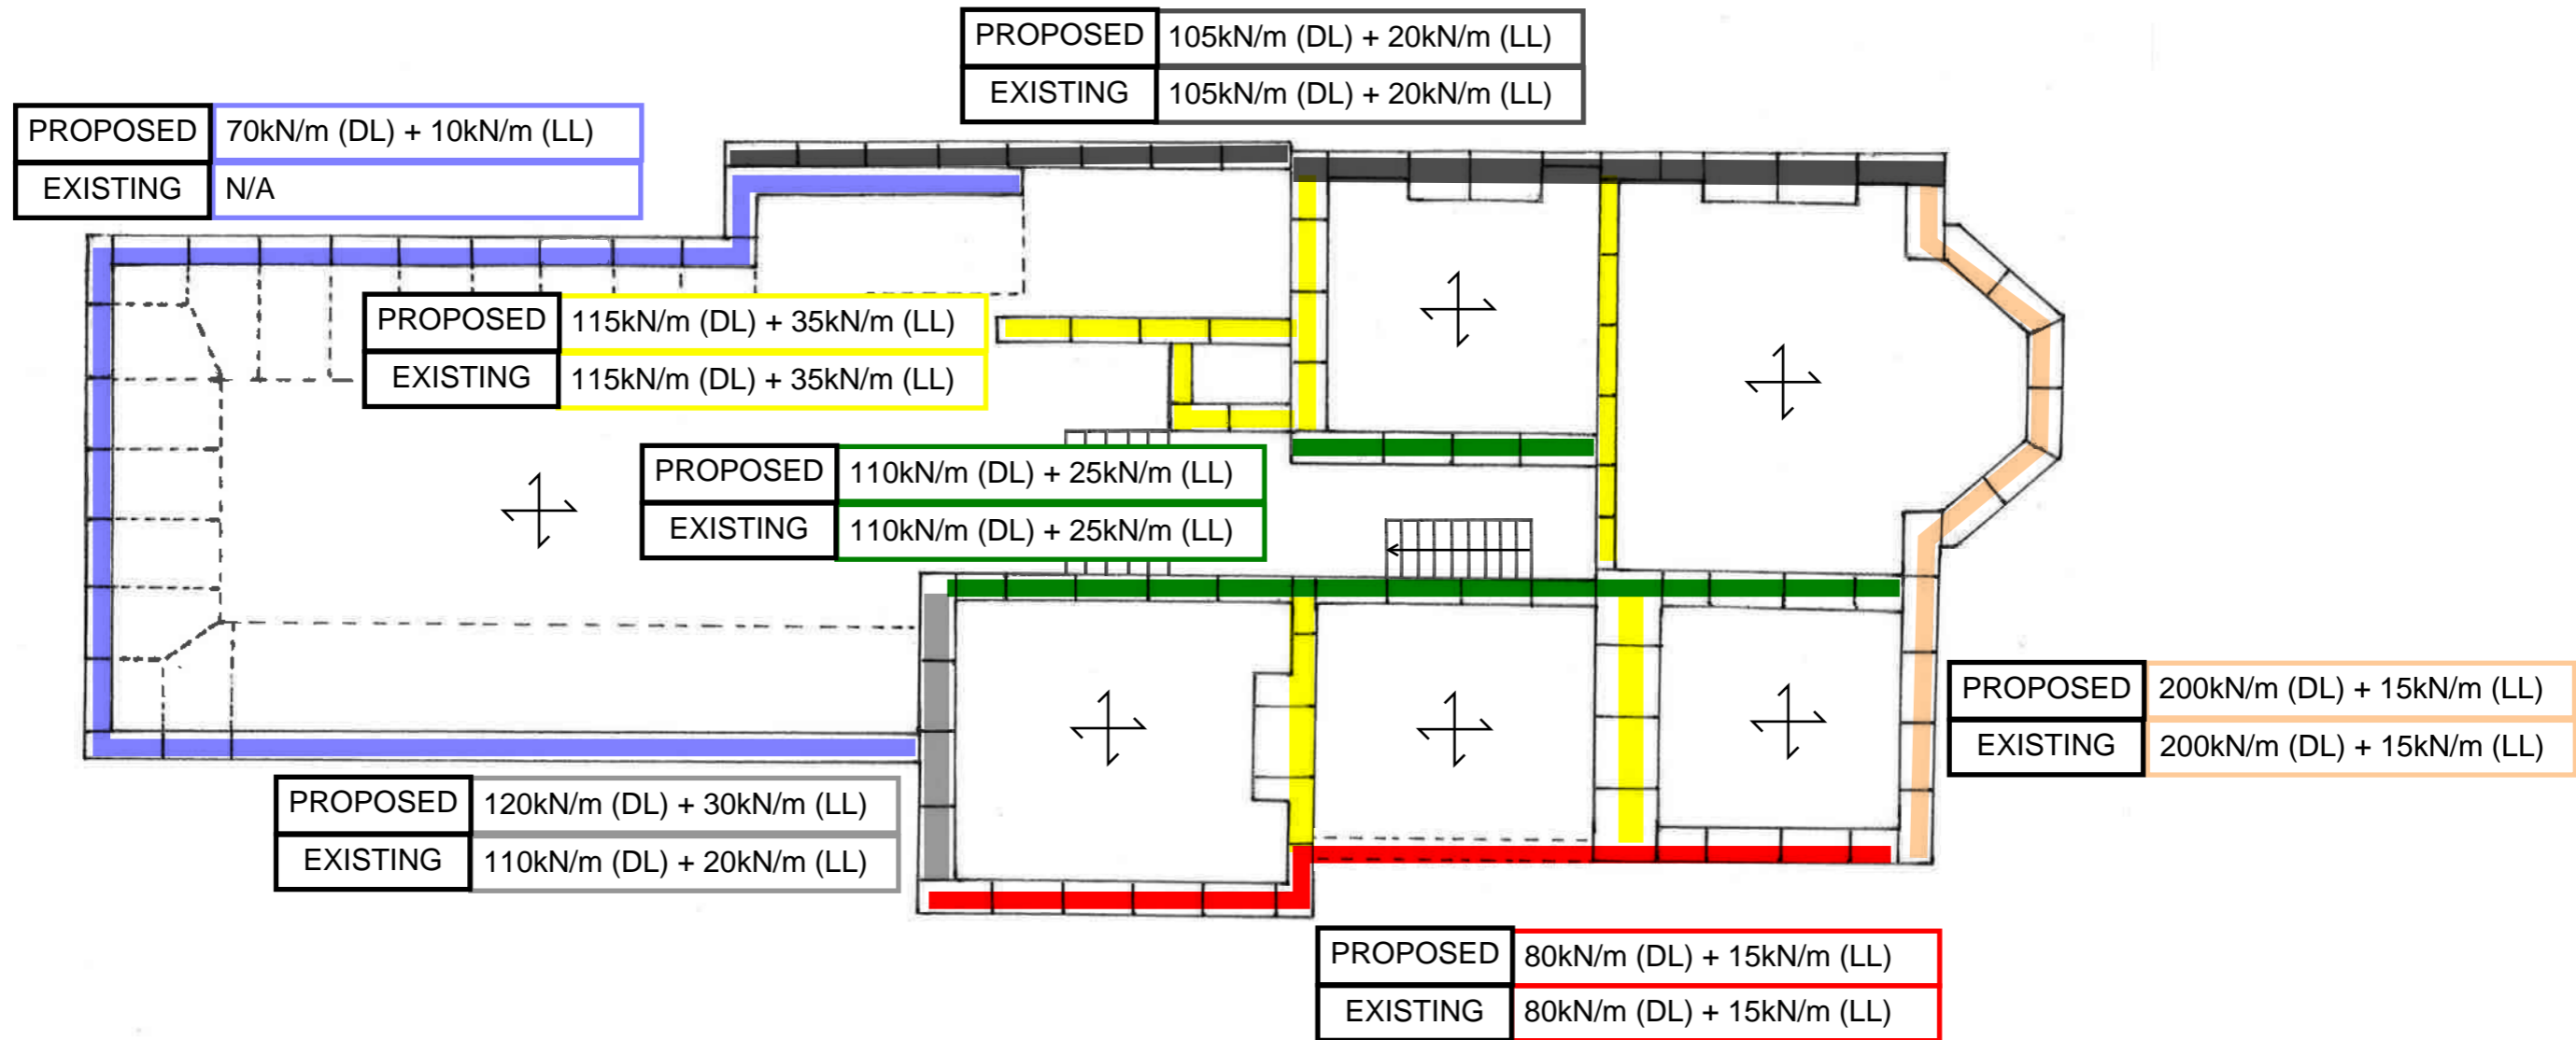
sketch title  
EXISTING + PROPOSED  
BASEMENT LOAD TAKEDOWN

**NOTE: ALL LOAD RUNS ARE SLS**

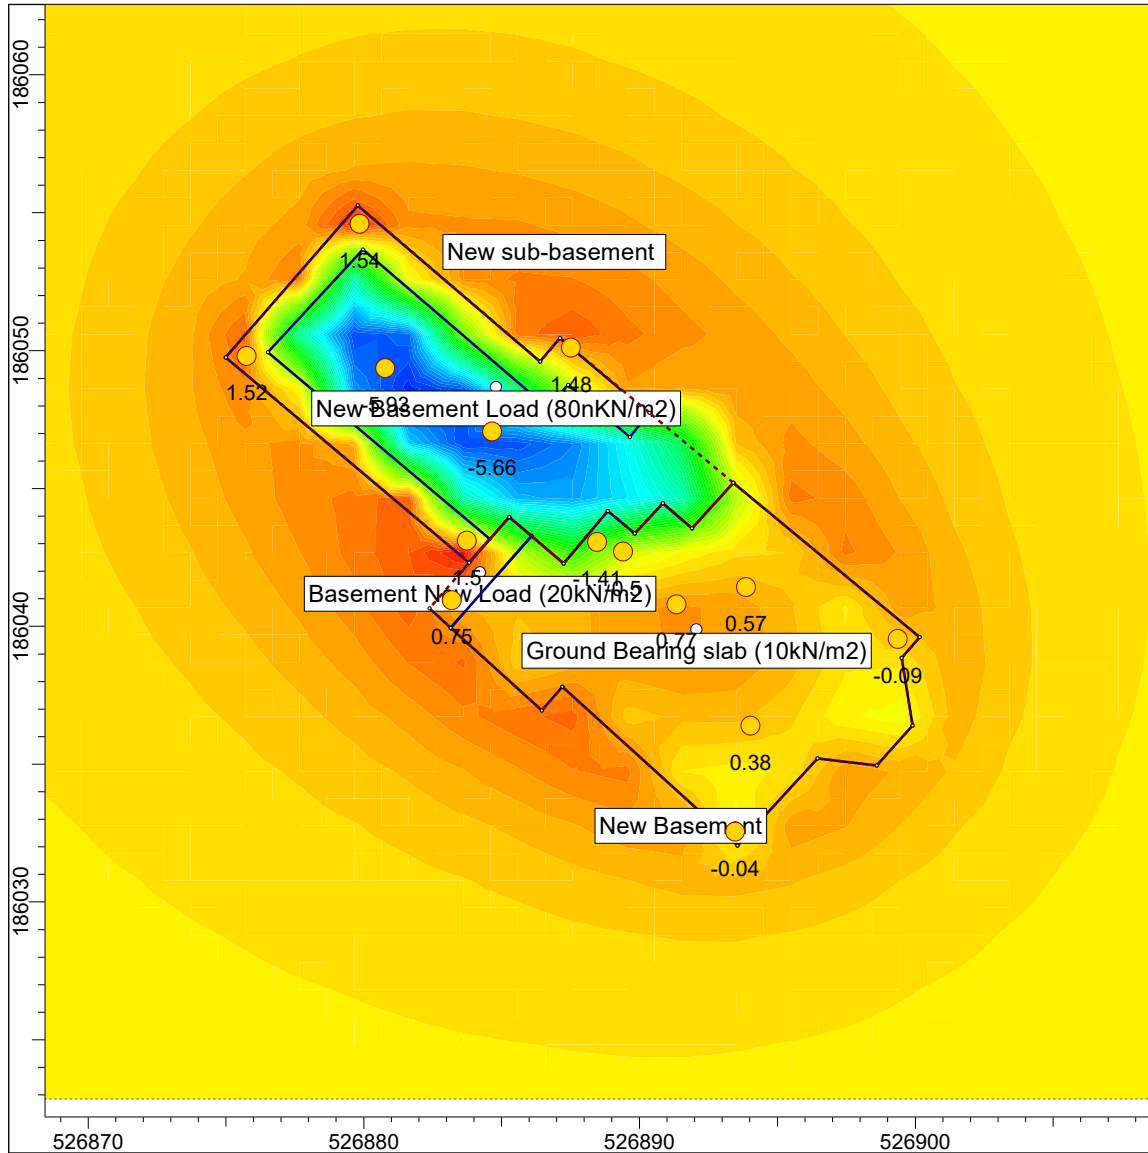
# Stage 2 - Undrained Reloading

Project	South Lodge, Heathside Ground Movement Assessment		
Analysis Description	Ground Movement Assessment		
Drawn By	JT	Company	Fairhurst
Date	10/04/2018, 11:00:30	File Name	Settle 3D - Stage 1,2 &3.s3z
