## 10. STAGE 4 – BASEMENT IMPACT ASSESSMENT

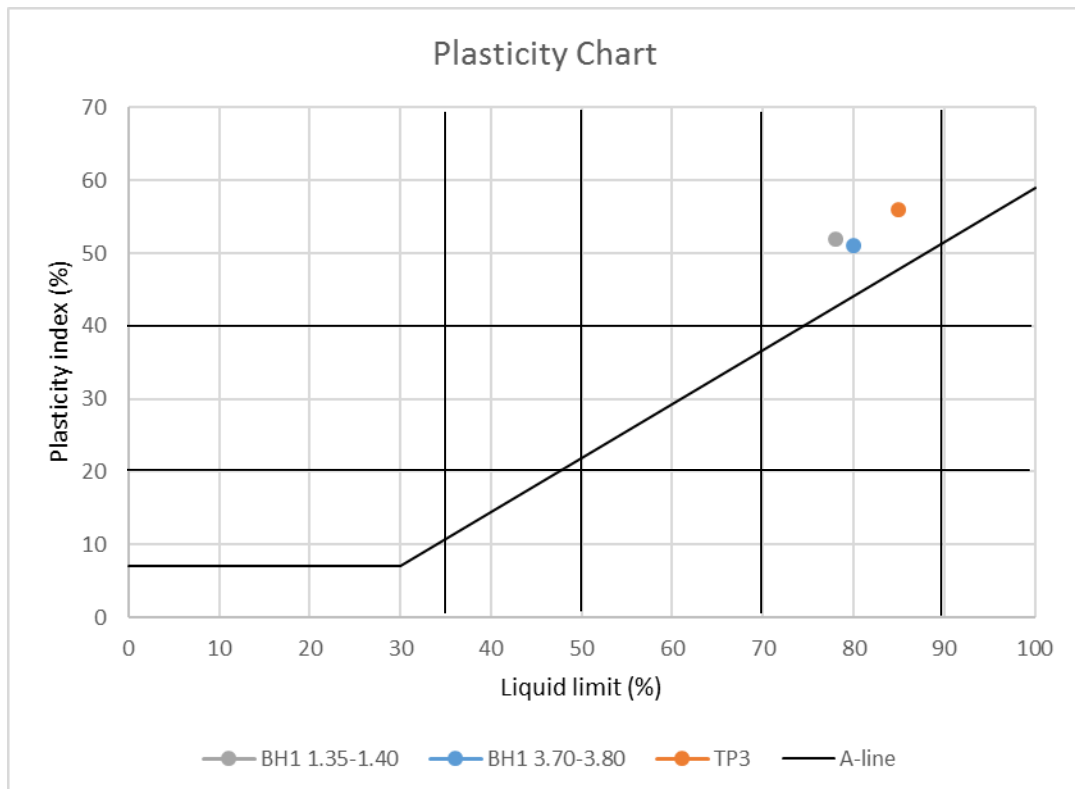
- 9.8 Laboratory tests were carried out by Geolabs Ltd on samples recovered from the borehole and trial pits. The testing comprised classification tests, including moisture content and plasticity, and chemical testing to assess the potential for acid or sulphate attack on buried concrete. The results are presented in Appendix F.
- 9.9 Plasticity tests were performed on two samples of the Weathered London Clay, recovered from BH1 at depths of 1.35-1.40m and 3.70-3.80m bgl, and on a sample of the 'Head Deposits/Soliflucted London Clay' recovered from TP3 at a depth of 0.70m – 0.80m bgl. All three samples were found to be of Very High Plasticity, as classified by BS5930 (2015), and High Volume change potential, as defined by the NHBC (NHBC Standards, 2018, Chapter 4.2, Building near Trees). These results are displayed in Figure 9.

**Figure 9:** Plasticity chart for samples recovered from BH1

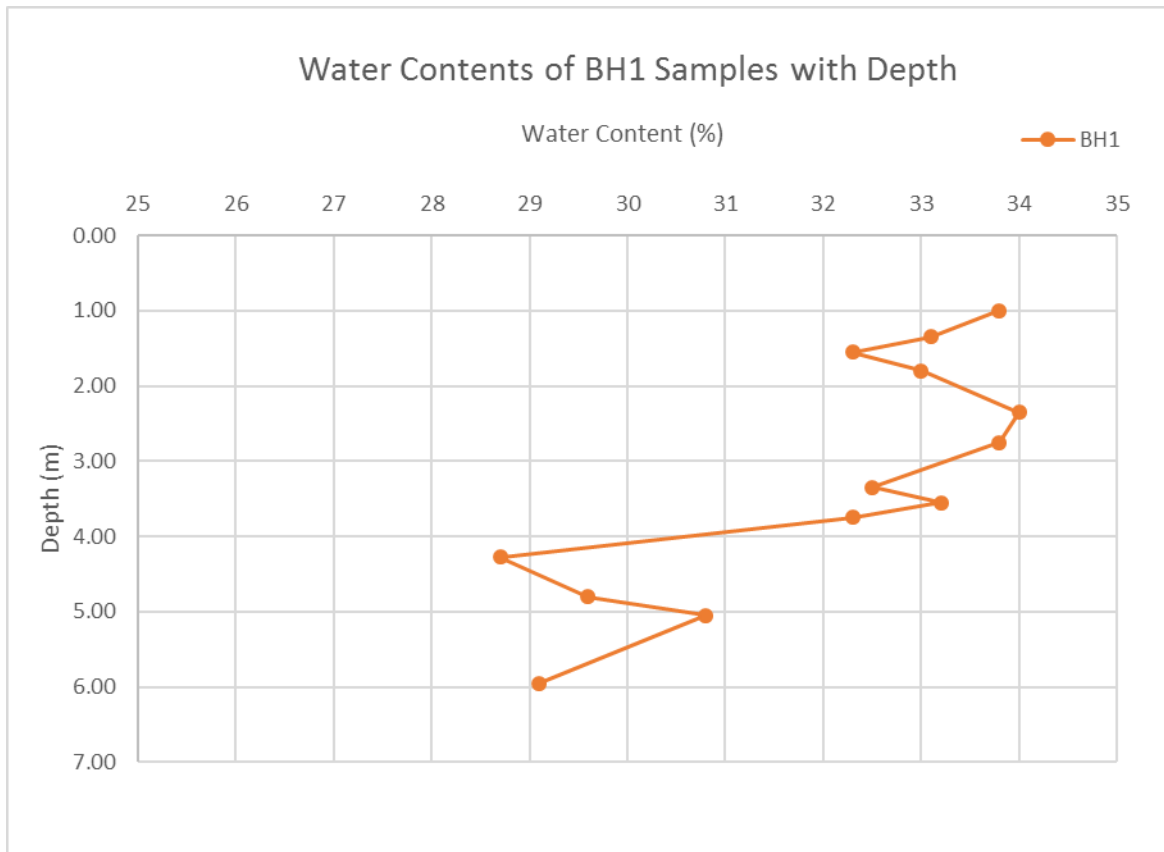
- 9.10 The water contents of fourteen samples recovered from BH1 between 1.00m and 6.00m bgl were found to vary between 28.7% and 34.0%. The plotted profile in Figure 10 shows an overall slight decrease in water content with depth in the

Weathered London Clay. The water content of a sample from TP3 at 0.70 - 0.80m was found to be 37.0%, within the Head/Soliflucted London Clay.

Figure 10: Profile of Water Content in BH1 with depth.

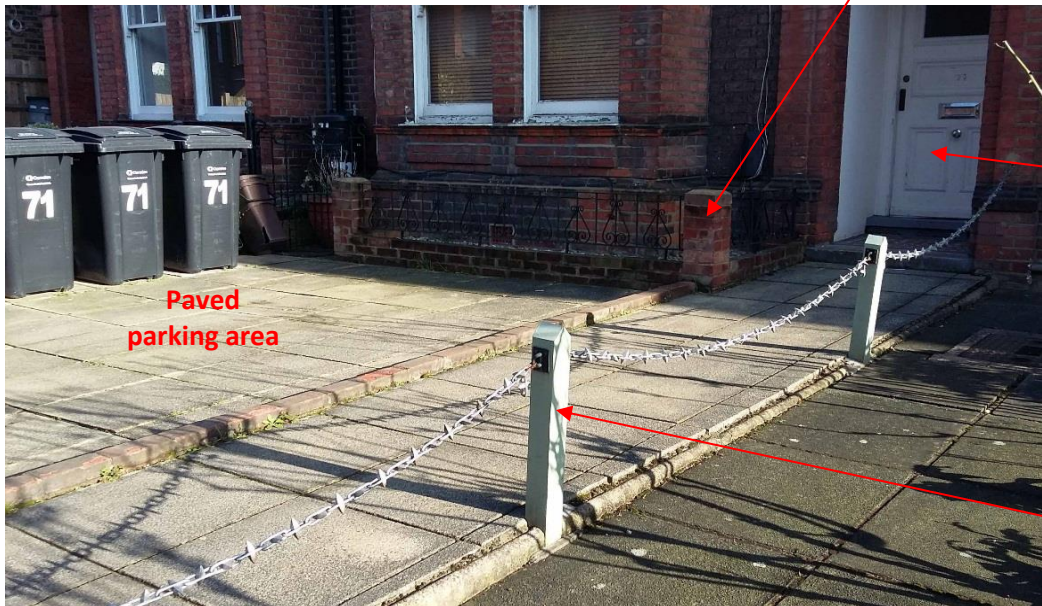
**Photo 2:** The parking area and path leading to the front door of No.71 slope slope towards the Goldhurst Terrace footway.

Path to No.71 entrance stepped up from paved parking area

Goldhurst Terrace footway

Planting area marking boundary between No.69 and No.71

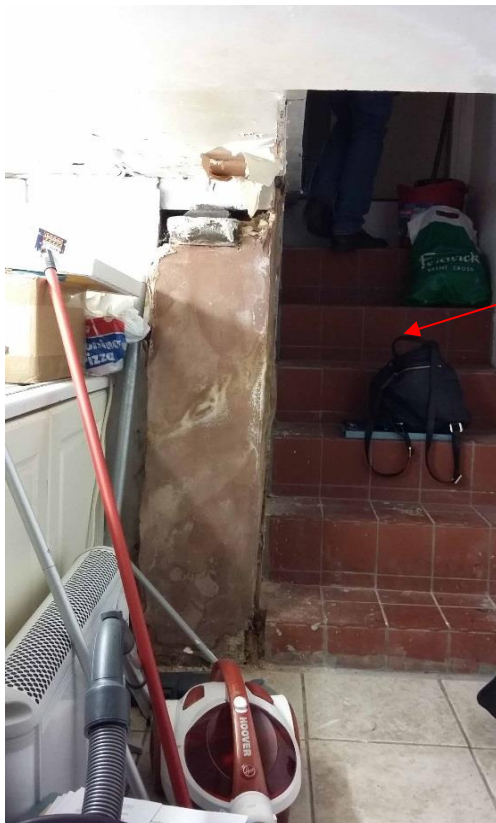
Stairs leading to Ground Floor level

Cellar headroom:  
1.25 - 1.27m

**Photo 4:** The existing cellar of No.71, looking north-east. The height of the existing cellar varies from 1.27m by the access stairs to 1.25m at the front wall, and was found to be very moist during the site inspection.

- The walls of the cellar were found to be moist to very moist. The origin of this moisture was probably a combination of normal moisture in and perched above these high plasticity clays, together with water leaking from the defective soil/vent pipe at the rear of the house.

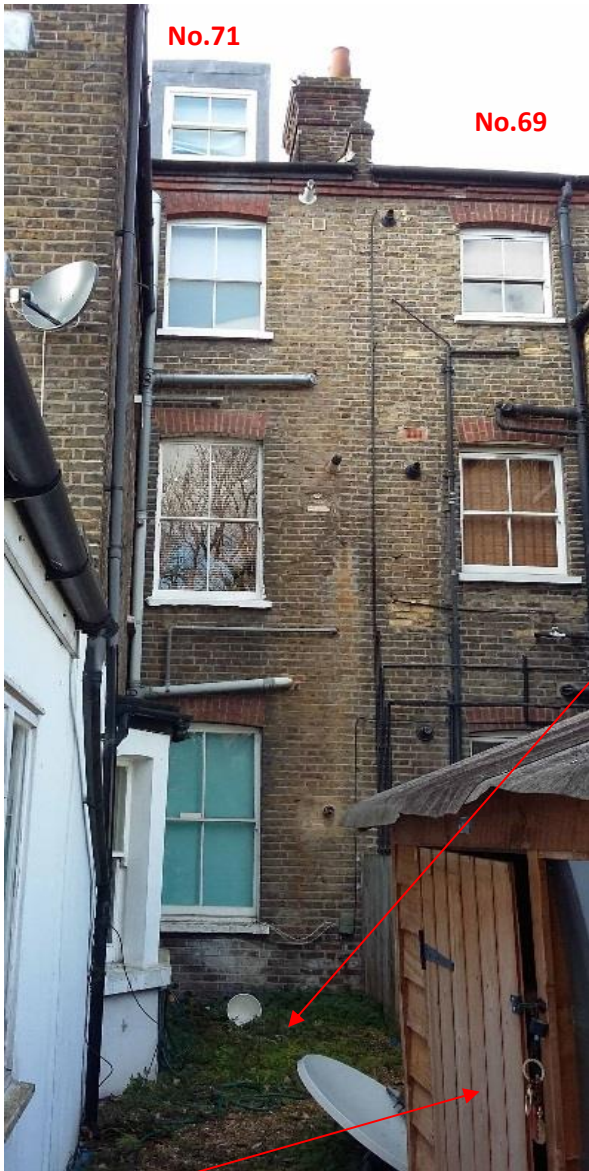
**Photo 5:** Rear elevation of No.71, looking north-west, showing the 'courtyard' between the rear wall and rear projection.

Rear gravel covered 'courtyard' with irregular vegetation (weeds)

Single-storey rear extension
