71, Goldhurst Terrace

Camden, London, NW6 3HA

Flood Risk Assessment Report (FRA)

Rev 00 - 24/05/2018

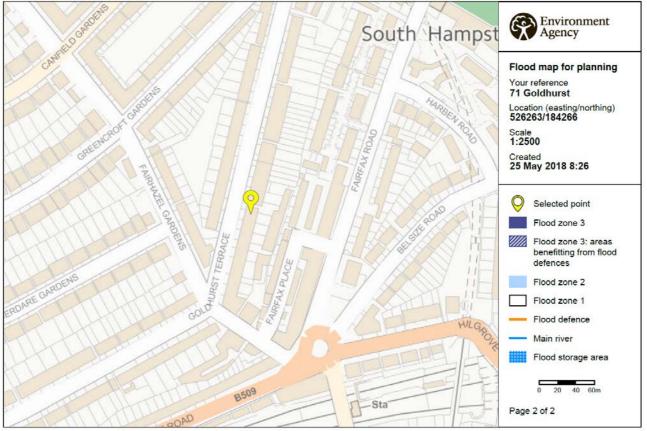
FIGURE 2

The current published EA flood zone map indicates that the site lies in the flood zone 1 (figure 2), with less than a 0.1 per cent (1 in 1000) chance of such flooding occurring each year.

Reference to Figure 2 demonstrates that the EA's modelling shows a 'Very Low' risk of surface water flooding for the entire site of No.71 Goldhurst Terrace, the neighbouring properties and along the Goldhurst Terrace carriageway outside the site. The Risk of tidal or fluvial flooding affecting the site is assessed as **very low** (Figure 3).

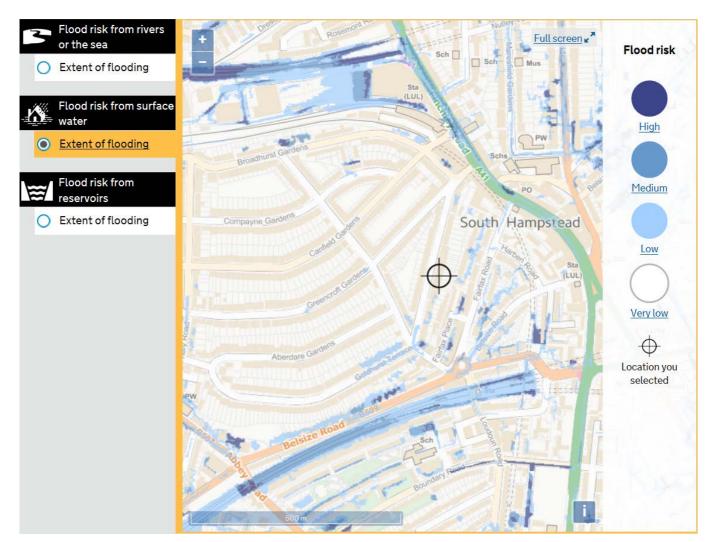
FIGURE 4

The EA's online map 'Risk of Flooding from Surface Water' reproduced below as Figure 4, indicates that the site is at a 'low' risk from this source of flooding. The risk of pluvial (surface water) flooding affecting the site is assessed as **Very low**.

The latest flood models by both the Environment Agency, and by URS for the Camden SFRA, gave a '**Very Low'** risk of surface water flooding, the lowest category which represents the national 'background' level of risk, for No.71's site, and for all other properties in the vicinity on Goldhurst Terrace. The run-off route from the 'Low' risk of flooding on the upslope side of No's 39/41/43 Fairfax Close, which adjoin No.71's rear garden, is expected to be down Fairfax Close so will not require any additional precautions for the proposed basement.

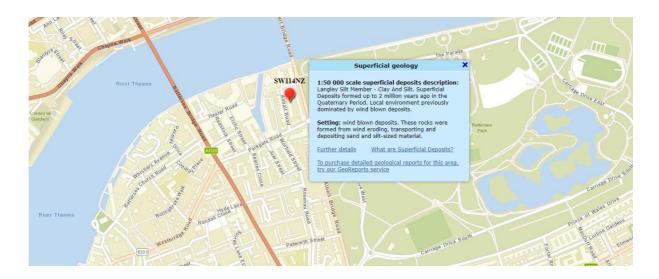
FIGURE 5

The British Geological Survey website indicates the underlying ground condition to be London Clay. This has been confirmed by the site investigation carried out which has confirmed the ground conditions to comprise of firm to stiff brown clay immediately below the disturbed material found at the surface.

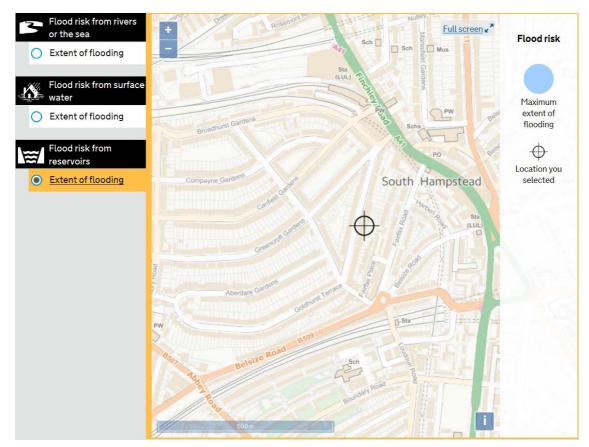
FIGURE 6

The EA's internet reservoir flooding map as reproduced in Figure 8, indicates that the site lies inside an area at no risk of flooding from reservoirs.

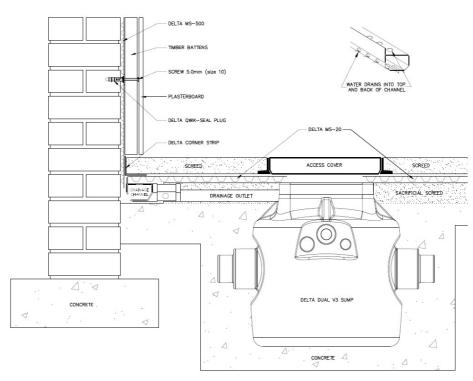
FIGURE 7 - TYPICAL WATERPROOFING DETAIL

The new basement will be protected from flooding thanks to the integration of a Delta membrane waterproofing system. This system provides two pumps, one for the water coming from outside the membrane, from the soil, and one for the foul water drainage.

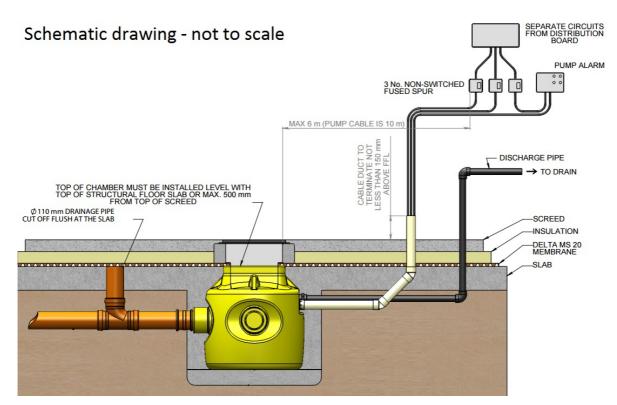
FIGURE 8 - TYPICAL PUMPING SCHEME
