## ARBORICULTURAL ASSESSMENT REPORT

<b>For:</b>	<b>Client:</b>	Richard F Gill & Associates
	<b>Insurer:</b>	Richard F Gill & Associates
<b>Site:</b>	<b>Policyholder:</b>	[REDACTED]
	<b>Risk Address:</b>	12 Akenside Road, London, NW3 5BT
<b>Refs:</b>	<b>OCA Ref:</b>	70365
	<b>Client Ref:</b>	16108
	<b>Insurer Ref:</b>

<b>Arborist Name:</b>	Tom Peppiatt	<b>Date:</b>	06/11/2017
-----------------------	--------------	--------------	------------

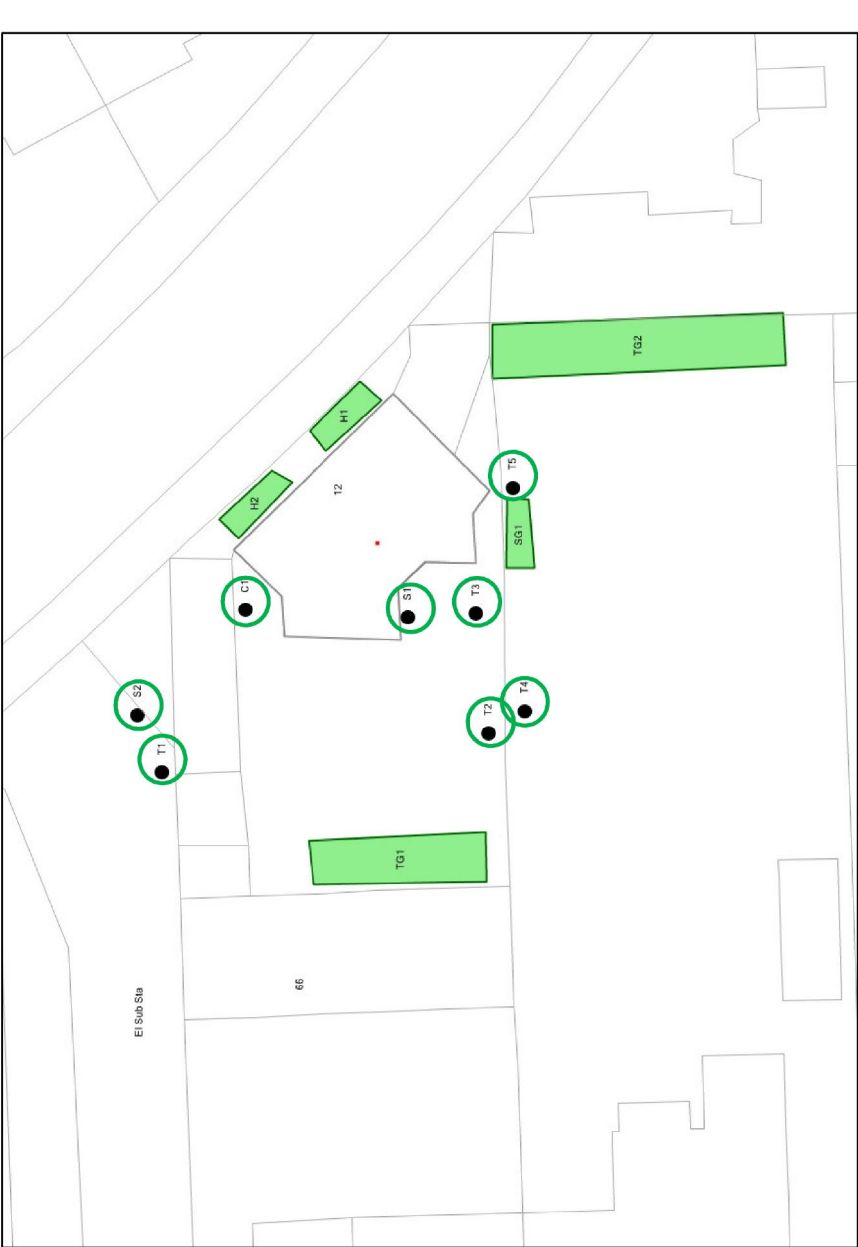
## 8.0 APPENDIX 2: SITE PLAN

Location:	12 Akenside Road, London, NW3 5BT
Job Ref:	70365
Survey Date:	6 <sup>th</sup> of November - NTS
By OCA Insurance Limited	
Crown copyright 2016. License number 100043594
