## **ADDENDUM TECHNICAL REPORT**

**Crawford Reference: SU1604808**

**Gilling Court (Hampstead) Ltd  
Gilling Court  
Belsize Grove  
Hampstead  
London  
NW3 4UY**

**SUBSIDENCE CLAIM**

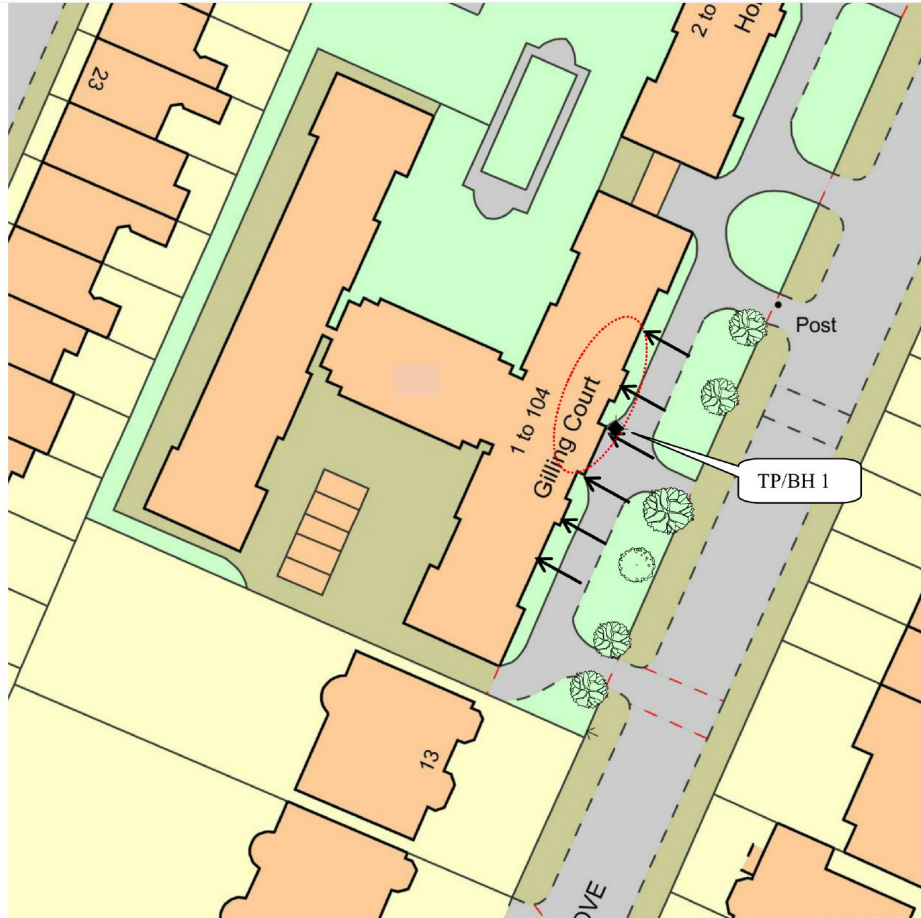
**Site Plan**
**This plan is Not to Scale**

This plan is diagrammatic only and has been prepared to illustrate the general position of the property and its relationship to nearby trees etc. The boundaries are not accurate, and do not infer or confer any rights of ownership or right of way. Position of utilities is only indicative and contractors must satisfy themselves regarding actual location before commencing works.

A trial hole was excavated to the right hand corner of the main entrance projection to expose the foundations - see site plan for location and the diagram below for details.
