Mulroy

29 Inkerman Road, Kentish Town, London NW5 3BT Design, Access & Heritage Statement

17187-A30-001C

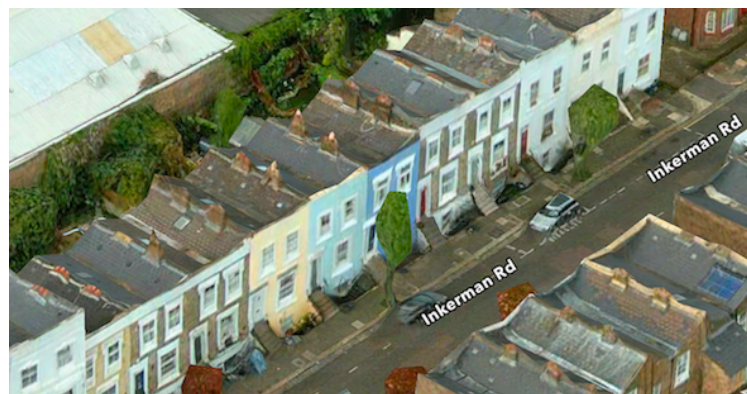
2.02

No. 29 Inkerman Road has a purple rendered front elevation in the centre of the picture above. The factory on the rear boundary is visible, top left.

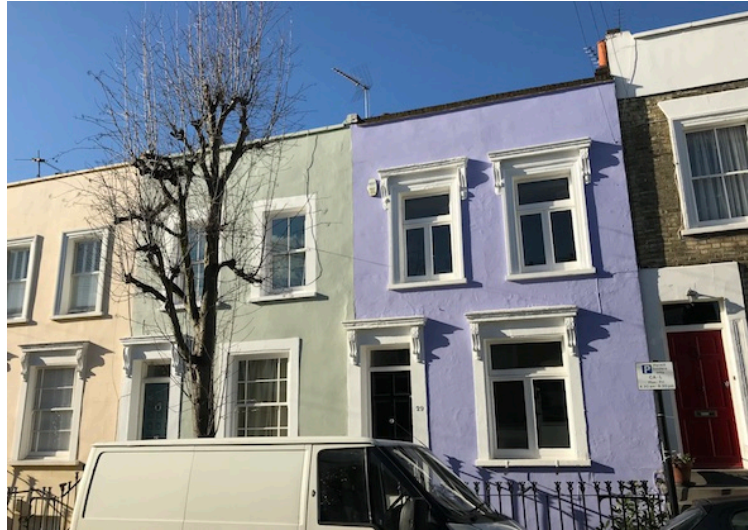
2.03

29 Inkerman Road is one of three rendered properties within a terrace that has the original London stock brick and white frieze facades. The properties to the north are at a higher level. Most properties, apart from No.29, have steps within the front area down to the basement.

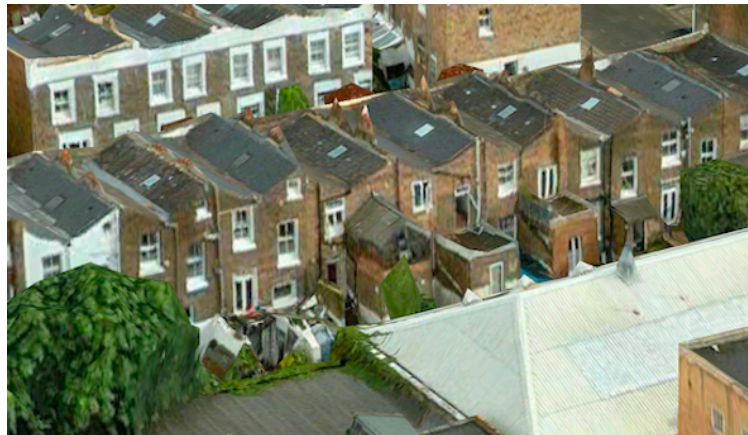
2.04

To the rear, No. 29 is notable in that there is a fully glazed first floor extension to the top of the rear projection rather than flat roofs and terraces.

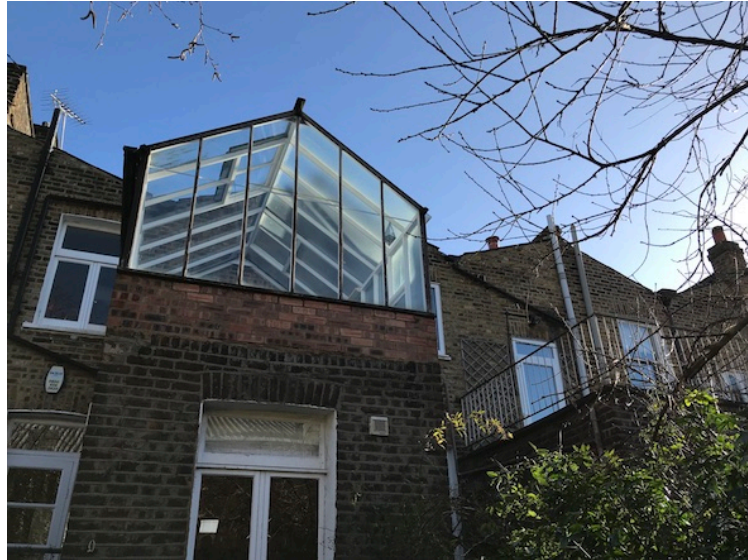
2.05

The rear projection has been extended up to a parapet and a conservatory added. This is fully glazed, including the wall to the adjacent property. Note section of poorly matching masonry below conservatory.

1. We propose to remove the rear projection and conservatory with its variety of non-original materials. This will address the condition issues noted above.

4. The replacement projection will have the same plan form as the existing.
5. As part of the replacement projection, the conservatory will be rebuilt in more durable and permanent masonry in order to address the light pollution, rainwater discharge and fire spread issues present on the boundary with No.30.

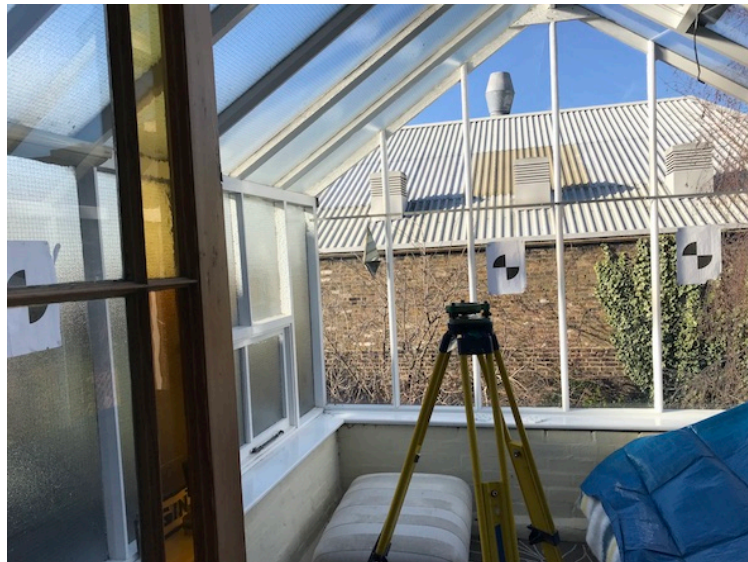
2.06

Internally, the conservatory is unheated and single glazed. There is a window opening over the boundary to No. 30 to the south (left) in the picture above. The factory is visible to the rear.

- 6.12 Ink23 – Conservatories – the plan is to replace the conservatory – an old and incongruous structure with a higher quality piece of architecture.
