28 Fitzroy Square –

Further listed building feedback following 2nd site visit (17.05.18)

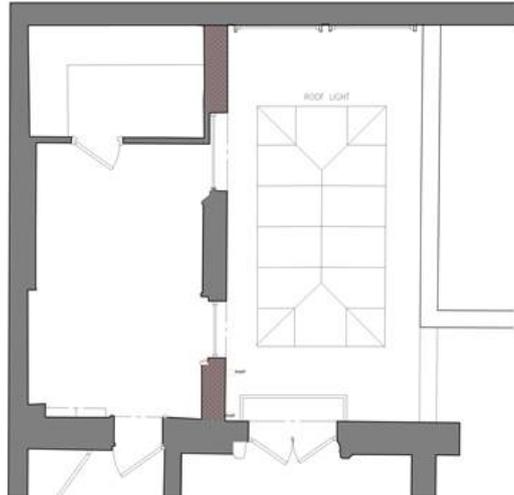
The ground floor rear extension appears to be historic and whilst we are prepared to take a view on demolition of the wall facing the courtyard as part of the overall scheme there would be some harm caused through its removal. It would therefore seem beneficial to retain as much of the wall, and understanding of the development of the building, as possible. In this respect the section of wall which attached to the rear façade should be retained and a larger nib retained at its far end

Commented [AF15]: Understood, we will revise the GA to show the nib by new door as existing and extend the opposite end further
