ADDENDUM

HERITAGE SCHEDULE OF PROPOSED INTERNAL WORKS

18 WELL ROAD, HAMPSTEAD

This report describes the areas affected by the internal alterations, and also those areas where the works to the existing building are both internal and external. The descriptions are accompanied by photographs and other relevant illustrations of the areas affected by the proposal.

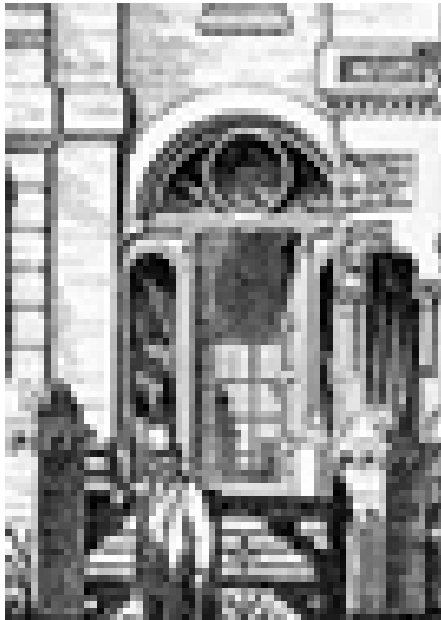
1.1. Extract from original etching

The screen is shown on the original architect's etching (see 1.1). During the 1952 conversion it was removed (see 1.3) and later reinstated with modern square section details (see 1.4).

The subframe is to follow the profile of the opening as the original did (see 1.1).

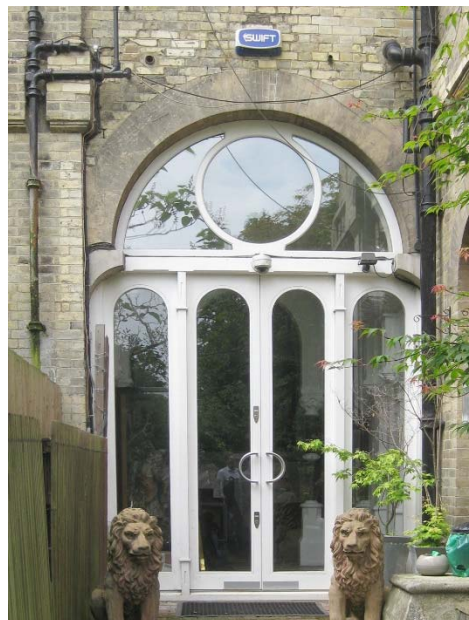
1.2. Front door now

- 1 Renew modern main entrance doors and screen to historic design.

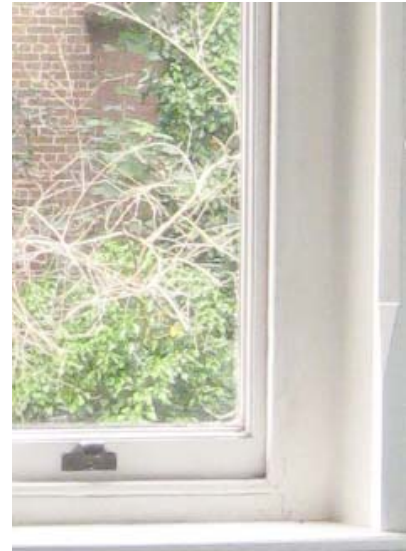
1.5 Typical ovolo and bead mouldings

The joinery is to match the existing historic details elsewhere in the house as follows:

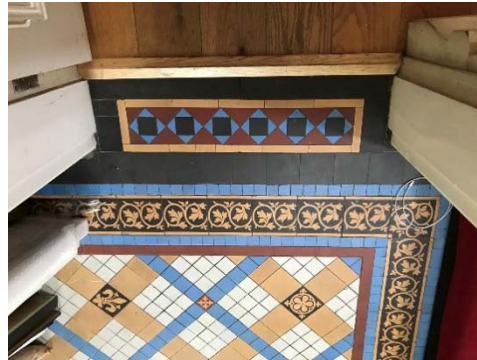
3.4 Typical door opening within Stair Hall to be matched

This was blocked up after 1968, losing the symmetry of openings in the Stair Hall. The door will be reinstated as a timber panelled door and architraves to match the existing historic doors in the Hall. The Minton tile threshold is to be repaired to match.

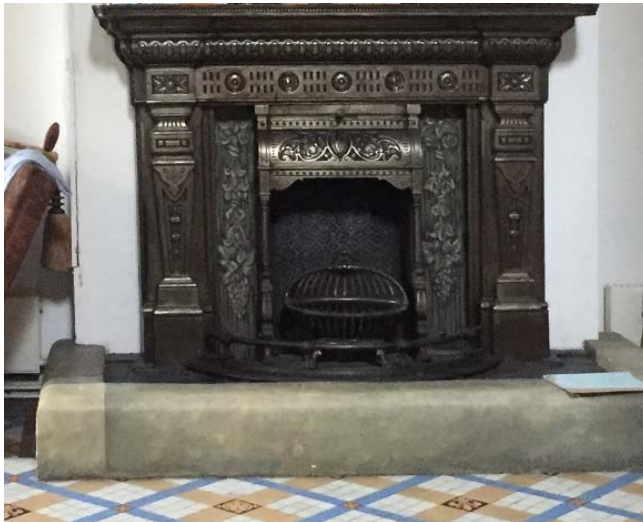
4.1 Modern fireplace

- 4 Reinstating fireplace to the original width as shown by hearth tiles (circled blue on the plan sequence and photograph 4.2). Open up to determine the extent of the previous fire surround. Allow to provide a mid C19 Gothic hearth and fireplace to detail, or an alternative design agreed with the Conservation Officer.

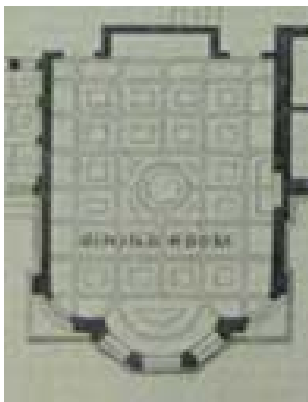
7.1. 1868 showing the decorative ceiling. 7.2 1952 subdivision. 7.3 1968 subdivision.

Since the 1952 conversion, and at the time of listing, the space has been subdivided. When the building was divided into individual flats, this included Bedroom and Kitchen spaces. It has also had a number of different floor levels.

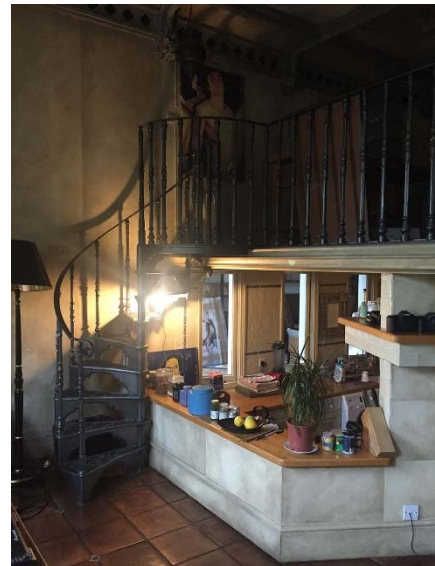
7.4. Lowest floor level below modern mezzanine

The modern structures shown in this photograph are to be removed as part of the proposals.

- Remove spiral staircase projecting into main volume. This spiral staircase and mezzanine are modern, after this 1968 plan (see 7.4).

The balustrade is to be replaced with a wall, maintained clear of the ceiling to allow natural light to be maintained in the mezzanine volume. This simple form will avoid competition with the intricacy of the original decorative ceiling.

14. Relocate modern spiral staircase (see 7.4) into existing bathroom to provide a mezzanine. Since the 1952 conversion, the space has been opened up below a glazed roof structure.

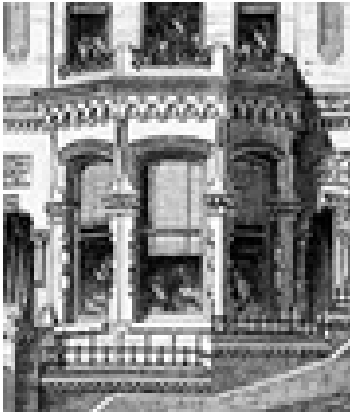
9.1 Original 1868 etching 9.2 Showing partial balustrade and deformation of stonework.

Carry out conservation like-for-like stone, iron and timber repairs to improve the longevity of the structure and replace missing elements like-for-like to reinstate it to its original recorded appearance (see 9.1).

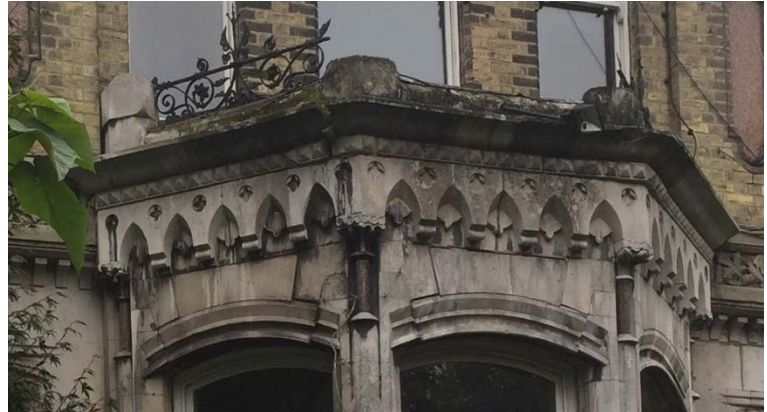
As the stone structure has deformed above window arch level, it is likely that the structural metal cramps have rusted (see 9.2). Investigate and (unless agreed otherwise with the Conservation Officer), assume this will include replacement of the rusted fixings in stainless steel or other similar non-ferrous metal as appropriate, with minimal like-for-like conservation reconstruction where necessary, incorporating the existing historic fabric where sound.

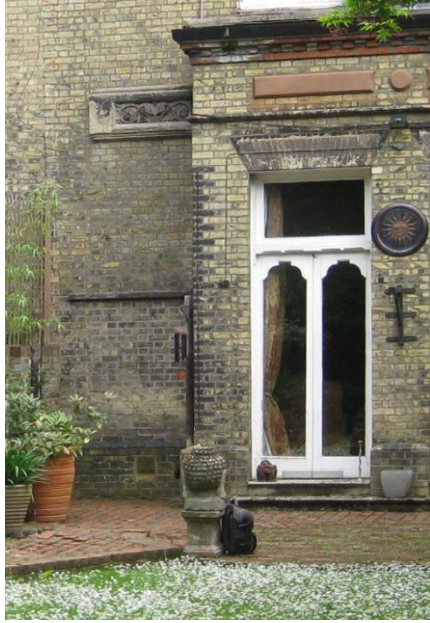
10.4 Bay and LH wall behind

Provide doorway opening on the RH side of bay within a former unsympathetically blocked up opening (see 9.5). The doorway is to match the arch and reveal of bay (see 9.4). Make good brickwork where poorly matched, like-for-like to match the original elevation.

11. Provide new doorway on LH side of bay to improve symmetry to match RH side.

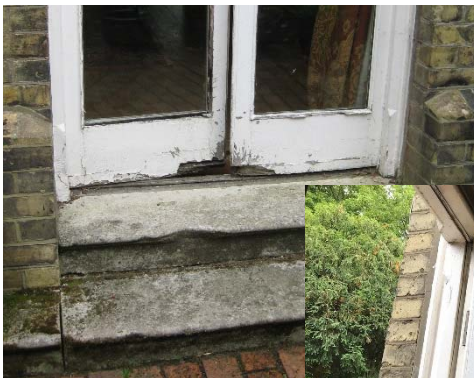
12.1 Typical rot

12. Renew modern rotted doors of bay to match historical profiles.

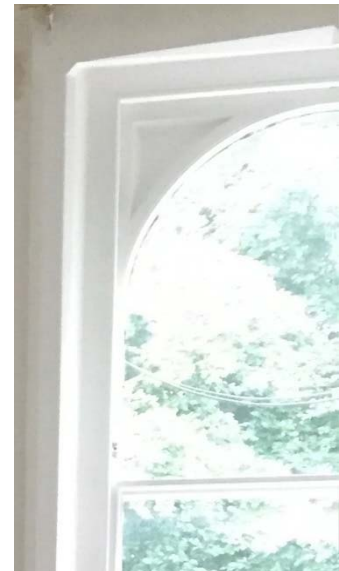
12.3 Historic recessed moulding

Reinstate painted timber doors with integral inset mouldings at the head, matching historic inset head mouldings and ovolos (see 11.3 to match mouldings of the existing Bedroom window above).

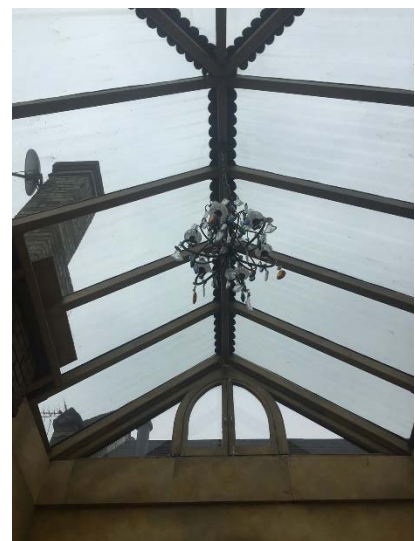
14.3 Modern glazed roof behind existing chimney

15. Existing roof lantern to be replaced with minimal frame glazing appropriate to the existing house; introducing open-able panels.

The elevation will match the existing, omitting the fussy detailing of the existing glazing.

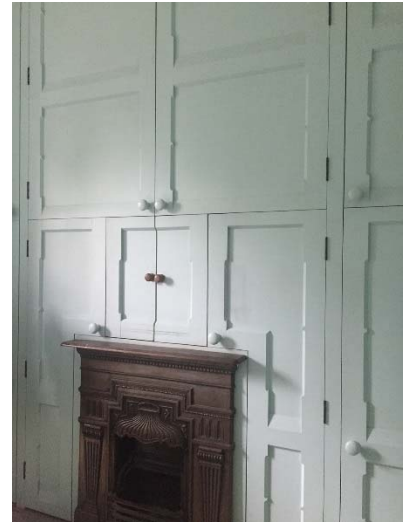
16.3. Typical fitted cupboards

Fire surround applied to the face

Remove modern fitted cupboards and investigate to locate the exact position of the doorway marked on the historic plans pre 1952. Install a panelled timber doorway to match the existing door and surround to Bed 3.

Remove modern fitted cupboards and investigate to determine the extent of survival of the fireplace marked on the historic plans pre 1952. Repair and/or reinstate as appropriate to the agreement of the Conservation Officer.
