GROUND MOVEMENT ANALYSIS REPORT

38 GLENLOCH ROAD, CAMDEN LONDON NW3 4DN

NW3 PROPERTIES

Report Reference: GWPR2718/GIR/August 2018		Status: FINAL
Issue:	Prepared By:	Verified By:
V1.00 August 2018

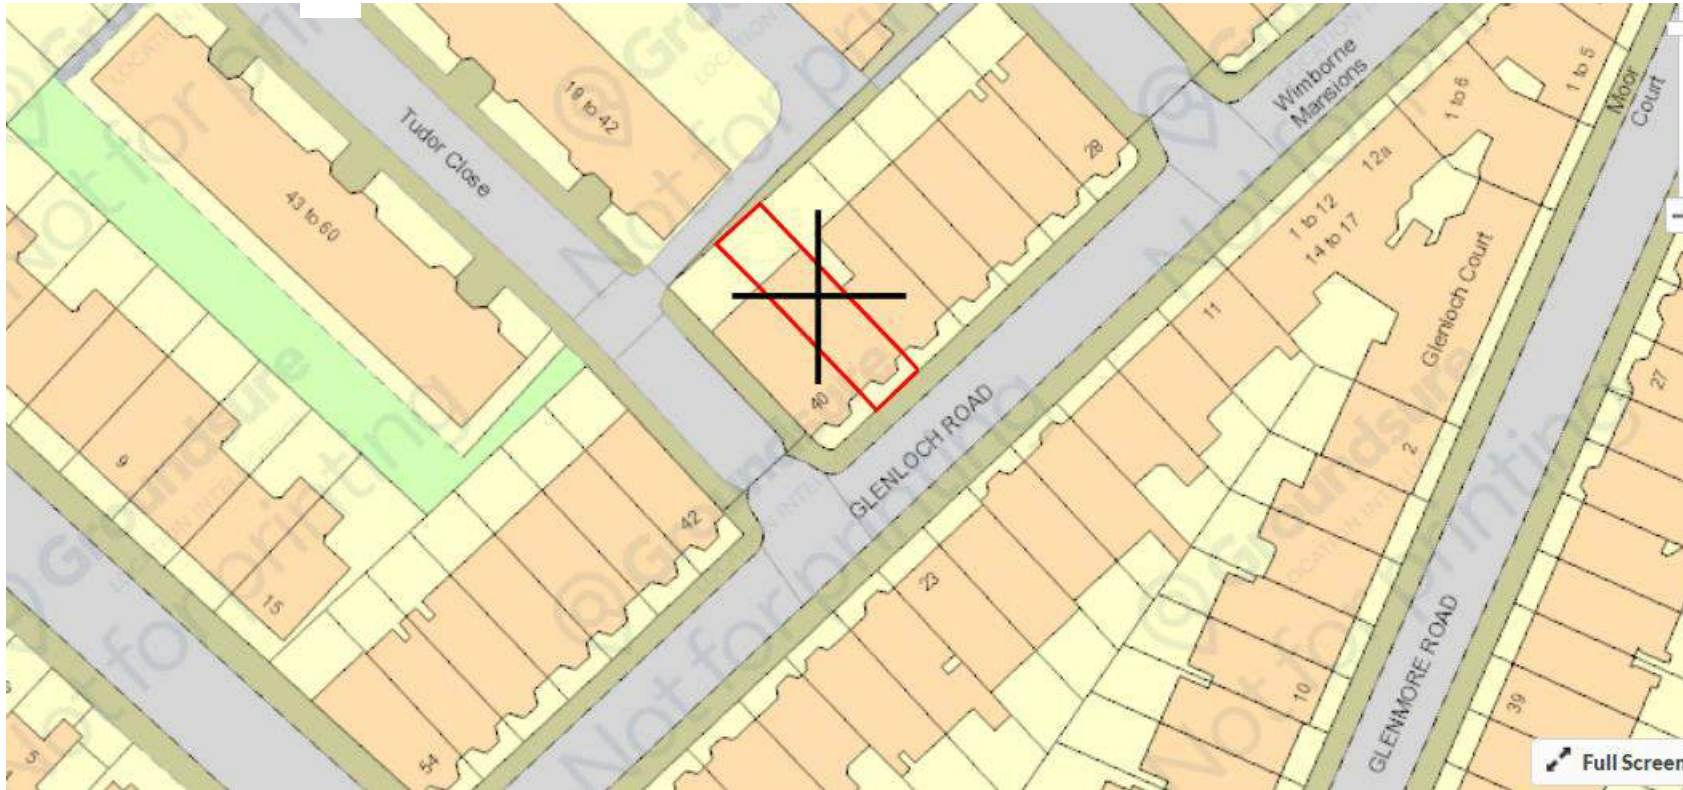
Figure 2

APPROXIMATE SITE BOUNDARY

The approximate National Grid Reference for the site was TQ 27173 84967. A site location plan is provided within Figure 1. A plan showing the site development area is given within Figure 2.

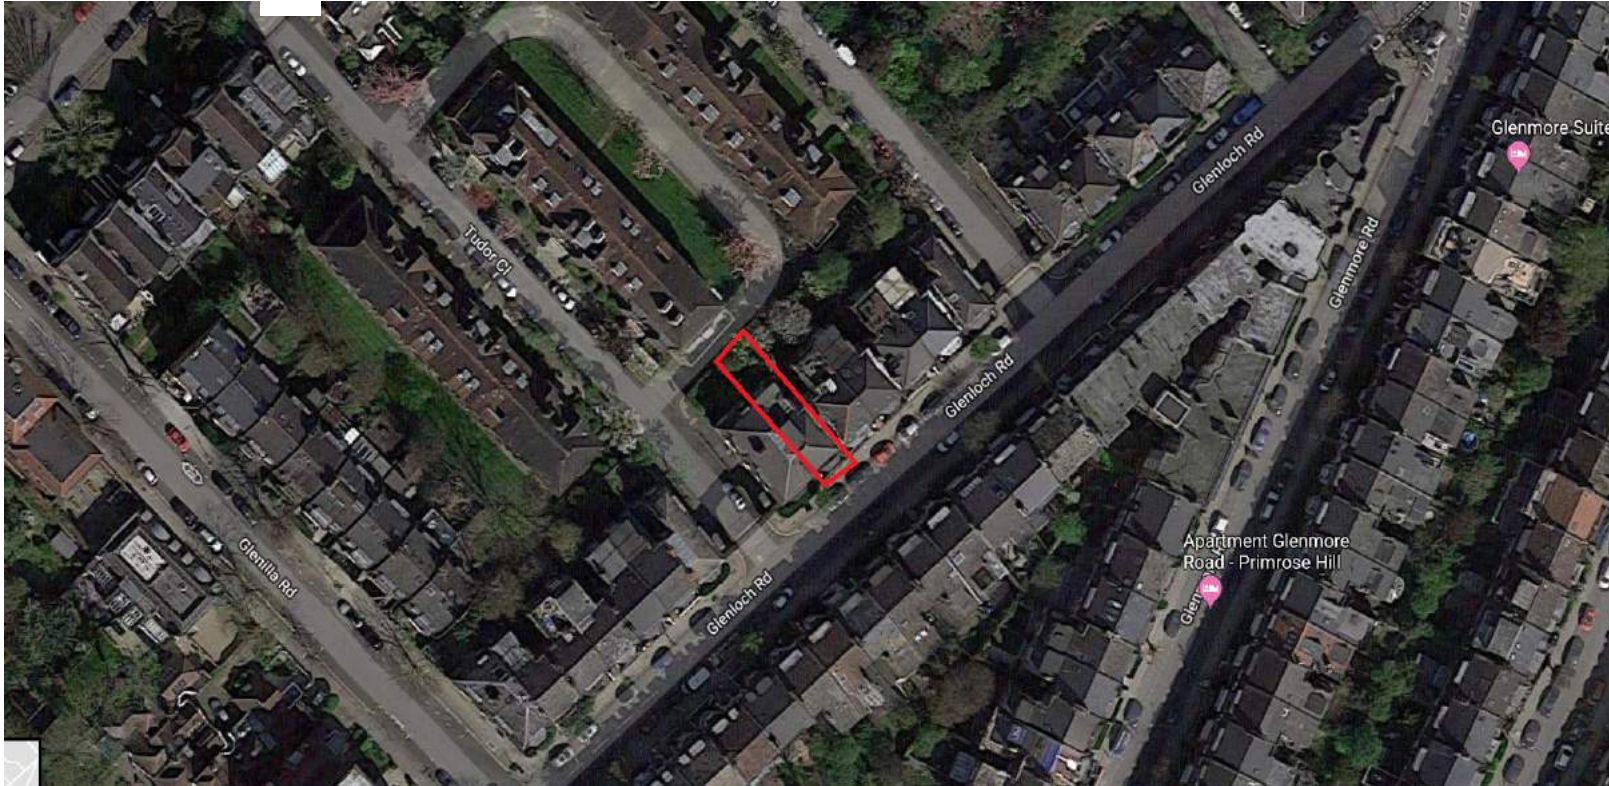
Figure 3

APPROXIMATE SITE BOUNDARY

An aerial view of the site showing an approximate site boundary is given in Figure 3. An existing plan and section view of the site can be seen in Figures 4 and 5.

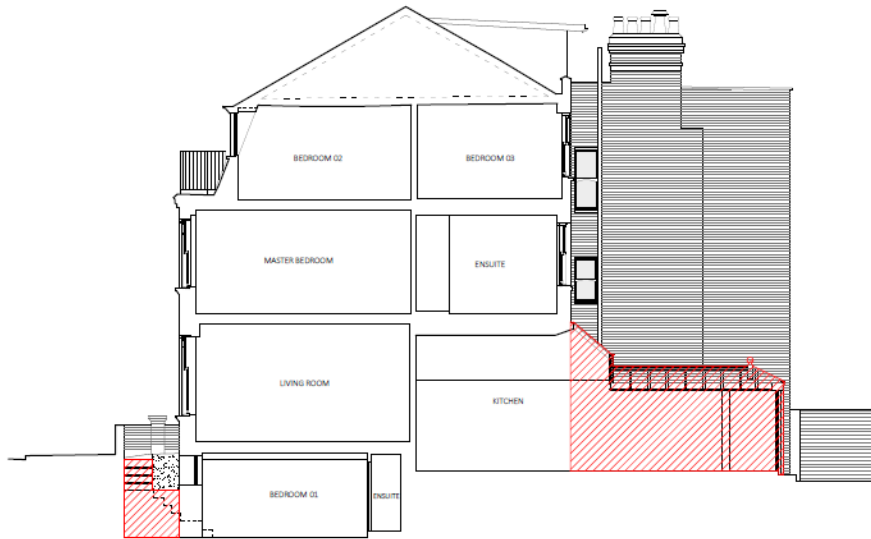
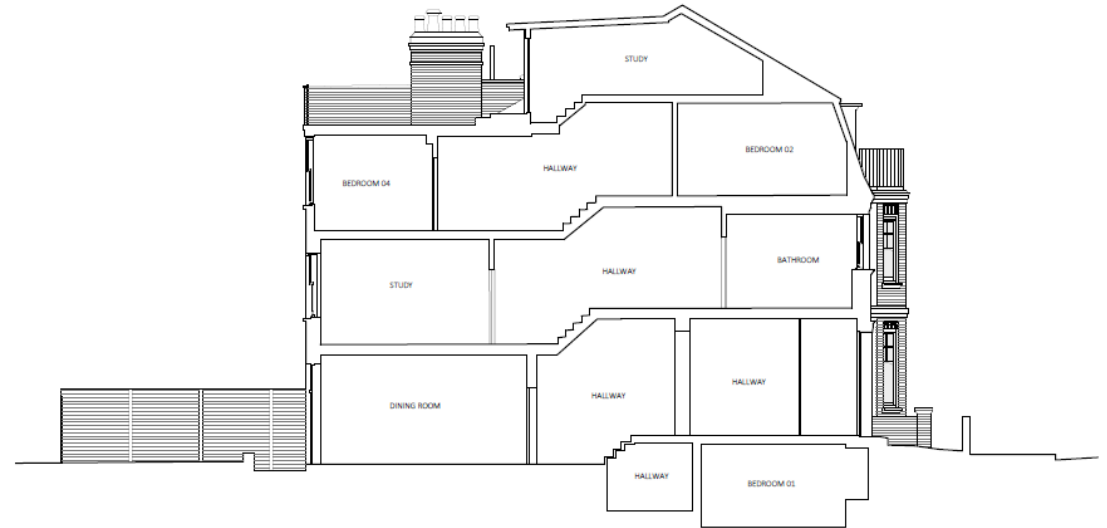
Figure 5

SECTION B-B

SECTION A-A

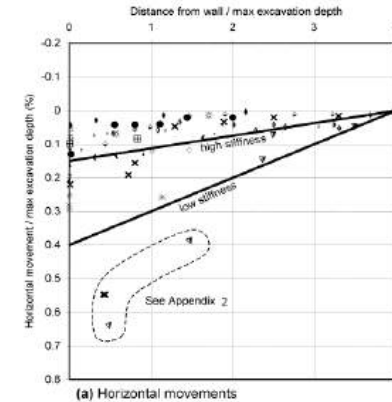
(a) Horizontal movements
CIRIA C760 does not cover Horizontal Movements for soft - firm clays. Therefore, these were derived from stiff clay results.

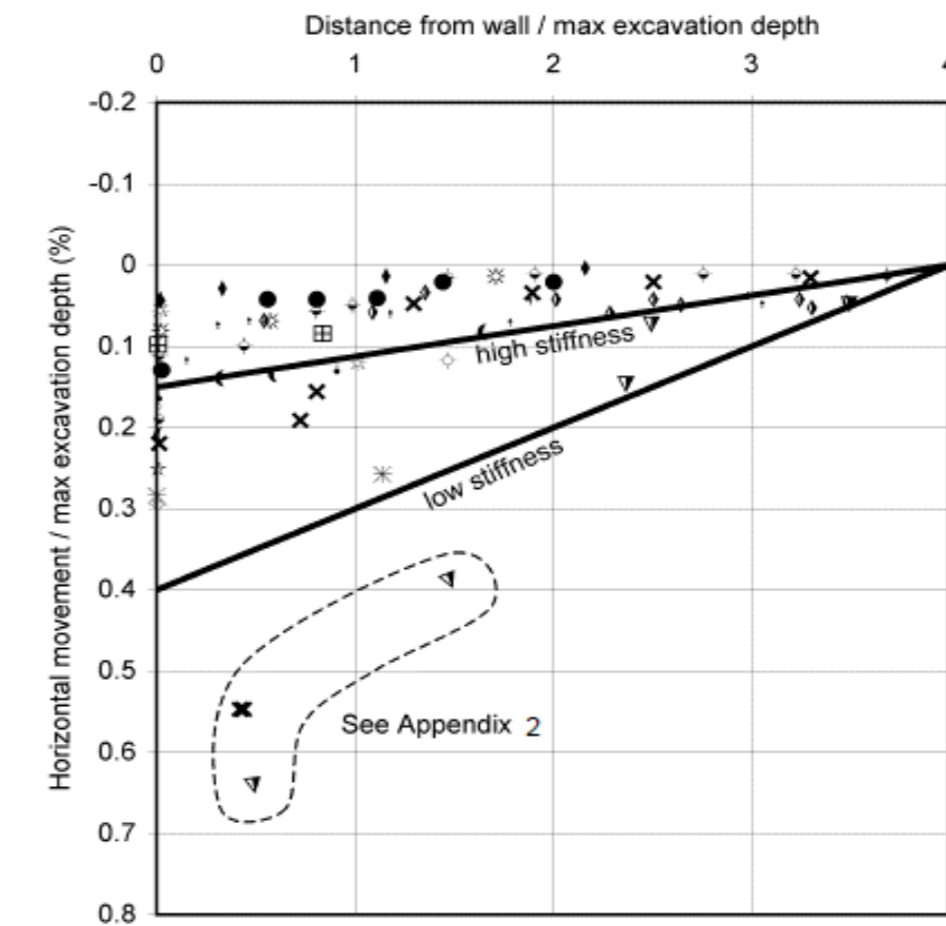
(a) Horizontal movements

CIRIA C760 does not cover Horizontal Movements for soft - firm clays. Therefore, these were derived from stiff clay results.

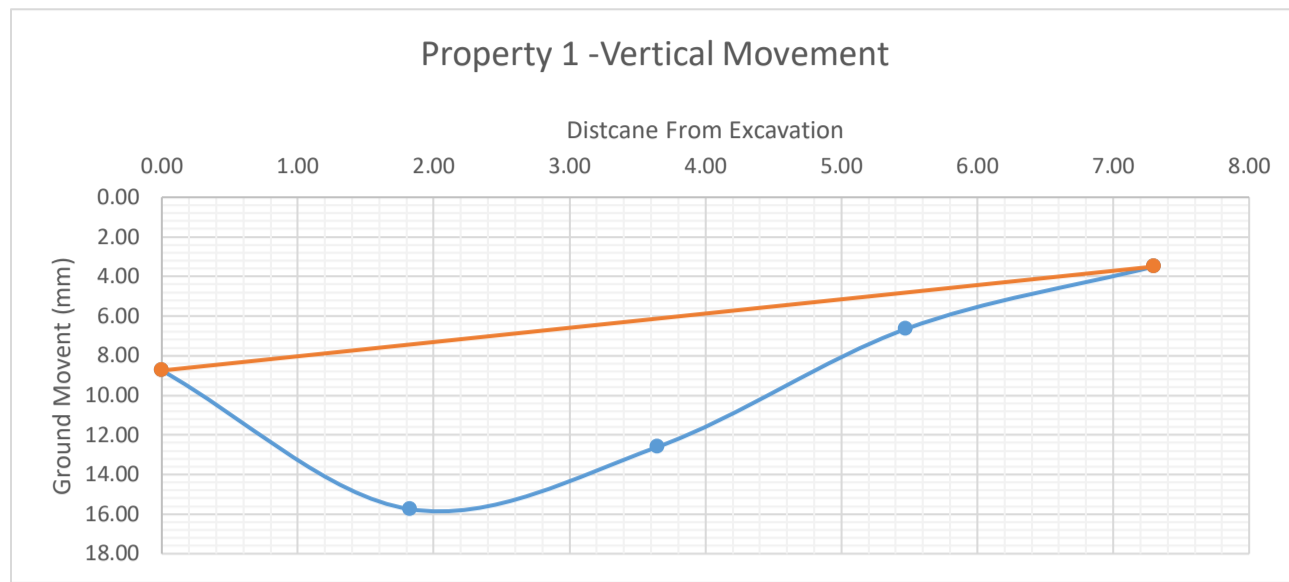
Potential Damage to Building

Soft to firm clays - Conservative

Neighbouring Property 1

No. 40

L/H	0.61	
Negligible damage limit (ϵ_{lim})	0.05	
(Δ/L)/(ϵ_{lim})	2.191780822	Plot this point on fig2.18 (b) if the plotted point is below the appropriate L/H line then damage falls into 'negligible' category - no need to plot points
(ϵ_h)/(ϵ_{lim})	0.75	
Very Slight damage limit (ϵ_{lim})	0.075	
(Δ/L)/(ϵ_{lim})	1.461187215	Plot this point on fig2.18 (b) if the plotted point is below the appropriate L/H line then damage falls into 'very slight' category - no need to plot points
(ϵ_h)/(ϵ_{lim})	0.5	
Slight damage limit (ϵ_{lim})	0.15	
(Δ/L)/(ϵ_{lim})	0.730593607	Plot this point on fig2.18 (b) if the plotted point is below the appropriate L/H line then damage falls into 'slight' category - no need to plot points below
(ϵ_h)/(ϵ_{lim})	0.25	
Moderate damage limit (ϵ_{lim})	0.3	
(Δ/L)/(ϵ_{lim})	0.365296804	Plot this point on fig2.18 (b) if the plotted point is below the appropriate L/H line then damage falls into 'moderate' category - if the point is not below, damage is 'severe'

Slight

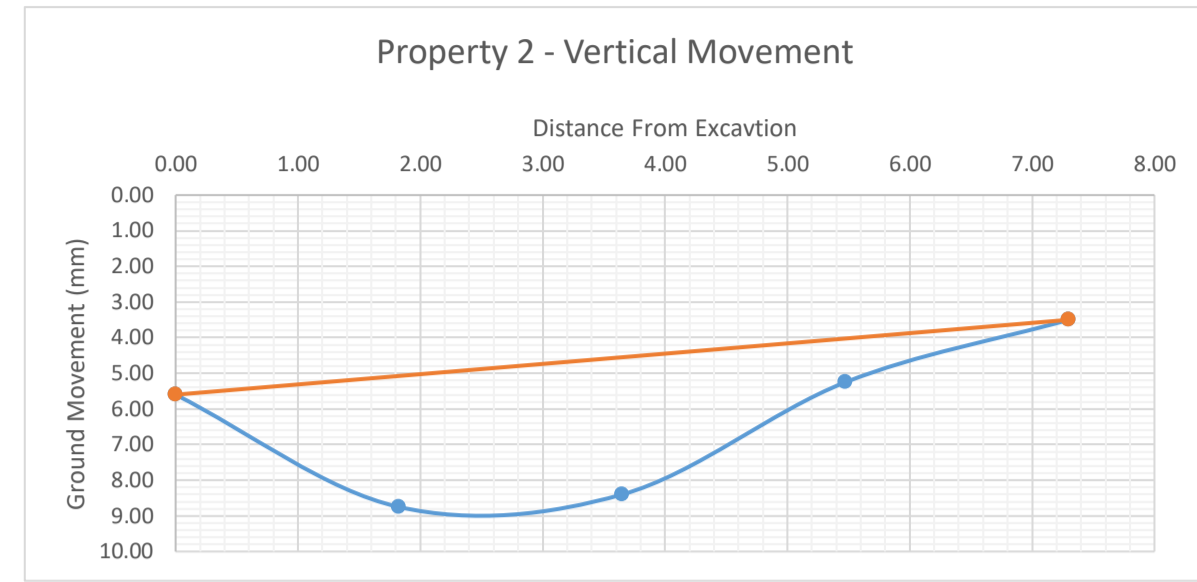
Potential Damage to Building

Soft to firm clays - Moderate

Neighbouring Property 1

No. 40

L/H	0.61
Negligible damage limit (ϵ_{lim})	0.05
(Δ/L)/(ϵ_{lim})	1.095890411
(ϵ_h)/(ϵ_{lim})	0.75
Plot this point on fig2.18 (b) if the plotted point is below the appropriate L/H line then damage falls into 'negligible' category - no need to plot points	
Very Slight damage limit (ϵ_{lim})	0.075
(Δ/L)/(ϵ_{lim})	0.730593607
(ϵ_h)/(ϵ_{lim})	0.5
Plot this point on fig2.18 (b) if the plotted point is below the appropriate L/H line then damage falls into 'very slight' category - no need to plot points	
Slight damage limit (ϵ_{lim})	0.15
(Δ/L)/(ϵ_{lim})	0.365296804
(ϵ_h)/(ϵ_{lim})	0.25
Plot this point on fig2.18 (b) if the plotted point is below the appropriate L/H line then damage falls into 'slight' category - no need to plot points below	
Moderate damage limit (ϵ_{lim})	0.3
(Δ/L)/(ϵ_{lim})	0.182648402
(ϵ_h)/(ϵ_{lim})	0.125
Plot this point on fig2.18 (b) if the plotted point is below the appropriate L/H line then damage falls into 'moderate' category - if the point is not below, damage is 'severe'

Calculated Category of Damage **Very Slight**

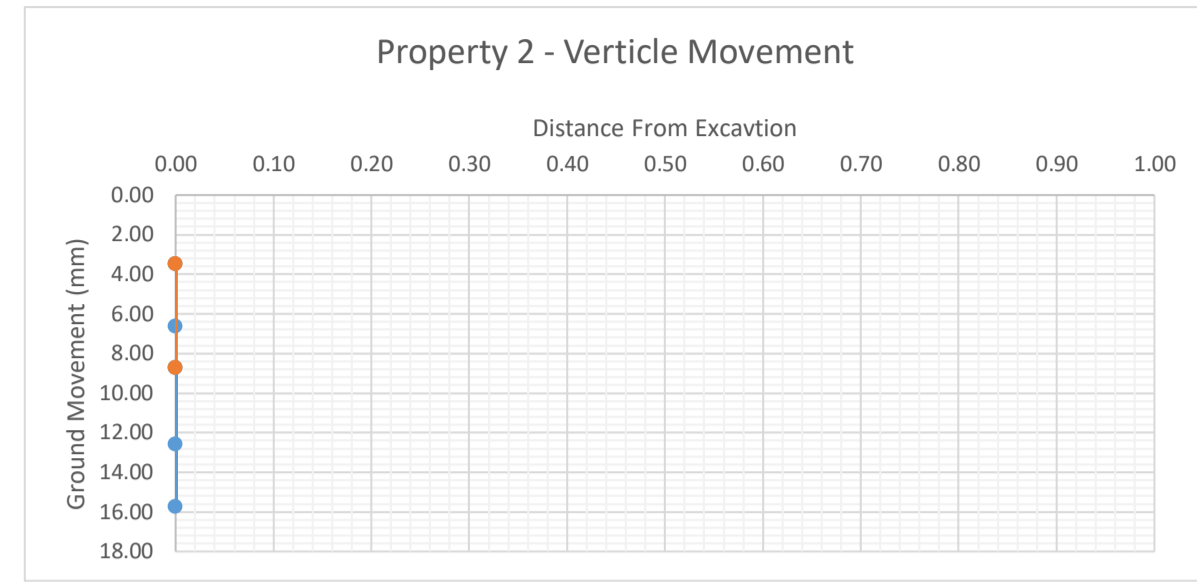
Neighbouring Property 2

No. 0

Calculated Category of Damage **Negligible**
