- All chimneys to be rebuilt from stone banding.
	Existing Rainwater Head Types
+125,910 3 Third Floor	1 Parallel
	1870
	1.
	. <u>All</u>
	Туре-01
	The second second
	I HANNE H
	Y CARL
+120,990	
2 Second Floor	Dimension
	Lucion -
	Type-02
	Concerned and a second second
+117,200 1 First Floor	
	Provide the second seco
	and the second
	Type-03 & Type-03-Corner to be similar in design
	MCSIGII
+112,780 0 Ground Floor	
	PL06 13.06.2018 Planning Issue JD
	Rev Date Descriptor Athr.
+109,250	
-1 Basement	SHHARCHITECTS INTERIOR DESIGNERS
	RIBA
	Chartered Practice
	1 Vencourt Place, Ravenscourt Park Hammersmith, London W6 9NU Phone +44 (0) 20 8600 4171 Email info@shh.co.uk shh.co.uk
	Project:
	Athlone House Hampstead Lane
	Client:
	Private Client

Drawing Title: 200 Elevations
	West Elevation - Proposed
	(Project number)DWG number_Revision: Checked:
	(817)AH-212_PL06

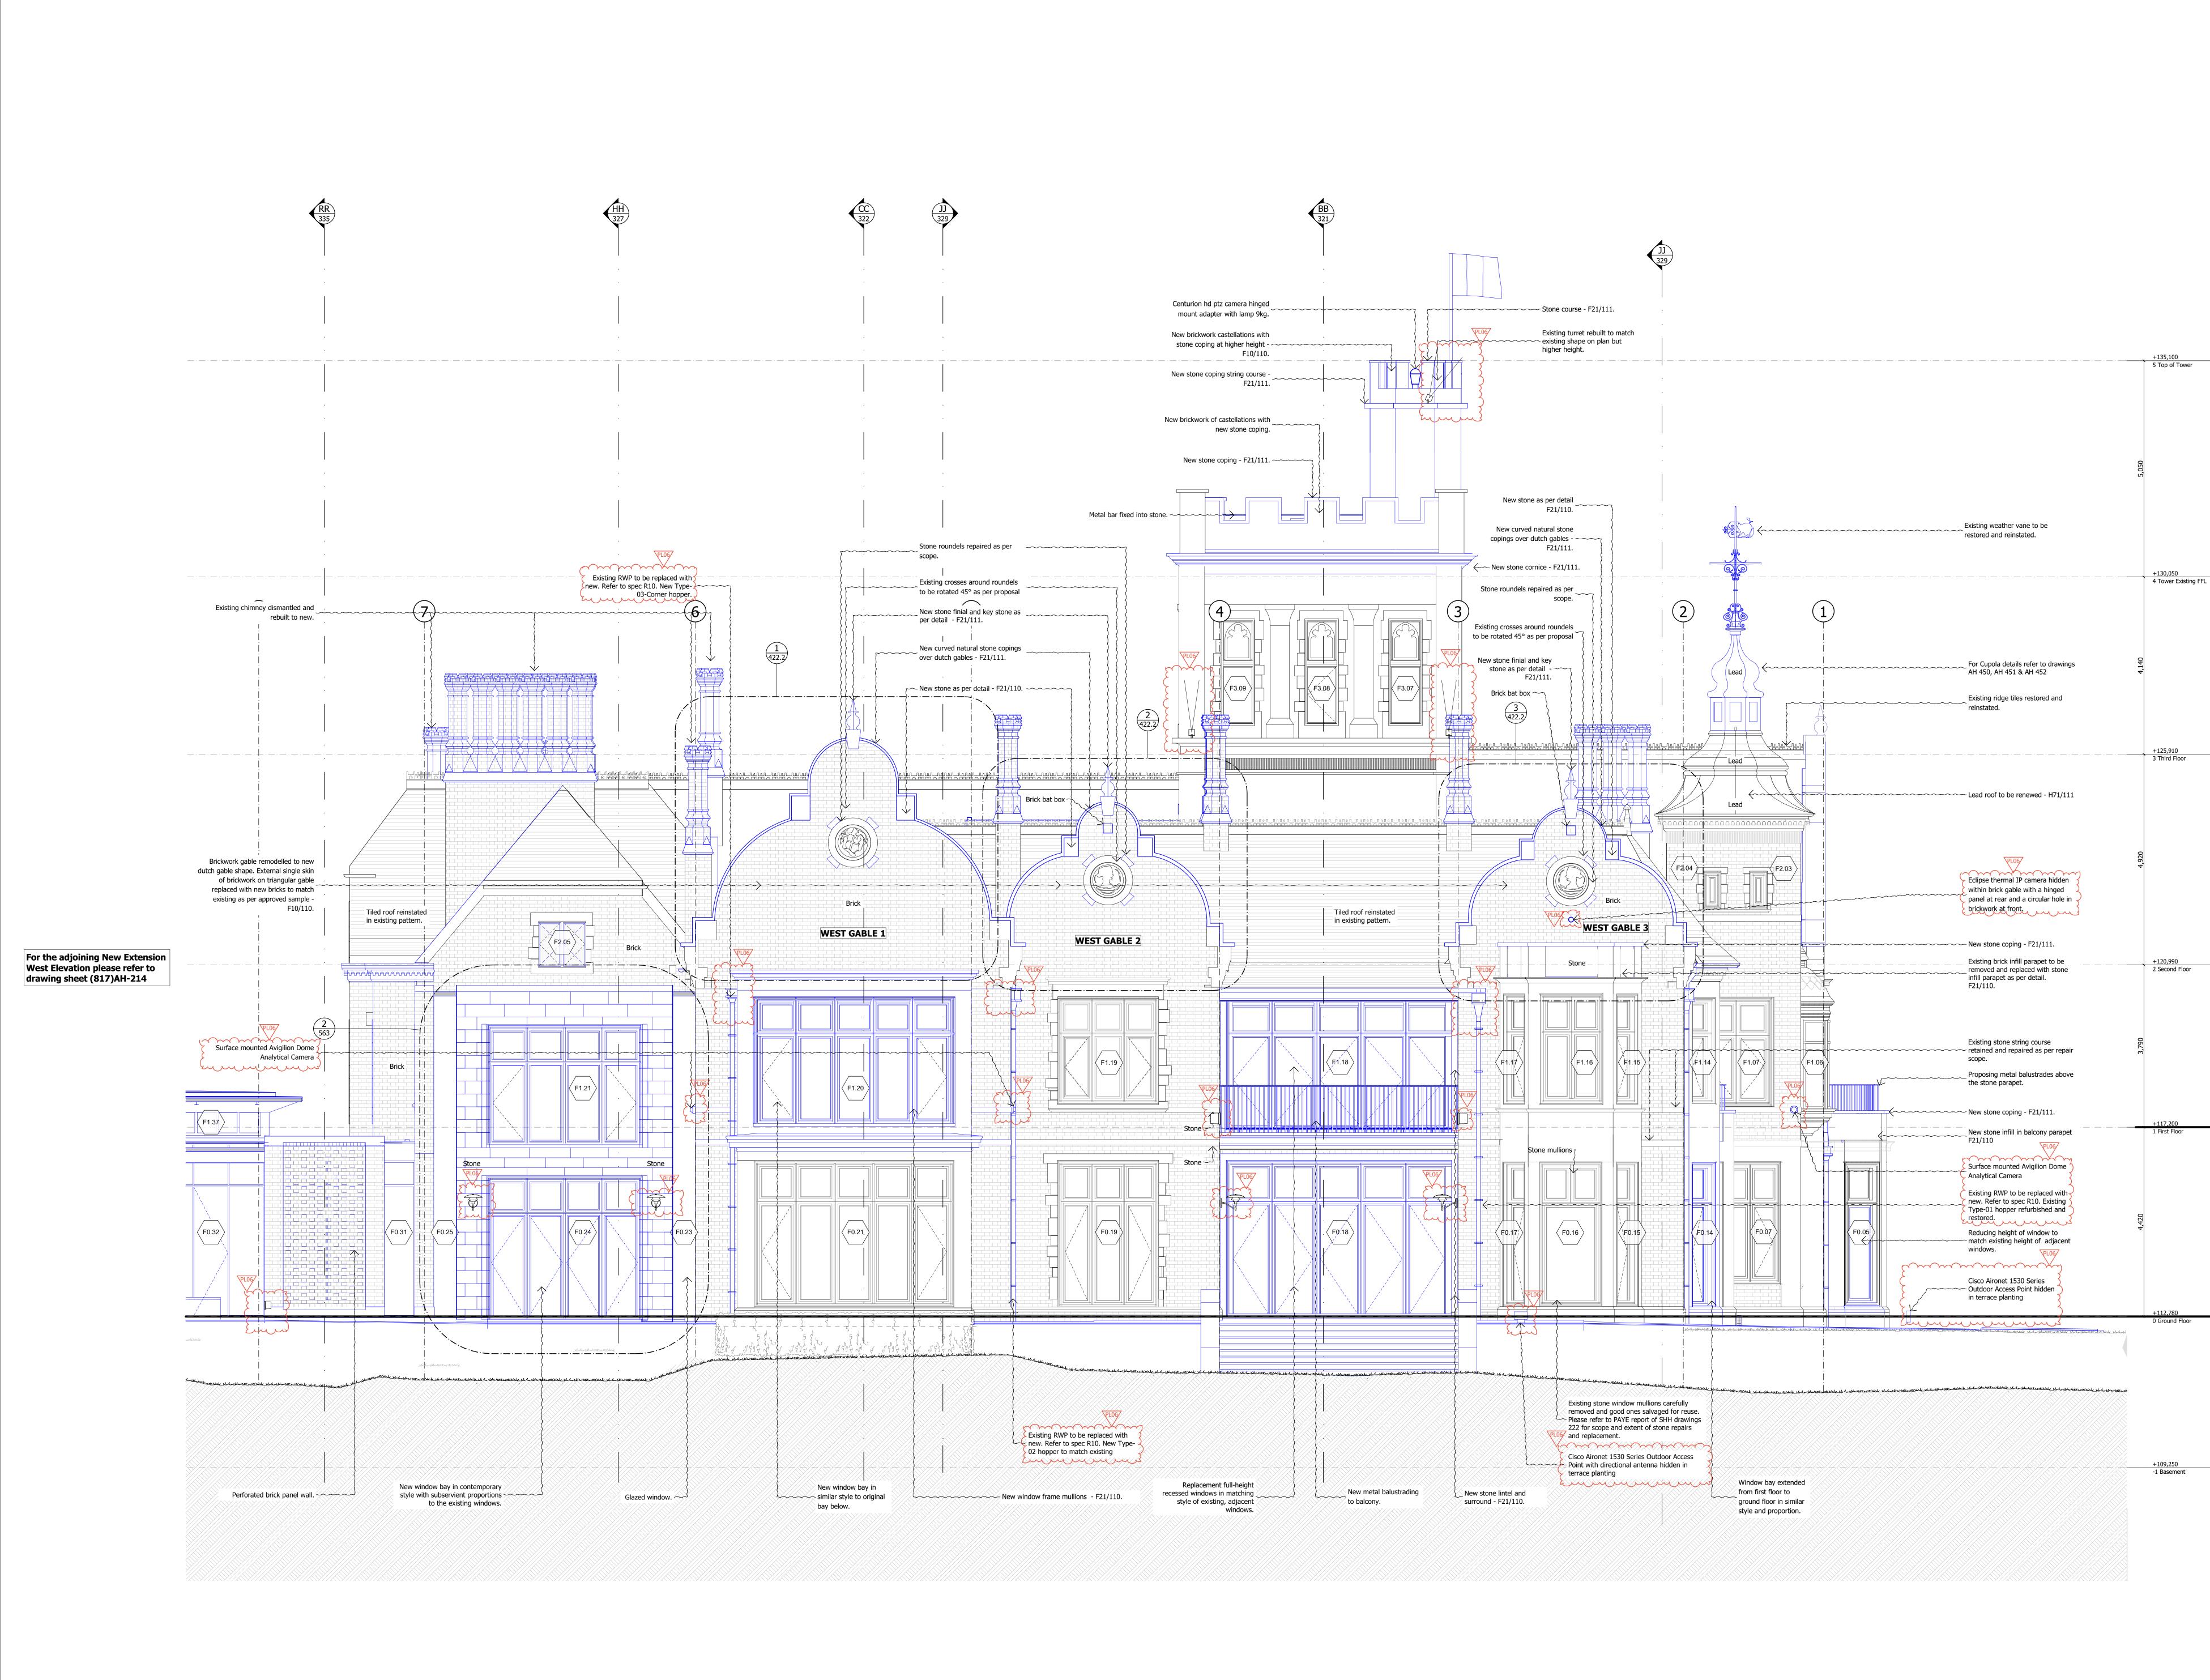
For Cupola details refer to drawings

Existing ridge tiles restored and

+125,910 3 Third Floor ---- Lead roof to be renewed - H71/111

--- New stone coping - F21/111. ____Existing brick infill parapet to be ____removed and replaced with stone

Existing RWP to be replaced with the new. Refer to spec R10. Existing Type-01 hopper refurbished and restored.
