### Level and Crack Monitoring

**Our Ref:** 505891 **Date of Issue:** 30/08/2018

**Level and Crack Monitoring - Site Sketch**

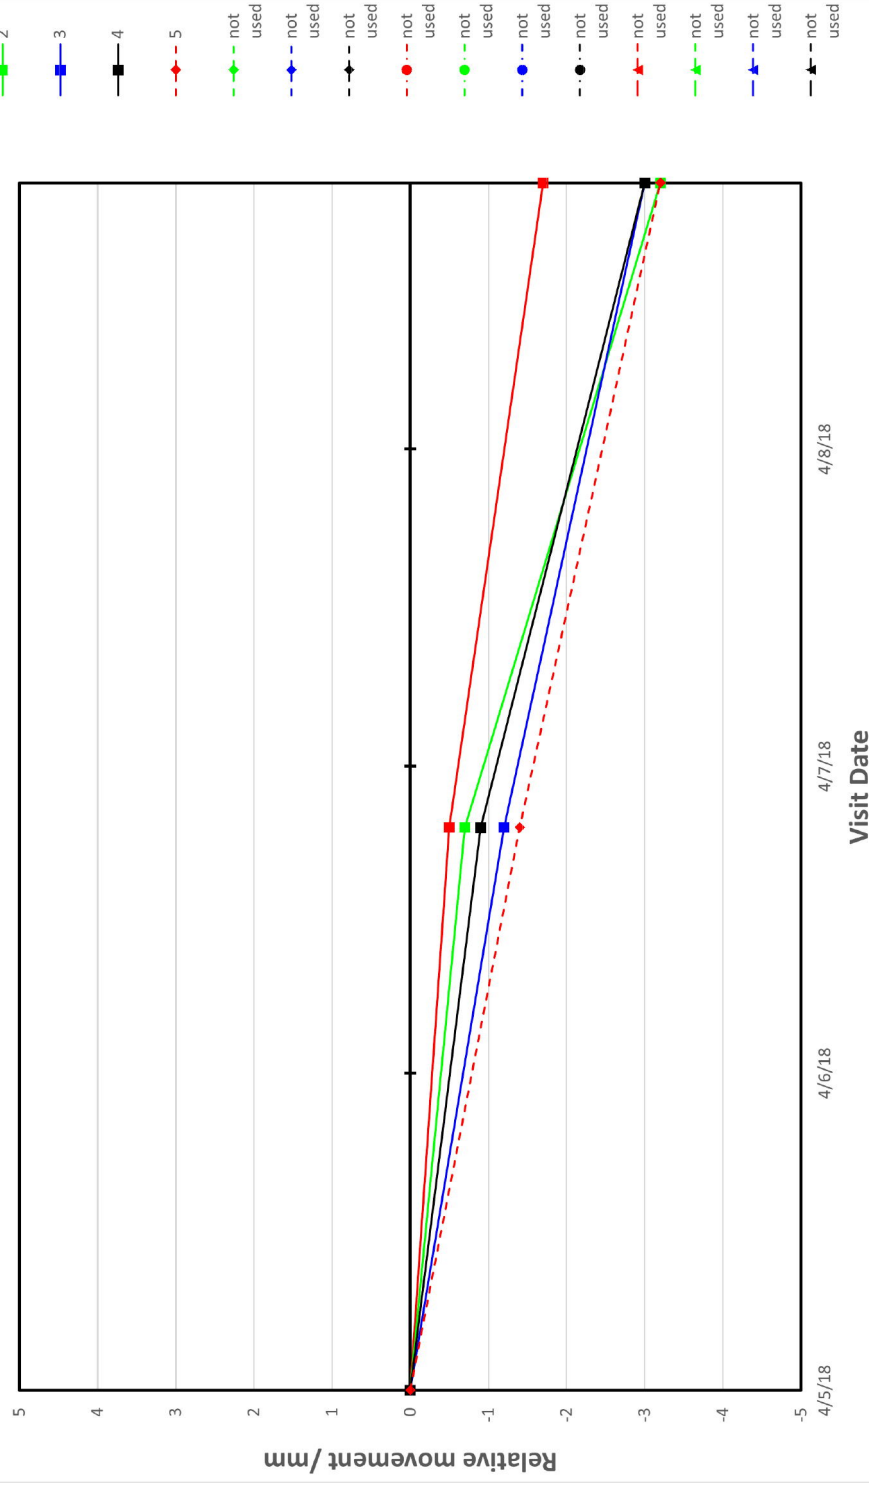
Level Monitoring - Movement relative to datum against Date

### Level Monitoring - Reduced Levels (in metres)

| Our Ref: | | 505891 | | Date of Issue: 30/08/18 | | | | | | | | | | | |
|---|---|---|---|---|---|---|---|---|---|---|---|---|--|--|--|
| 1 | 11.9718 | 11.9713 | 11.9701 | | | | | | | | | | | | |
| 2 | 11.9588 | 11.9581 | 11.9556 | | | | | | | | | | | | |
| 3 | 11.9519 | 11.9507 | 11.9489 | | | | | | | | | | | | |
| 4 | 11.9529 | 11.9520 | 11.9499 | | | | | | | | | | | | |
| 5 | 11.9779 | 11.9765 | 11.9747 | | | | | | | | | | | | |

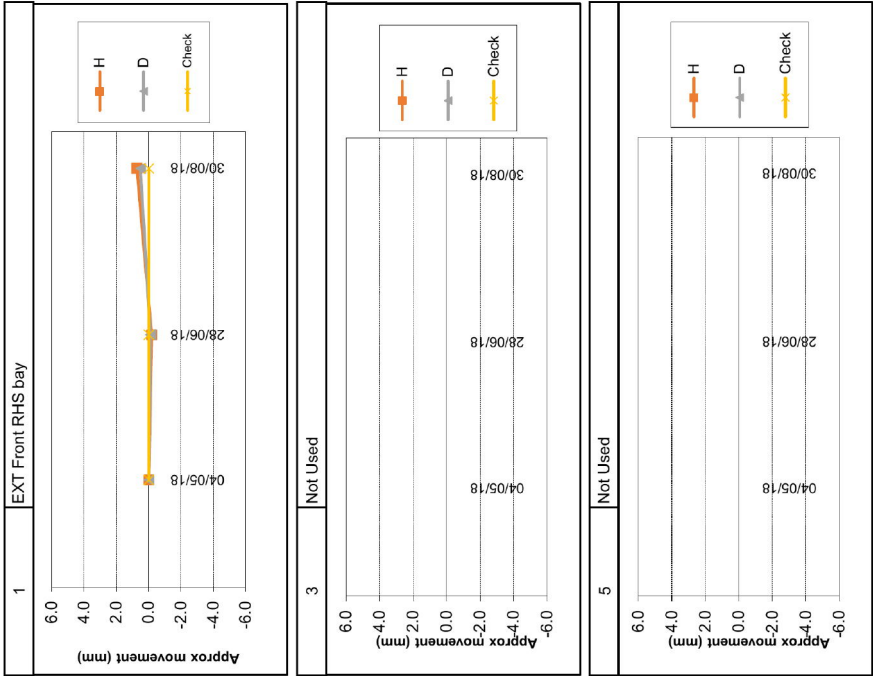
Crack Monitoring - Movement Against Time

### Crack Monitoring - Readings

| Studs nos. | Align-ment | Visit Date | | 04/05/18 | | Visit Date | | 28/06/18 | | Visit Date | | 30/08/18 | | Visit Date | | Current c/w | | Visit Date | | Current c/w | |
|---|---|---|--|---|---|---|---|---|---|---|---|---|---|---|---|---|---|---|---|---|---|
| 1 | D | | | 115.02 | 32.92 | 114.92 | 32.91 | 115.54 | 32.91 | 115.54 | 32.30 | 32.30 | | | | | | | | | |
