PLANNING & LISTED BUILDING APPLICATION FOR

113 ALBERT STREET
NW1 7NB

INTRODUCTION

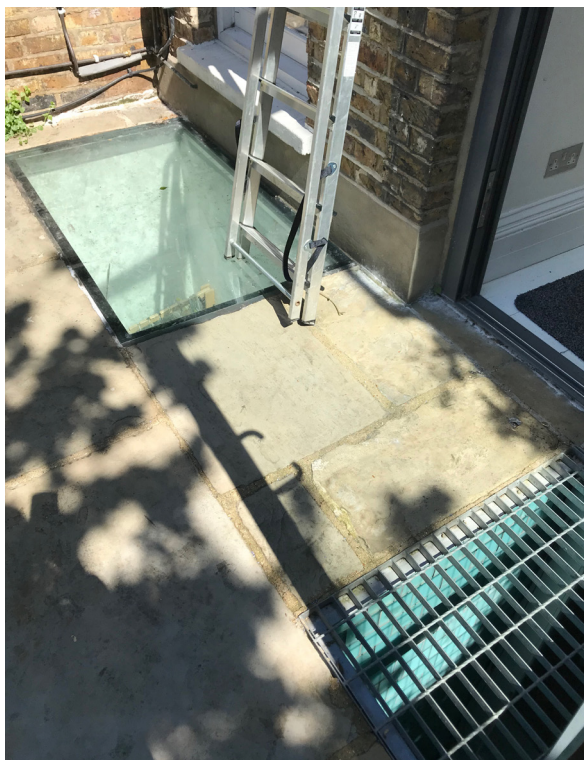
Existing rooflight and gridded lightwell cover

- one covered by a metal grille, directly outside the bi-folding doors at ground floor level that lead from the dining room into the garden
- one with a walk-on rooflight that leads to a storage room under the rear terrace.

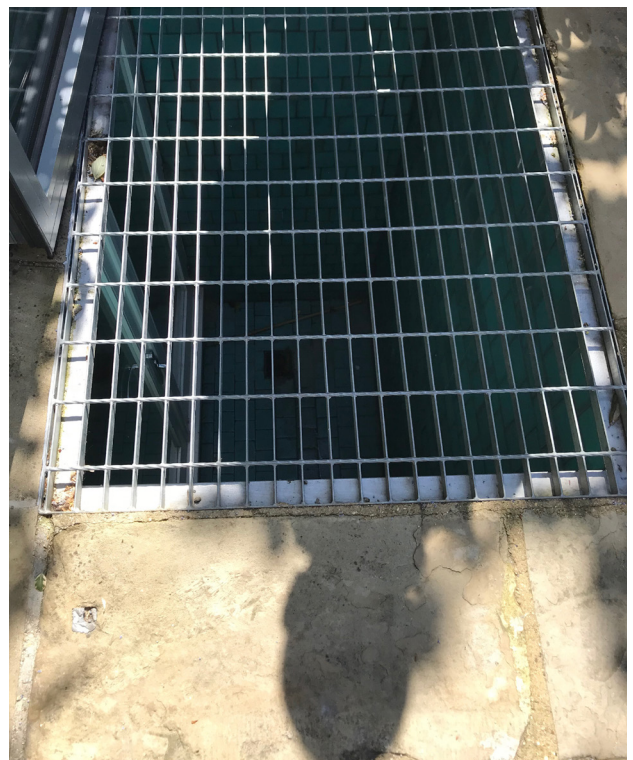
Lightwell grille cover directly outside main access to garden

This current configuration results in two separate small lightwells, which are not practical nor do they maximise natural daylight into the room. The metal grille located directly in front of the doors onto the terrace is in the area with heaviest footfall and makes for both an impractical and uncomfortable transition.

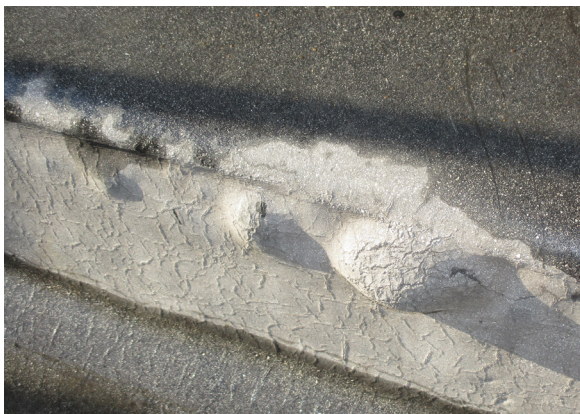
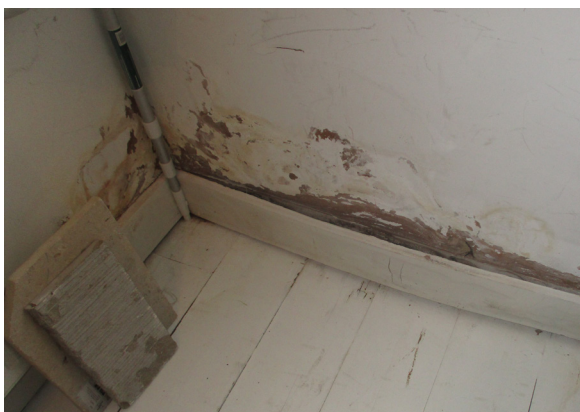
Mains access with blistered asphalted steps (above)
Interior damp damage (below)

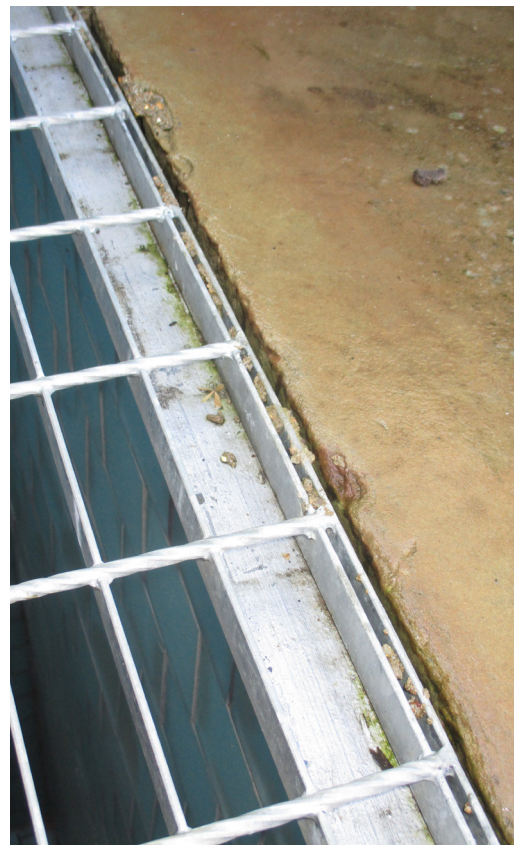
Weak waterproofing point around metal grille over rear lightwell

- As part of the works to connect both lightwells, the damp-proofing at the base of the rear elevation and around the lightwell would be improved, by installing cementitious waterproofing slurry to the walls below ground (retaining and façade) under sand-cement render.

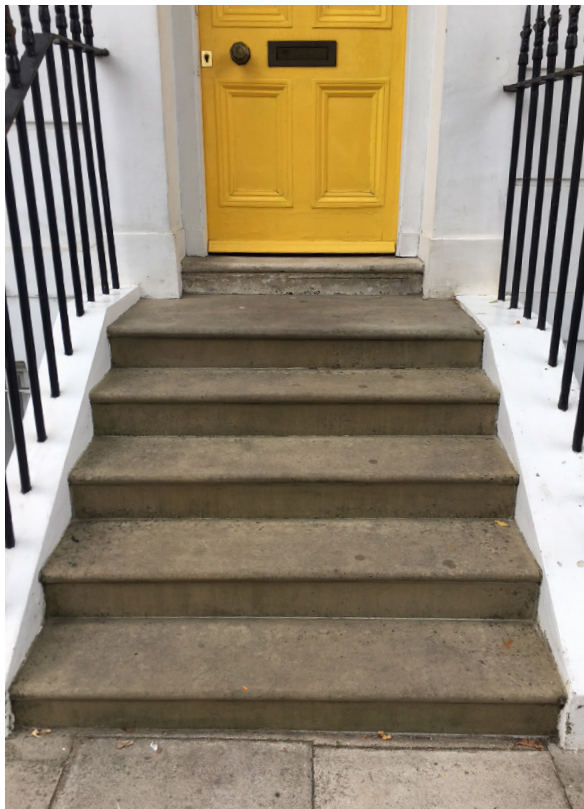
New proposed steps to raised ground floor to be clad in Portland stone to match neighbouring properties

The main access into the (raised) ground floor is via a series of steps up from street level. This arrangement is repeated along the terrace group of buildings, although the finish and treatment of these differs amongst the properties. In the case of 113 Albert Street, the steps are coated in a bituminous treatment that, as can be seen in the appended damp investigation report, show signs of damp damage. As part of the works we proposed to strip back the existing damaged asphalt and clad the treads and risers in Portland stone, with bull-nosed edges to the treads, to match neighbouring properties, such as no. 115. This would help enhance the overall appearance of the main access, and the terrace group in general.

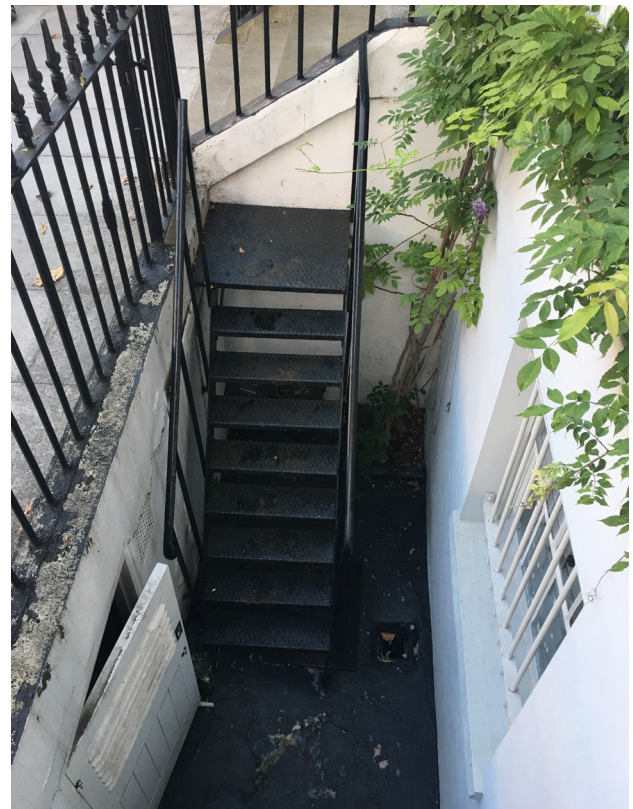
Existing steep, slippery and narrow stairs leading to front lightwell

The gate itself is only approximately 650mm wide, and the stair is not only steep but also slippery due to water collecting on the treads. The rubbish and recycling is stored in the front lightwell, away from clear view from the street, and the narrow steps therefore serve as the only route for the waste disposal removal. The current configuration with narrow, steep, slippery steps, and a narrow gate onto the street, makes maneuvering even the smallest of the council's recycling bins up to street level a hazardous activity.

To remedy this we propose to widen the existing (non-original) gate by a single finial to achieve a more comfortable (approx.) 700mm wide opening. We would then also replace the current impractical stair with a new cast iron one, in the style of the existing, but with a consistent, more gentle pitch and perforated treads (to avoid stagnating water) for ease of use. We have been liaising with a specialist metalworker to ensure we can achieve a finish for both railings/gate and stair that respect the history and fabric of the building to preserve the consistent style of the building and rest of the terrace group.
