106 HIGHGATE ROAD, LONDON NW5

## **HERITAGE STATEMENT**

INCLUDING DESIGN AND ACCESS STATEMENT

October 2018  
AAB architects

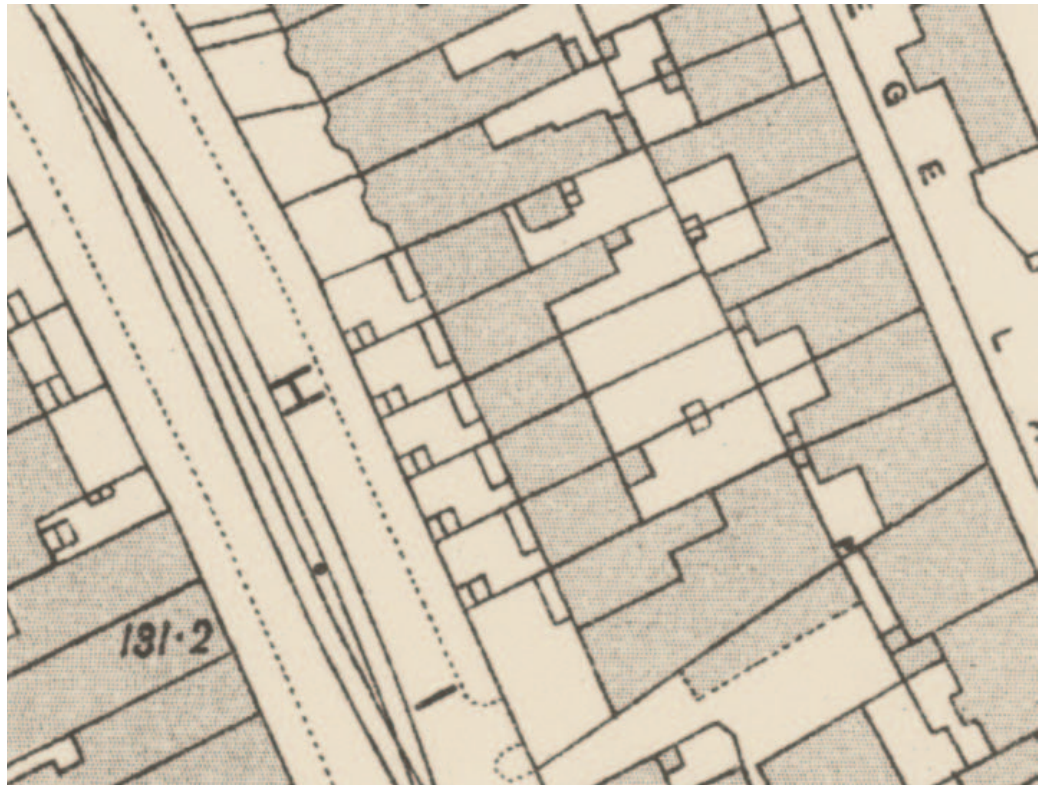
*OS plan 1893-95*

*Showing upper ground floor access to front doors and extension to no. 106*

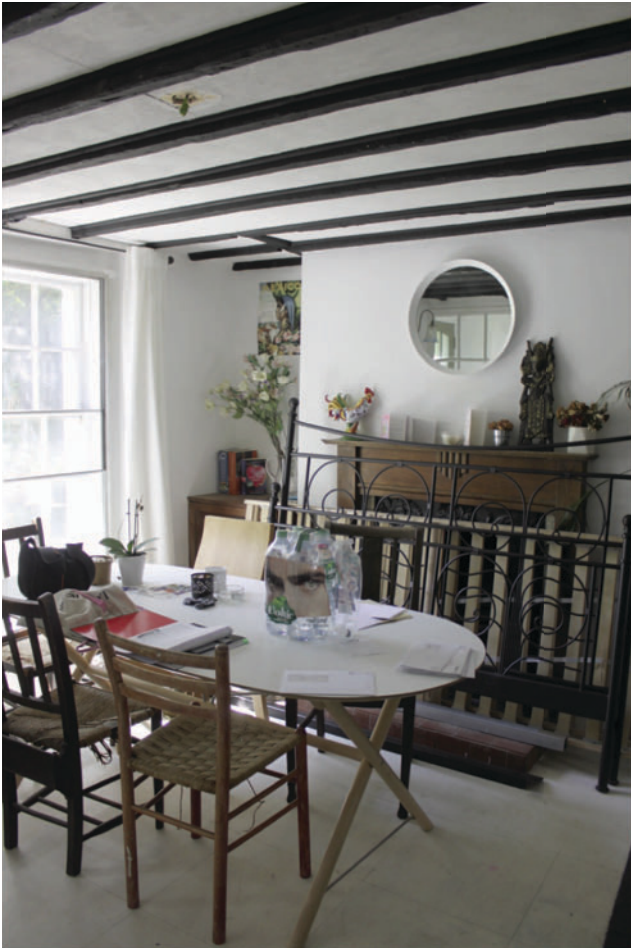
Lower ground floor, front room

Original ceiling has been removed and floor joists exposed. A modern board has been inserted between the joists.

Proposed works: fix plasterboard to underside of floor joists.

*See drg. 357\_LB\_1\_10*

At lower ground floor the original ceilings have previously been removed, and replaced with various modern materials (pine boarding and a lightweight board set between the existing joists). It is proposed to remove these and replace with fire resisting plasterboard.

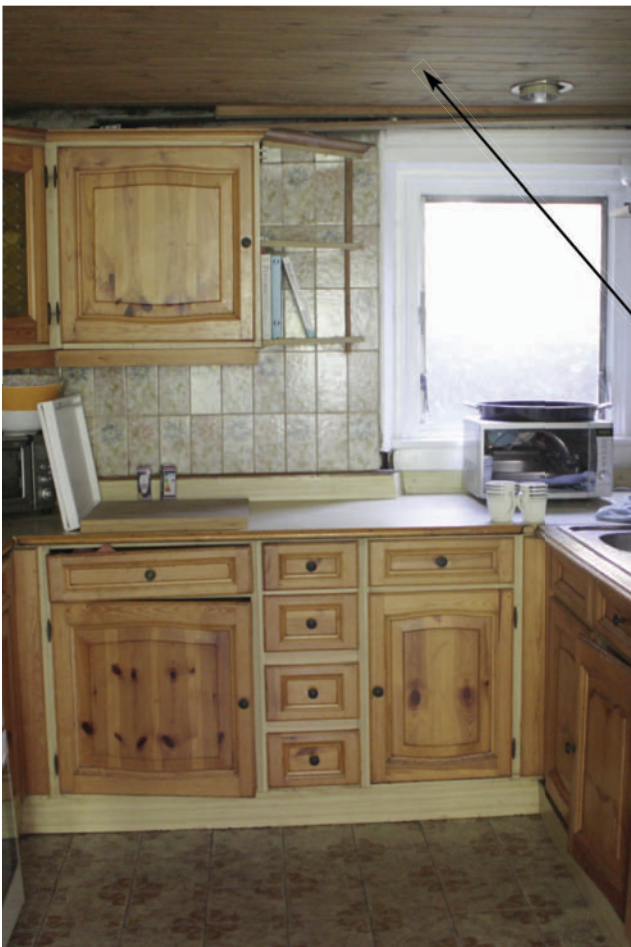
Lower ground floor, rear room

Proposed works: timber boarded ceiling to be removed and replaced with plasterboard

*See drg. 357\_LB\_1\_10*

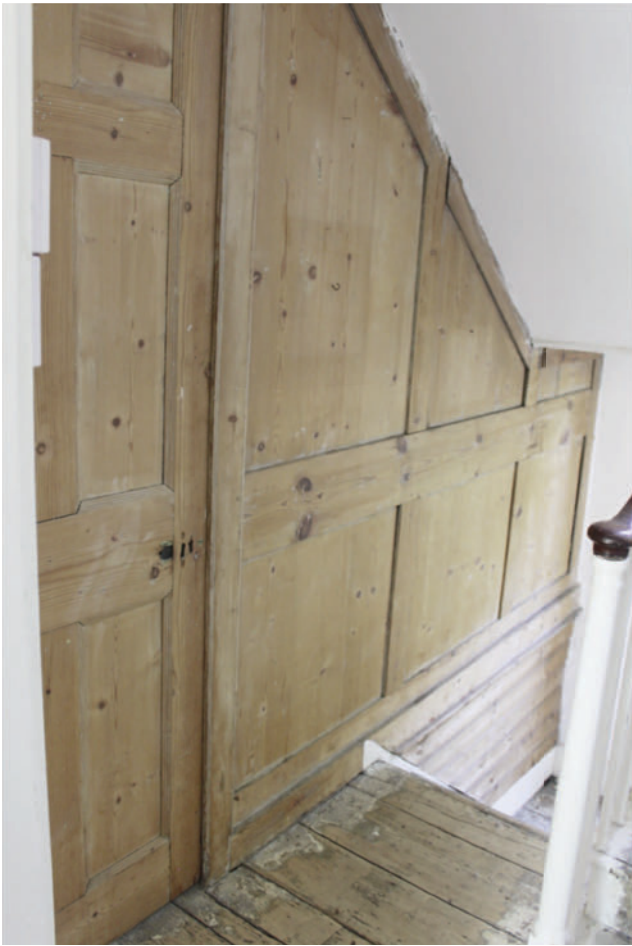
Upper ground floor, landing

Original timber panelling to ground floor bedroom, resulting in

- poor acoustic privacy
- disturbance from use of stairs
- lack of fire protection to stair

*See drg. 357\_LB\_0\_11*

Works are proposed to provide better acoustic and fire separation between the staircase and the rear rooms of the house at upper ground, first and second floors. At present the rooms are separated from the staircase by a thin, timber-panelled partition, which provides minimal resistance to the transfer of sound or fire.

The timber panelling is original, and contributes to the character of the building, along with the original doors and frames. It is proposed to retain the panelling insitu, and to upgrade its performance by adding plasterboard screens to the room side of the partition.

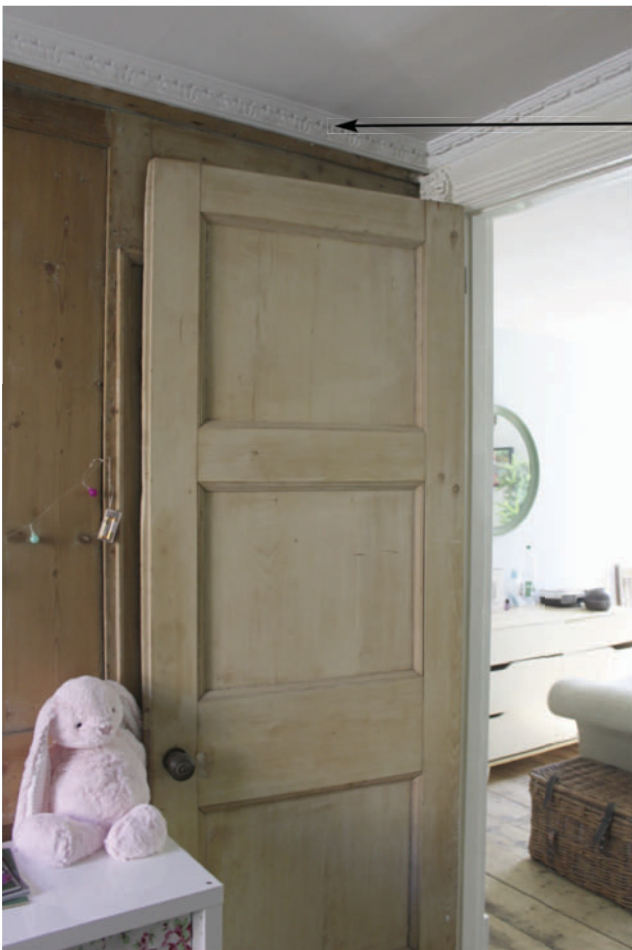
Upper ground floor, rear room

Non-original cornice to be removed along line of timber partition to enable installation of fire resisting lining.

Proposed works: provide plasterboard screen to bedroom side of the timber panelling. Partition to be designed to be demountable, with a minimum fixings to the historic fabric.

De-mountable plasterboard screen to be fitted into existing door frame opening, and doors kept shut.

*See drg. 357\_LB\_1\_11*

The screens are designed as modern elements that can be detached from the building fabric without damaging it, if and when required. They are clearly distinguishable from the original building fabric, which retains its legibility.

The proposed works have been designed to minimise the impact on the original building fabric. The screens will be free standing and pinned in place at top and bottom with a minimum number of fixings. Rubber strips are used to separate the new timber screens from the existing floor and ceiling to avoid damage.

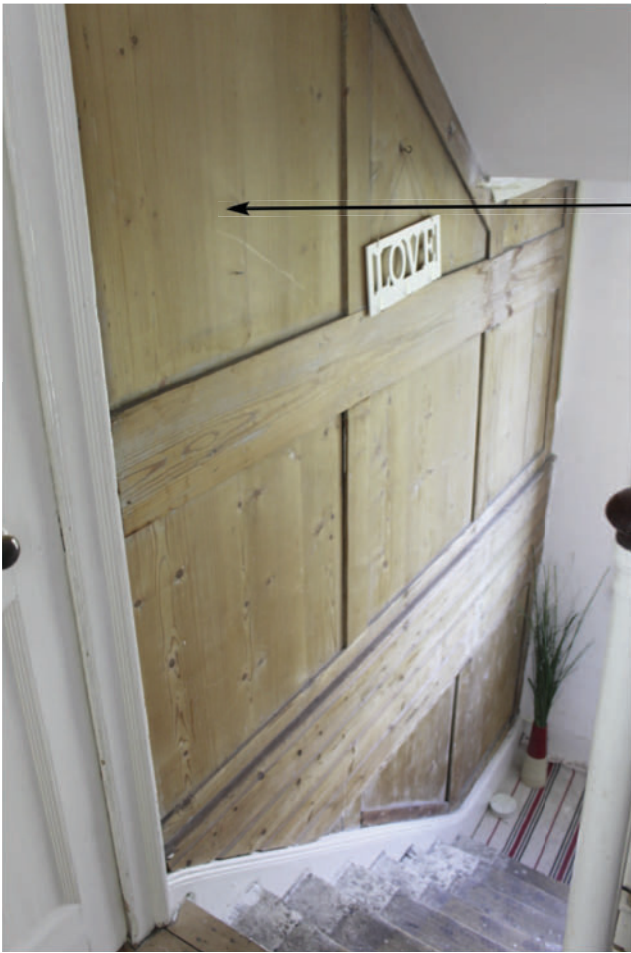
First floor, panelling

Original timber panelling to 1st floor bedroom, resulting in

- poor acoustic privacy
- disturbance from use of stairs
- lack of fire protection to stair

*See drg. 357\_LB\_0\_12*

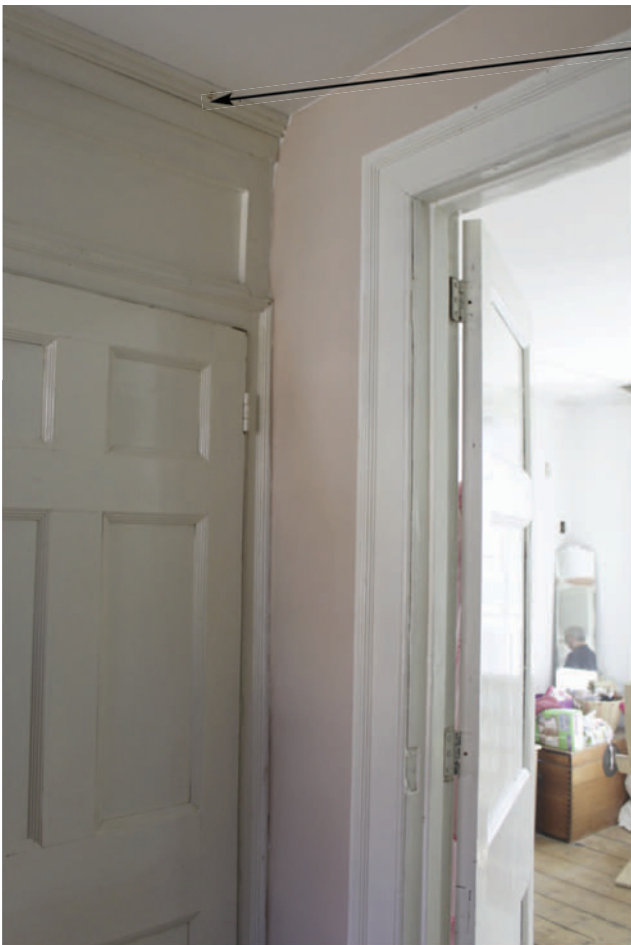
1st floor, rear bedroom

Non-original cornice to be removed along line of timber partition to enable installation of fire resisting lining.

Proposed works: provide plasterboard screen to bedroom side of the timber panelling. Partition to be designed to be demountable, with a minimum fixings to the historic fabric.

De-mountable plasterboard screen to be fitted into existing door frame opening, and doors kept shut.

*See drg. 357\_LB\_1\_12*

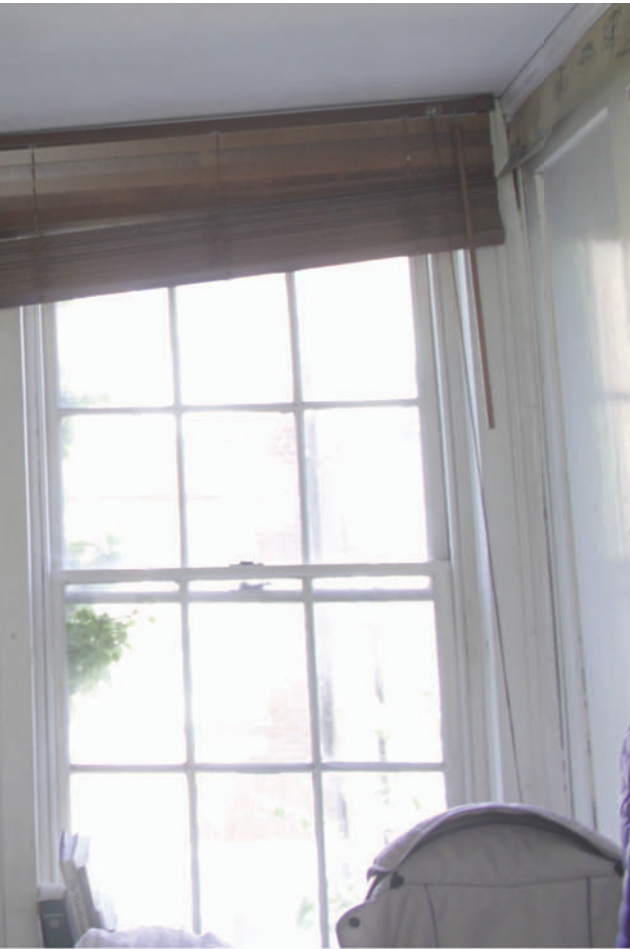
Window to first floor rear room

Timber panelling abutting window frame

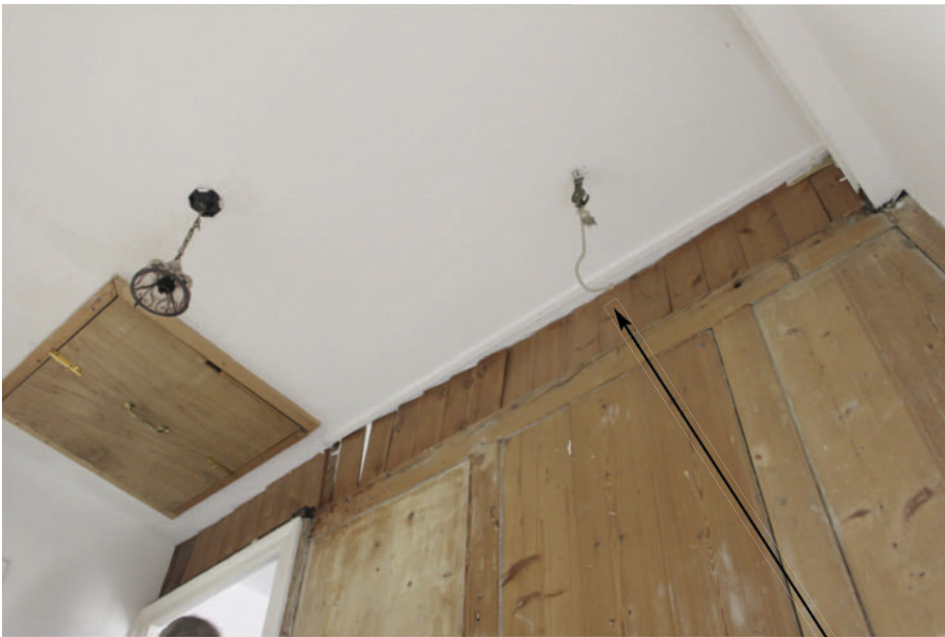
Timber panelling to stairway, 2nd floor

The original ceiling has been altered at some point in the building's history, and modern timber cladding inserted at high level.

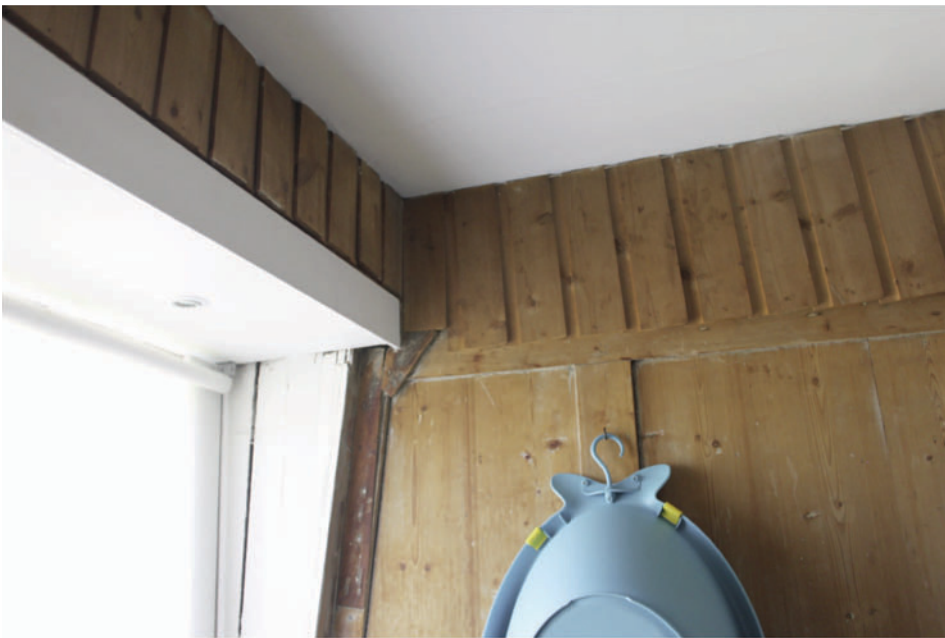
2nd floor rear bathroom

Modern timber cladding at high level.

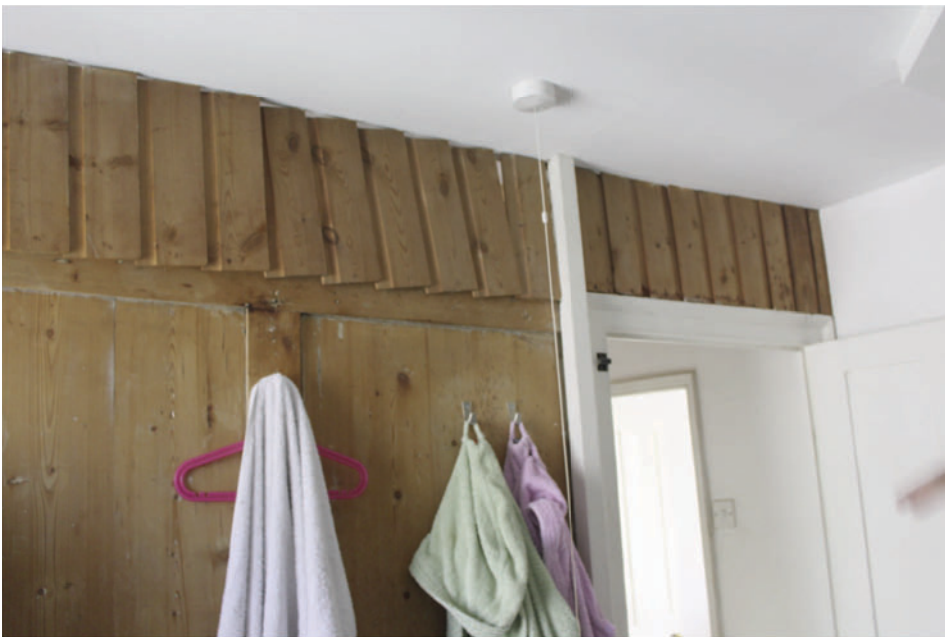
2nd floor rear bathroom

The original ceiling has been altered at some point in the building's history, and modern timber panelling inserted at high level.
