**Status:** -  
**Date:** 15/12/2017  
**Revision:** A  
**Job no:** 1843  
**Prepared by:** Siun O'Brien  
**Approved by:** Mark Tillett

Heyne Tillett Steel Limited has been appointed by Channing Junior School to consider the construction aspects and impact of the proposed subterranean development, in support of a planning application to the London Borough of Camden (LBC). The proposed development includes the construction of a standalone single storey basement to provide changing rooms and ancillary spaces in the southern end of the site and a further single storey basement which extends beneath the existing building to provide additional classrooms and a drama studio.

This Basement Impact Assessment (BIA) has been prepared by Heyne Tillett Steel in conjunction with GEA and in line with the Camden Planning Guidance CPG4 - Basement and Lightwells, along with section DP27 - Basement and Lightwells of Camden's Development Policies 2015 and supplementary reference documentation within these documents. This report provides specific details of each stage of the basement impact process as well as information on excavation, temporary works and construction techniques, including details

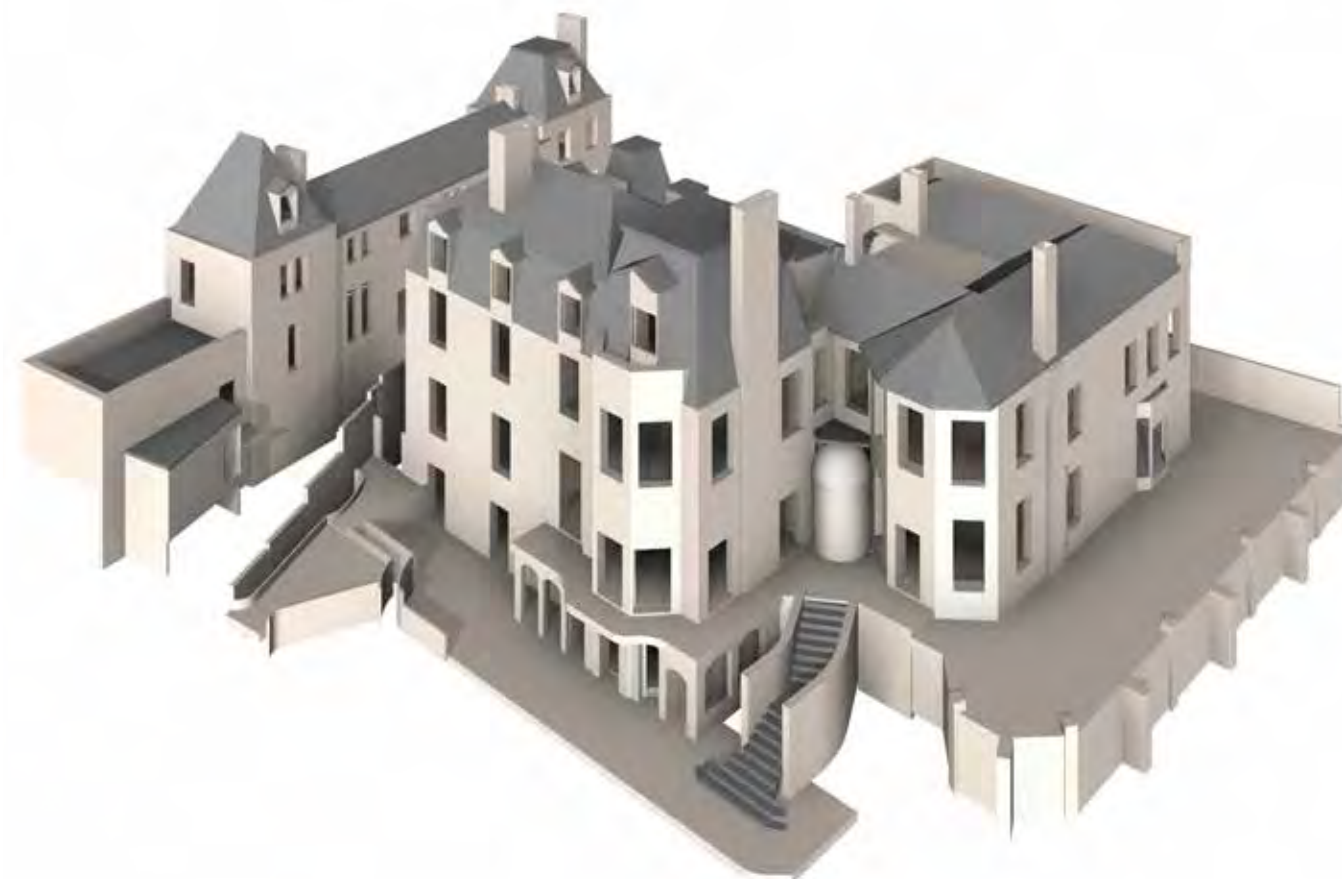
Isometric View of Existing Structure looking North

The existing structure comprises a series of loadbearing solid masonry walls supporting timber joists with lath and plaster ceilings typically. Ground floor slabs appear to be of ground bearing concrete construction or suspended timber joists spanning between solid masonry sleeper walls. The existing structure appears to be in reasonable condition where inspected.

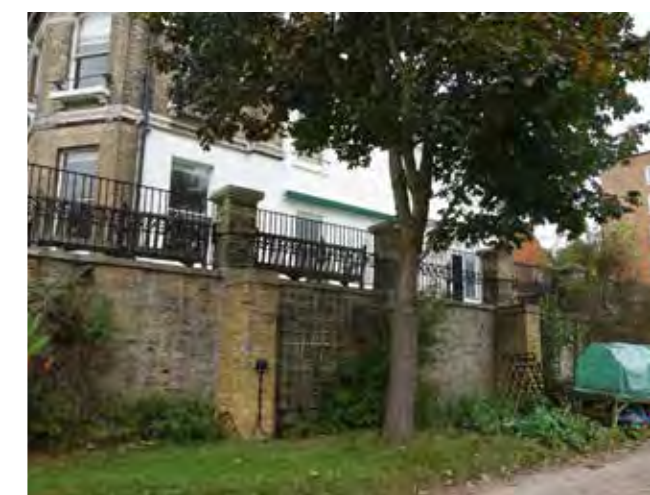
View of Existing Masonry Retaining Wall, East Elevation

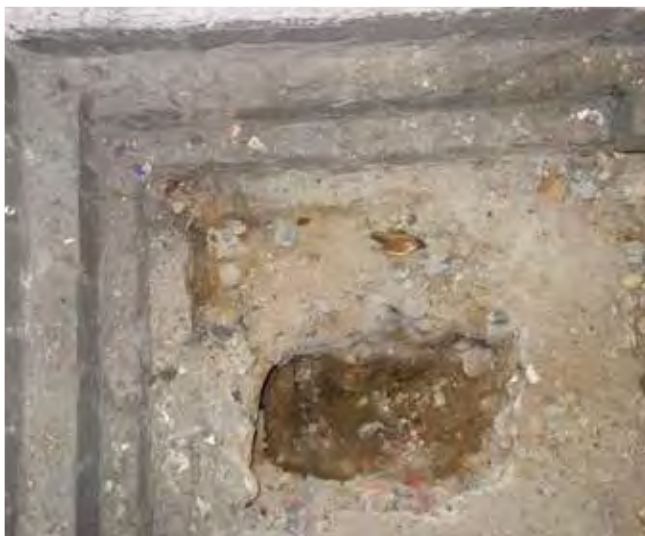
Site Photographs - Trial Pits, Main School Building

A series of trial pits were also undertaken at lower ground and ground floors respectively to establish the construction details of existing footings and their founding levels.

Existing loadbearing masonry walls appear to be founded on corbelled footings overlying concrete strip footings of varying depths. The concrete strip footings bear onto the firm silty sandy Bagshot Formation layer of the ground strata typically.

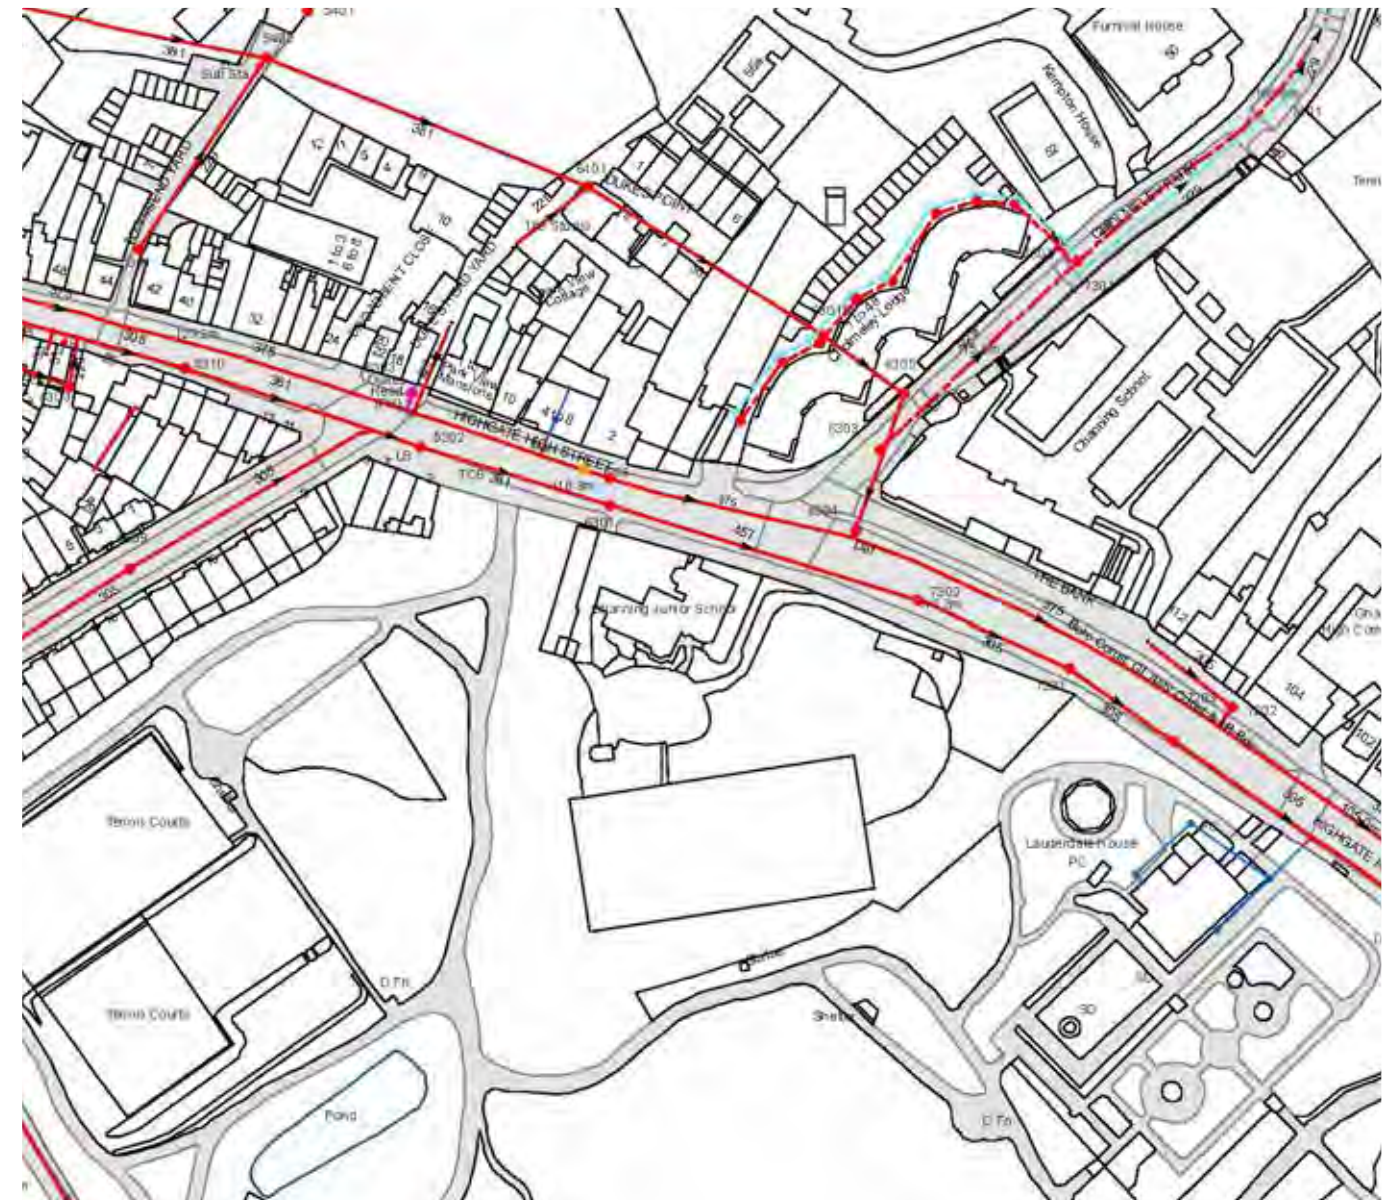
Thames Water Asset Location Plan

A Thames Water asset location search indicates that the site is served by a combined sewer, which runs in a southerly direction beneath Highgate High Street.

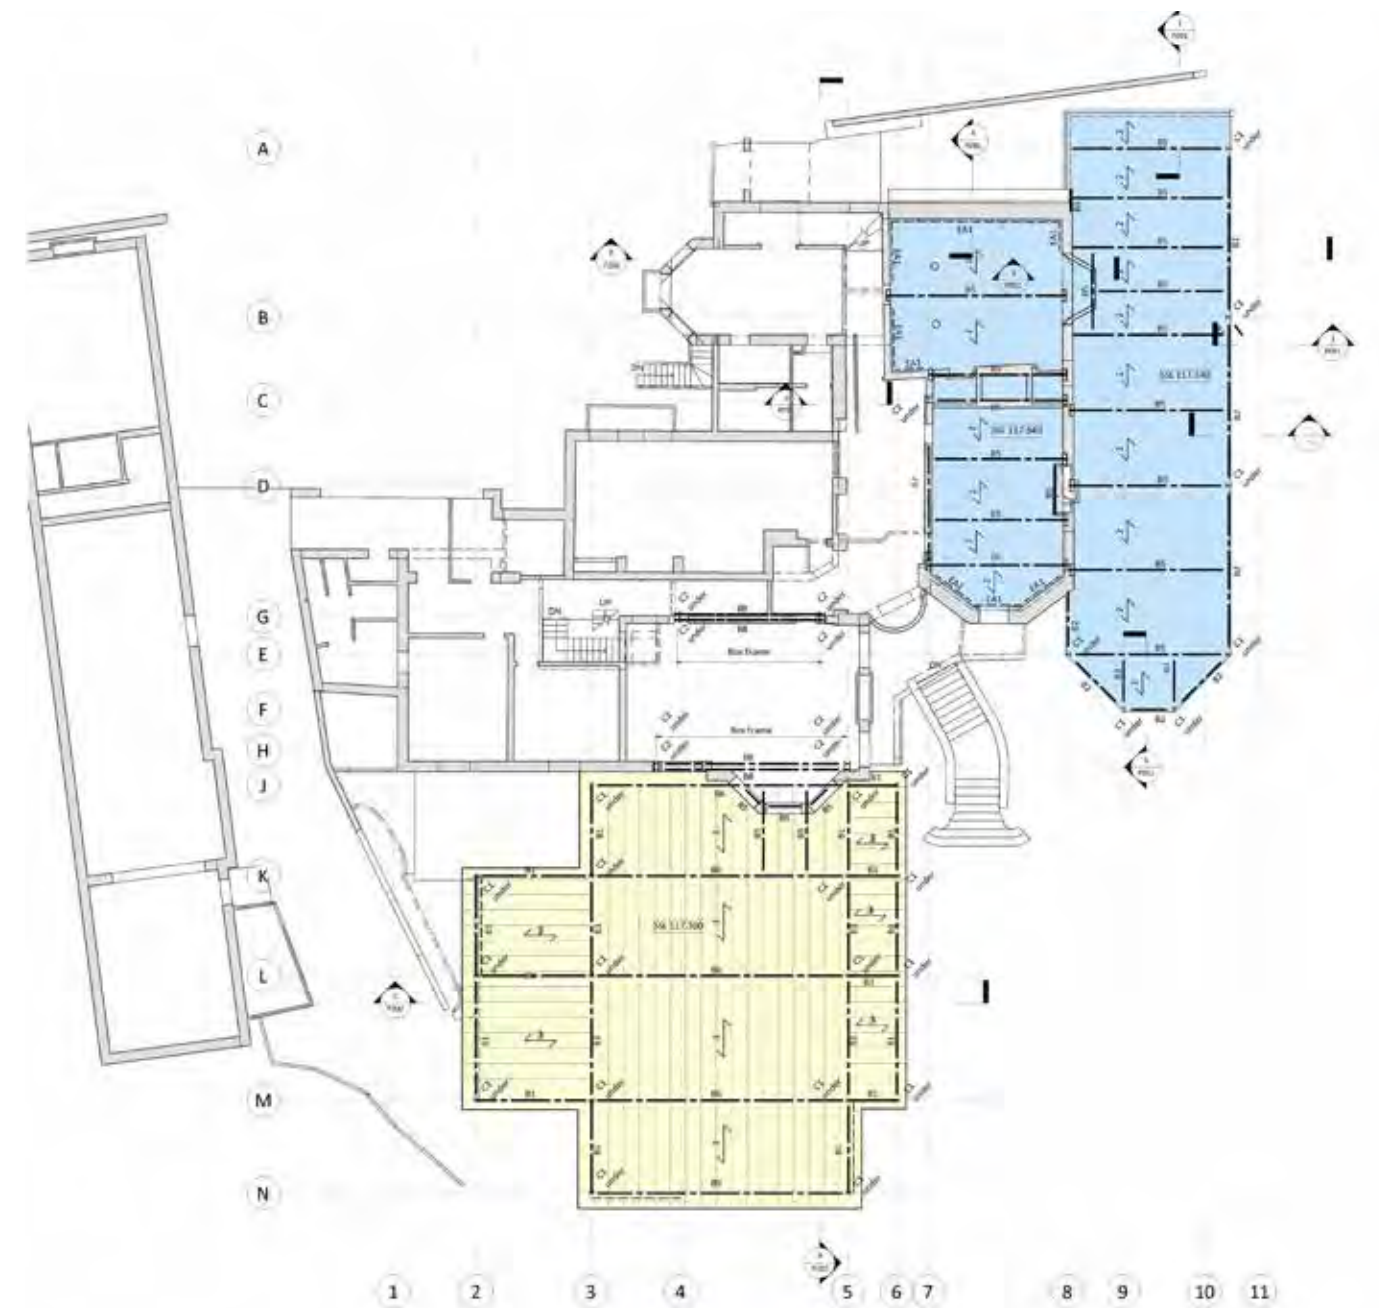
Proposed Structural GA - Ground Floor, East Extension and Hall / Dining Room

Steel columns along the eastern elevation of this extension will be founded on pad foundations, 1.5m x 1.5m x 0.35m deep typically. The pads will bypass the made ground / topsoil in this location, bearing directly onto the Bagshot Formation.

A number of reinforced concrete upstands are required along the eastern elevation of the extension due to the sloping site topography. These will act as short retaining walls, extending from ground beams spanning between pad foundations.

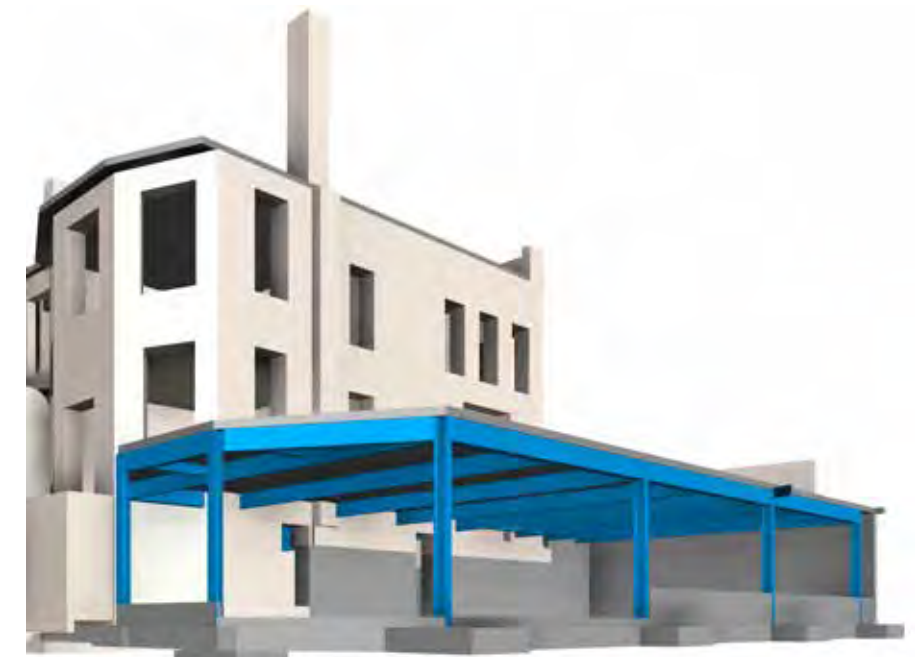
Construction of Pad Foundations / RC Slab

- Cast RC pad foundations to all remaining steel columns
- Cast RC ground bearing slab to entire footprint of extension, dowelling into existing RC underpins and retaining walls as required

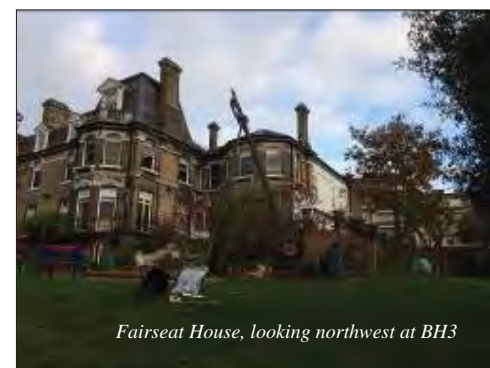
Fairseat House, looking northwest at BH3

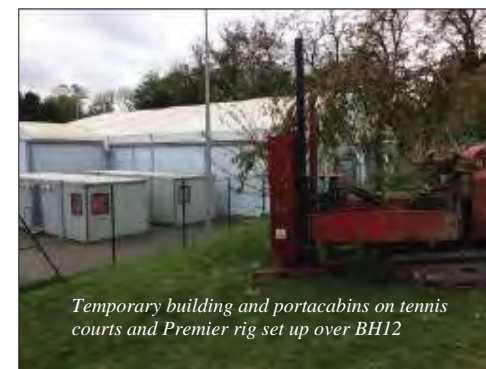
Temporary building and portacabins on tennis courts and Premier rig set up over BH12

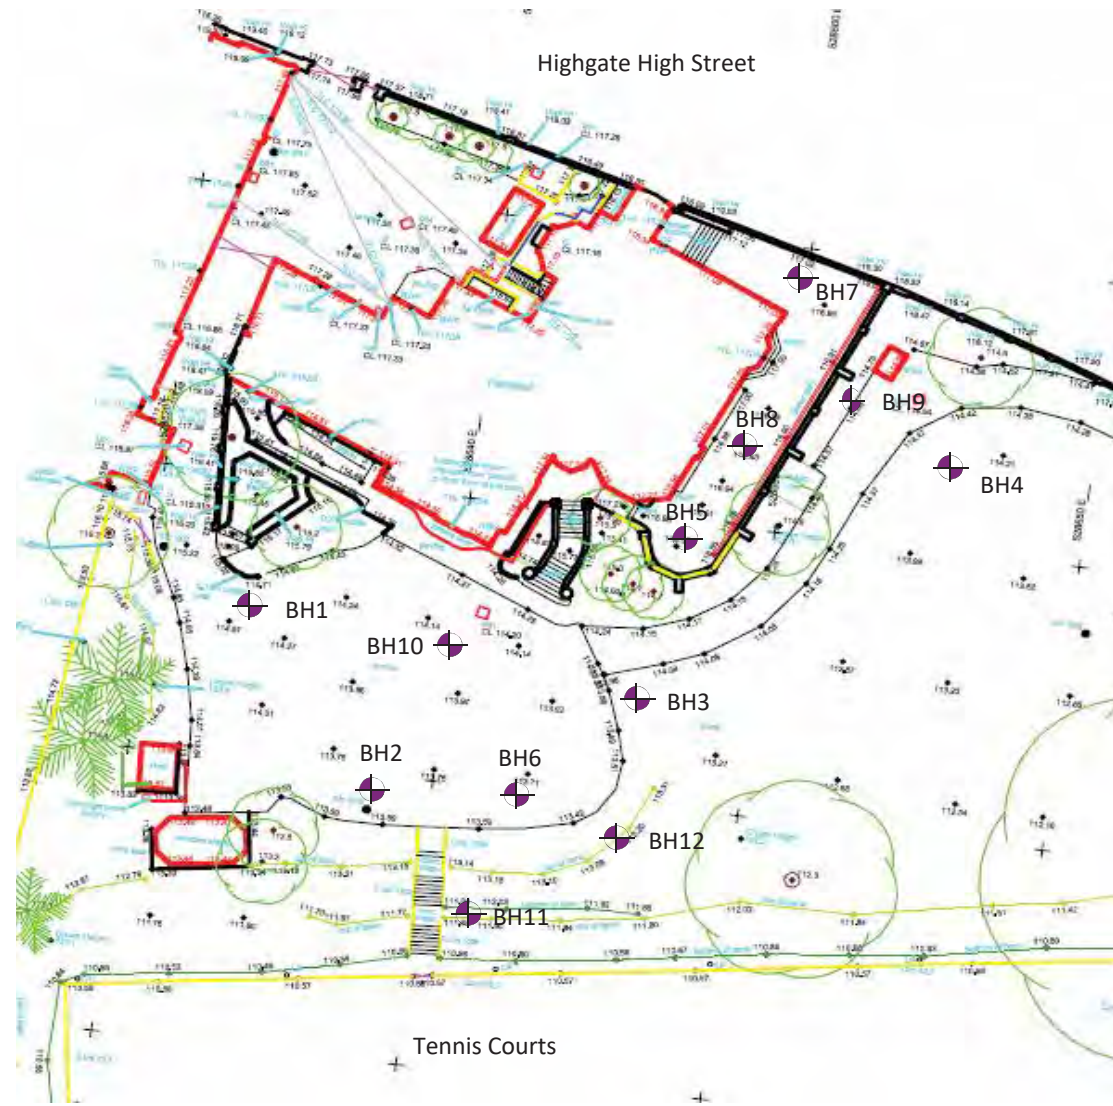
BOREHOLE LOCATIONS

Site Plan
