# 1508 High Holborn Estate, London, WC1V 6RQ - Historical Maps

Below Ground Drainage CCTV  
Survey - Spaflow

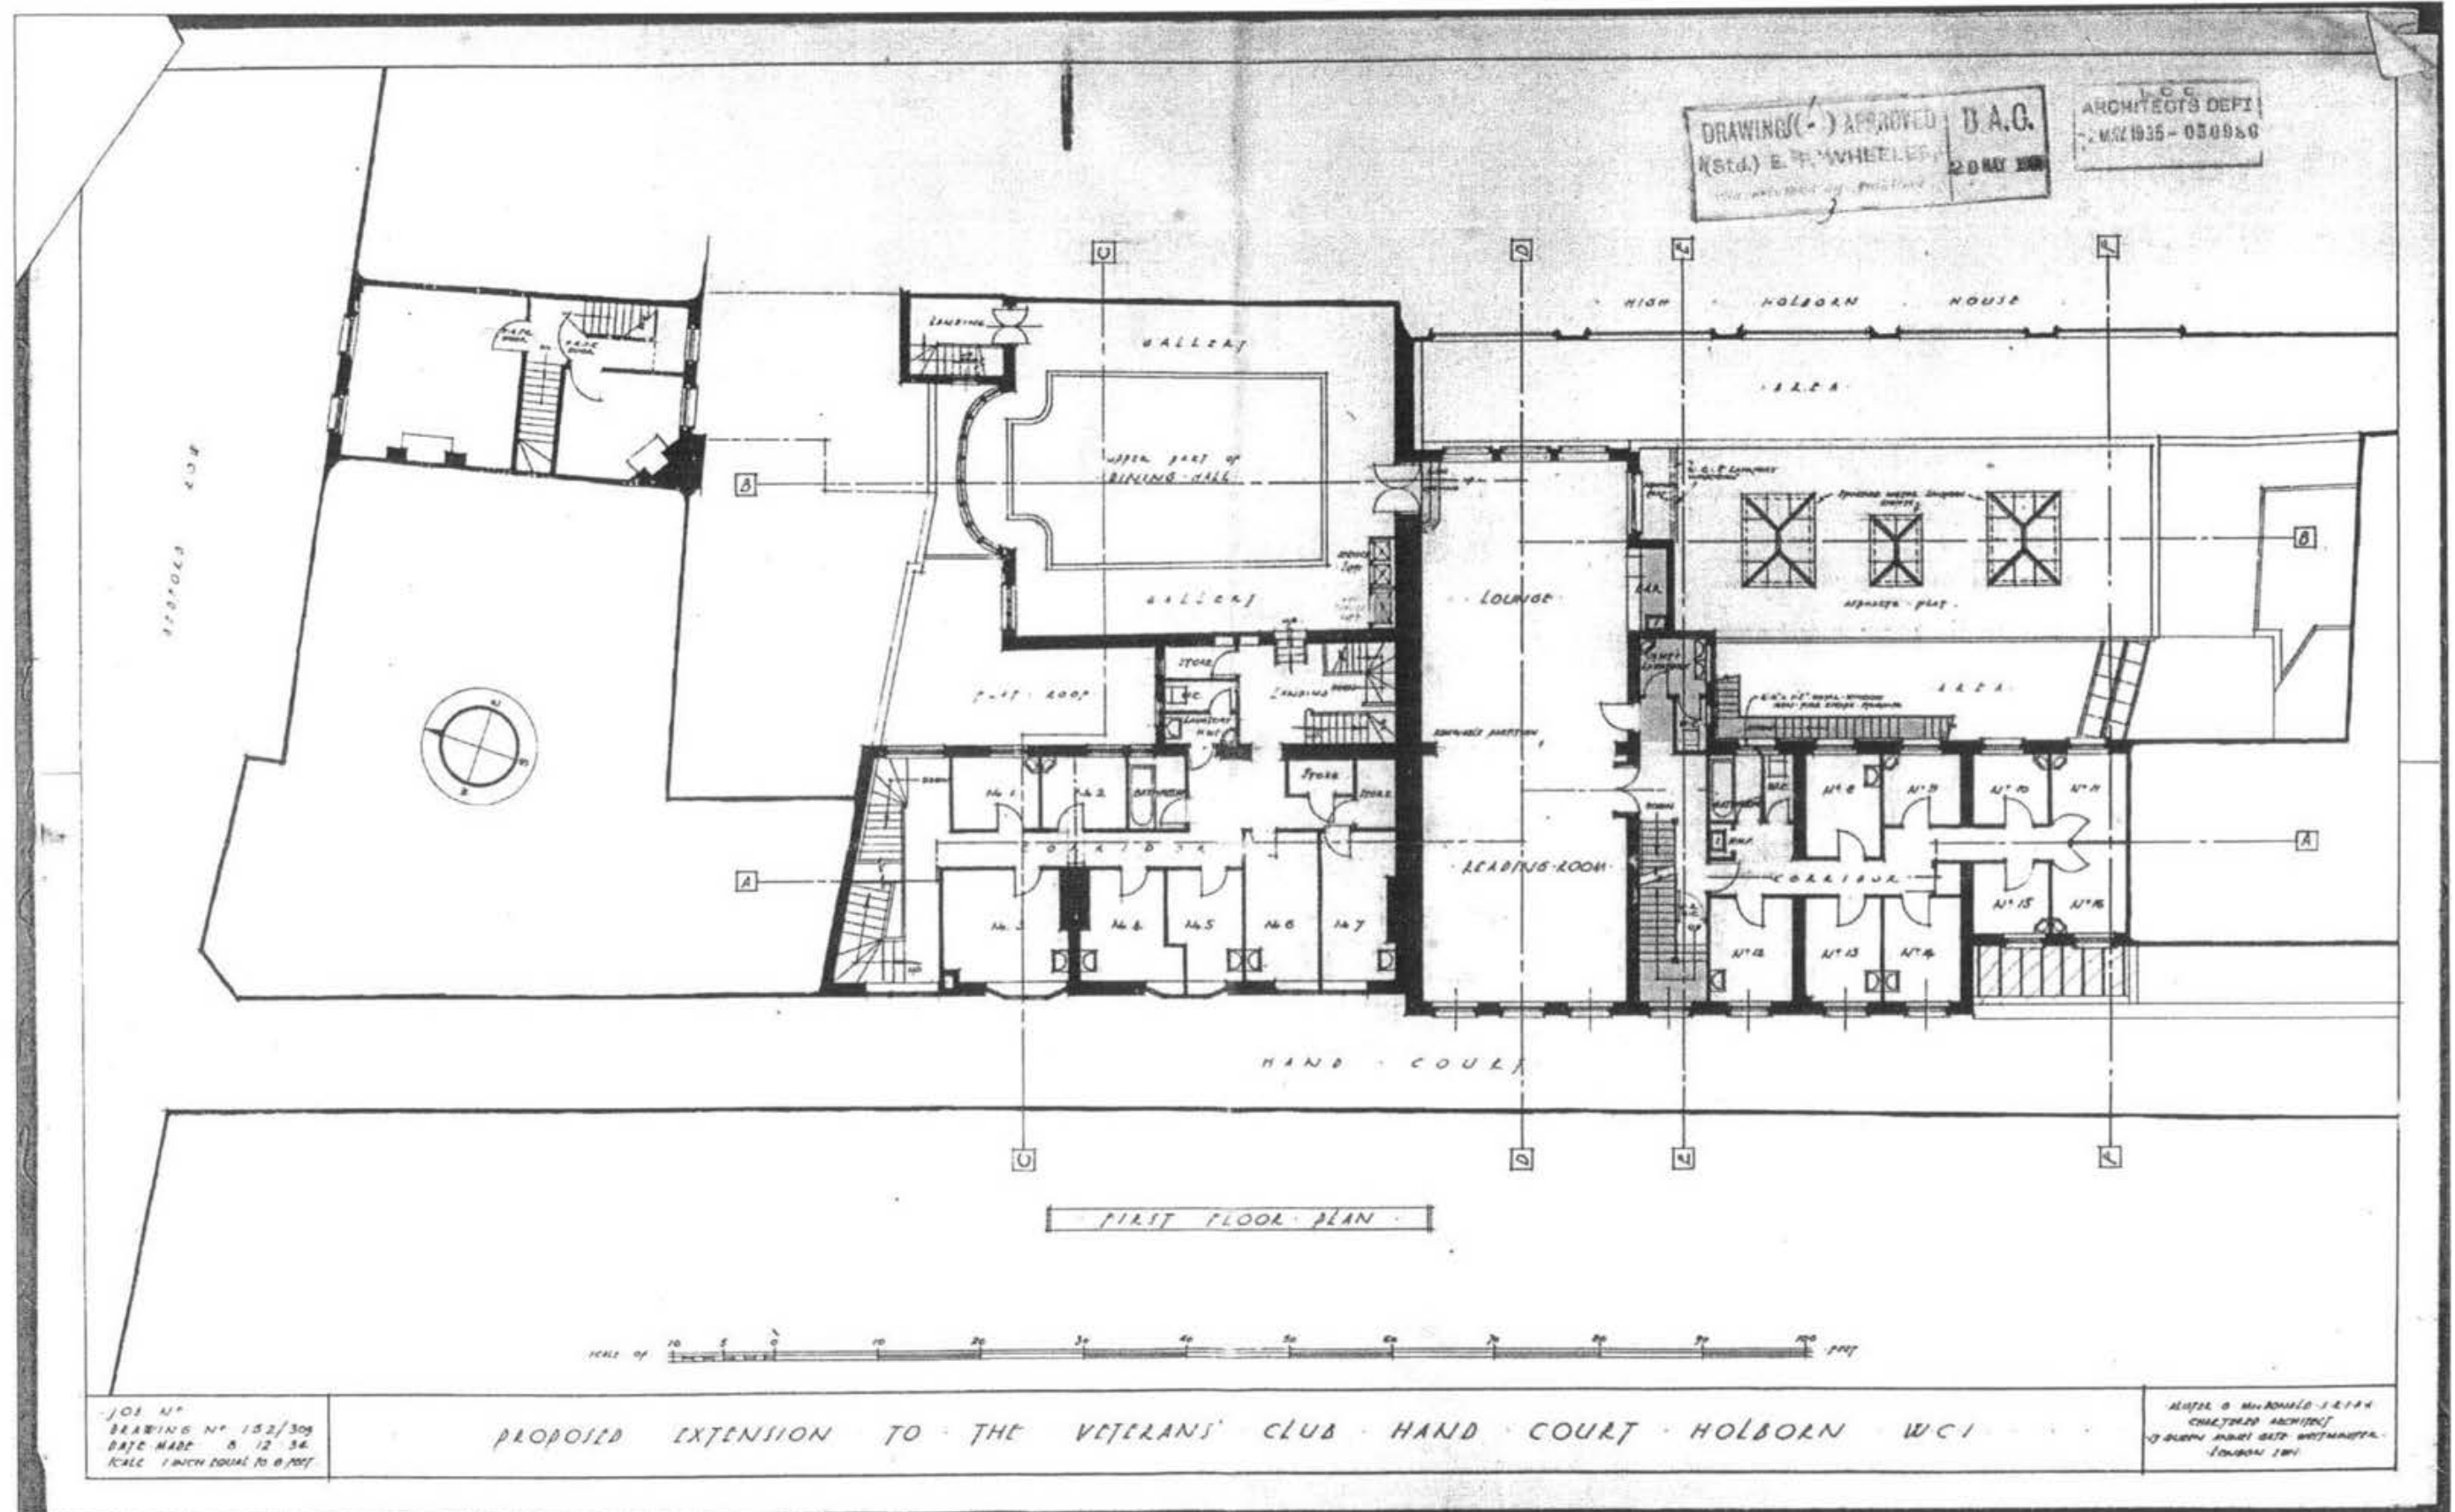
Plate XX Alister G MacDonald drawings of the Veterans Club extensions 1934/1935. These relate to what are now 16-23 Hand Court and 48 Bedford Row.

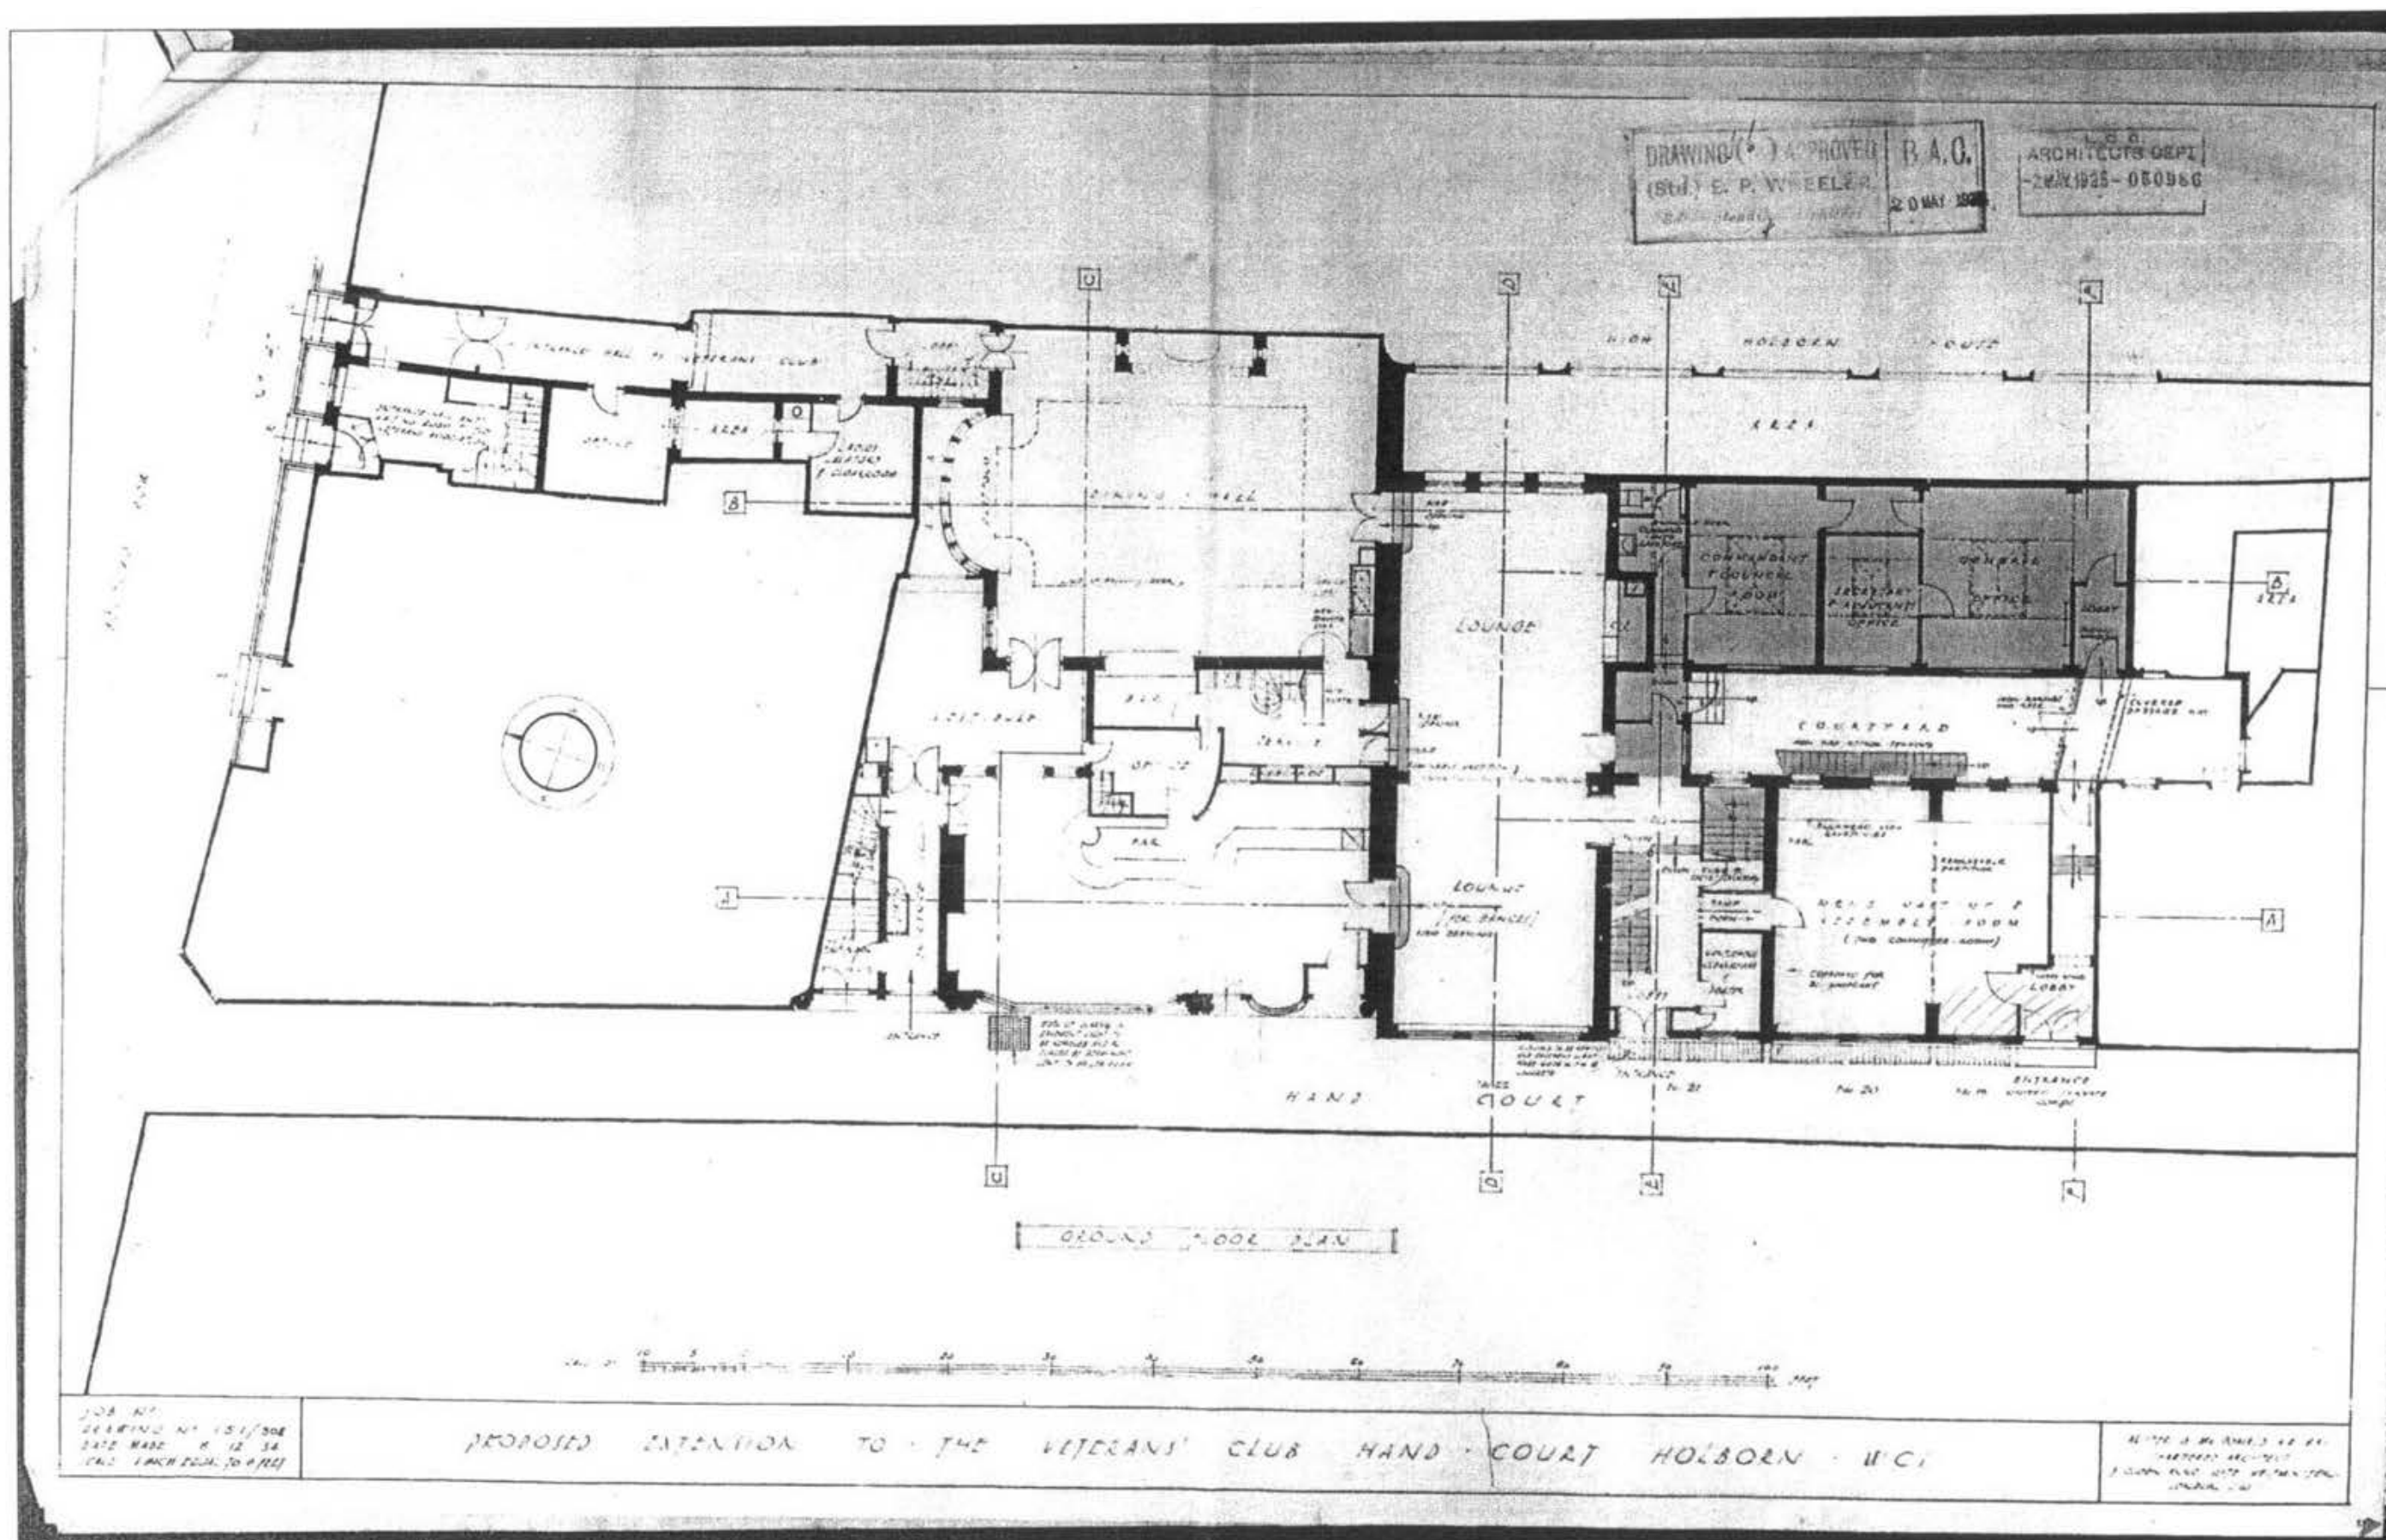
Plate XXI Alister G MacDonald drawings of the Veterans Club extensions 1934/1935. These relate to what are now 16-23 Hand Court and 48 Bedford Row.

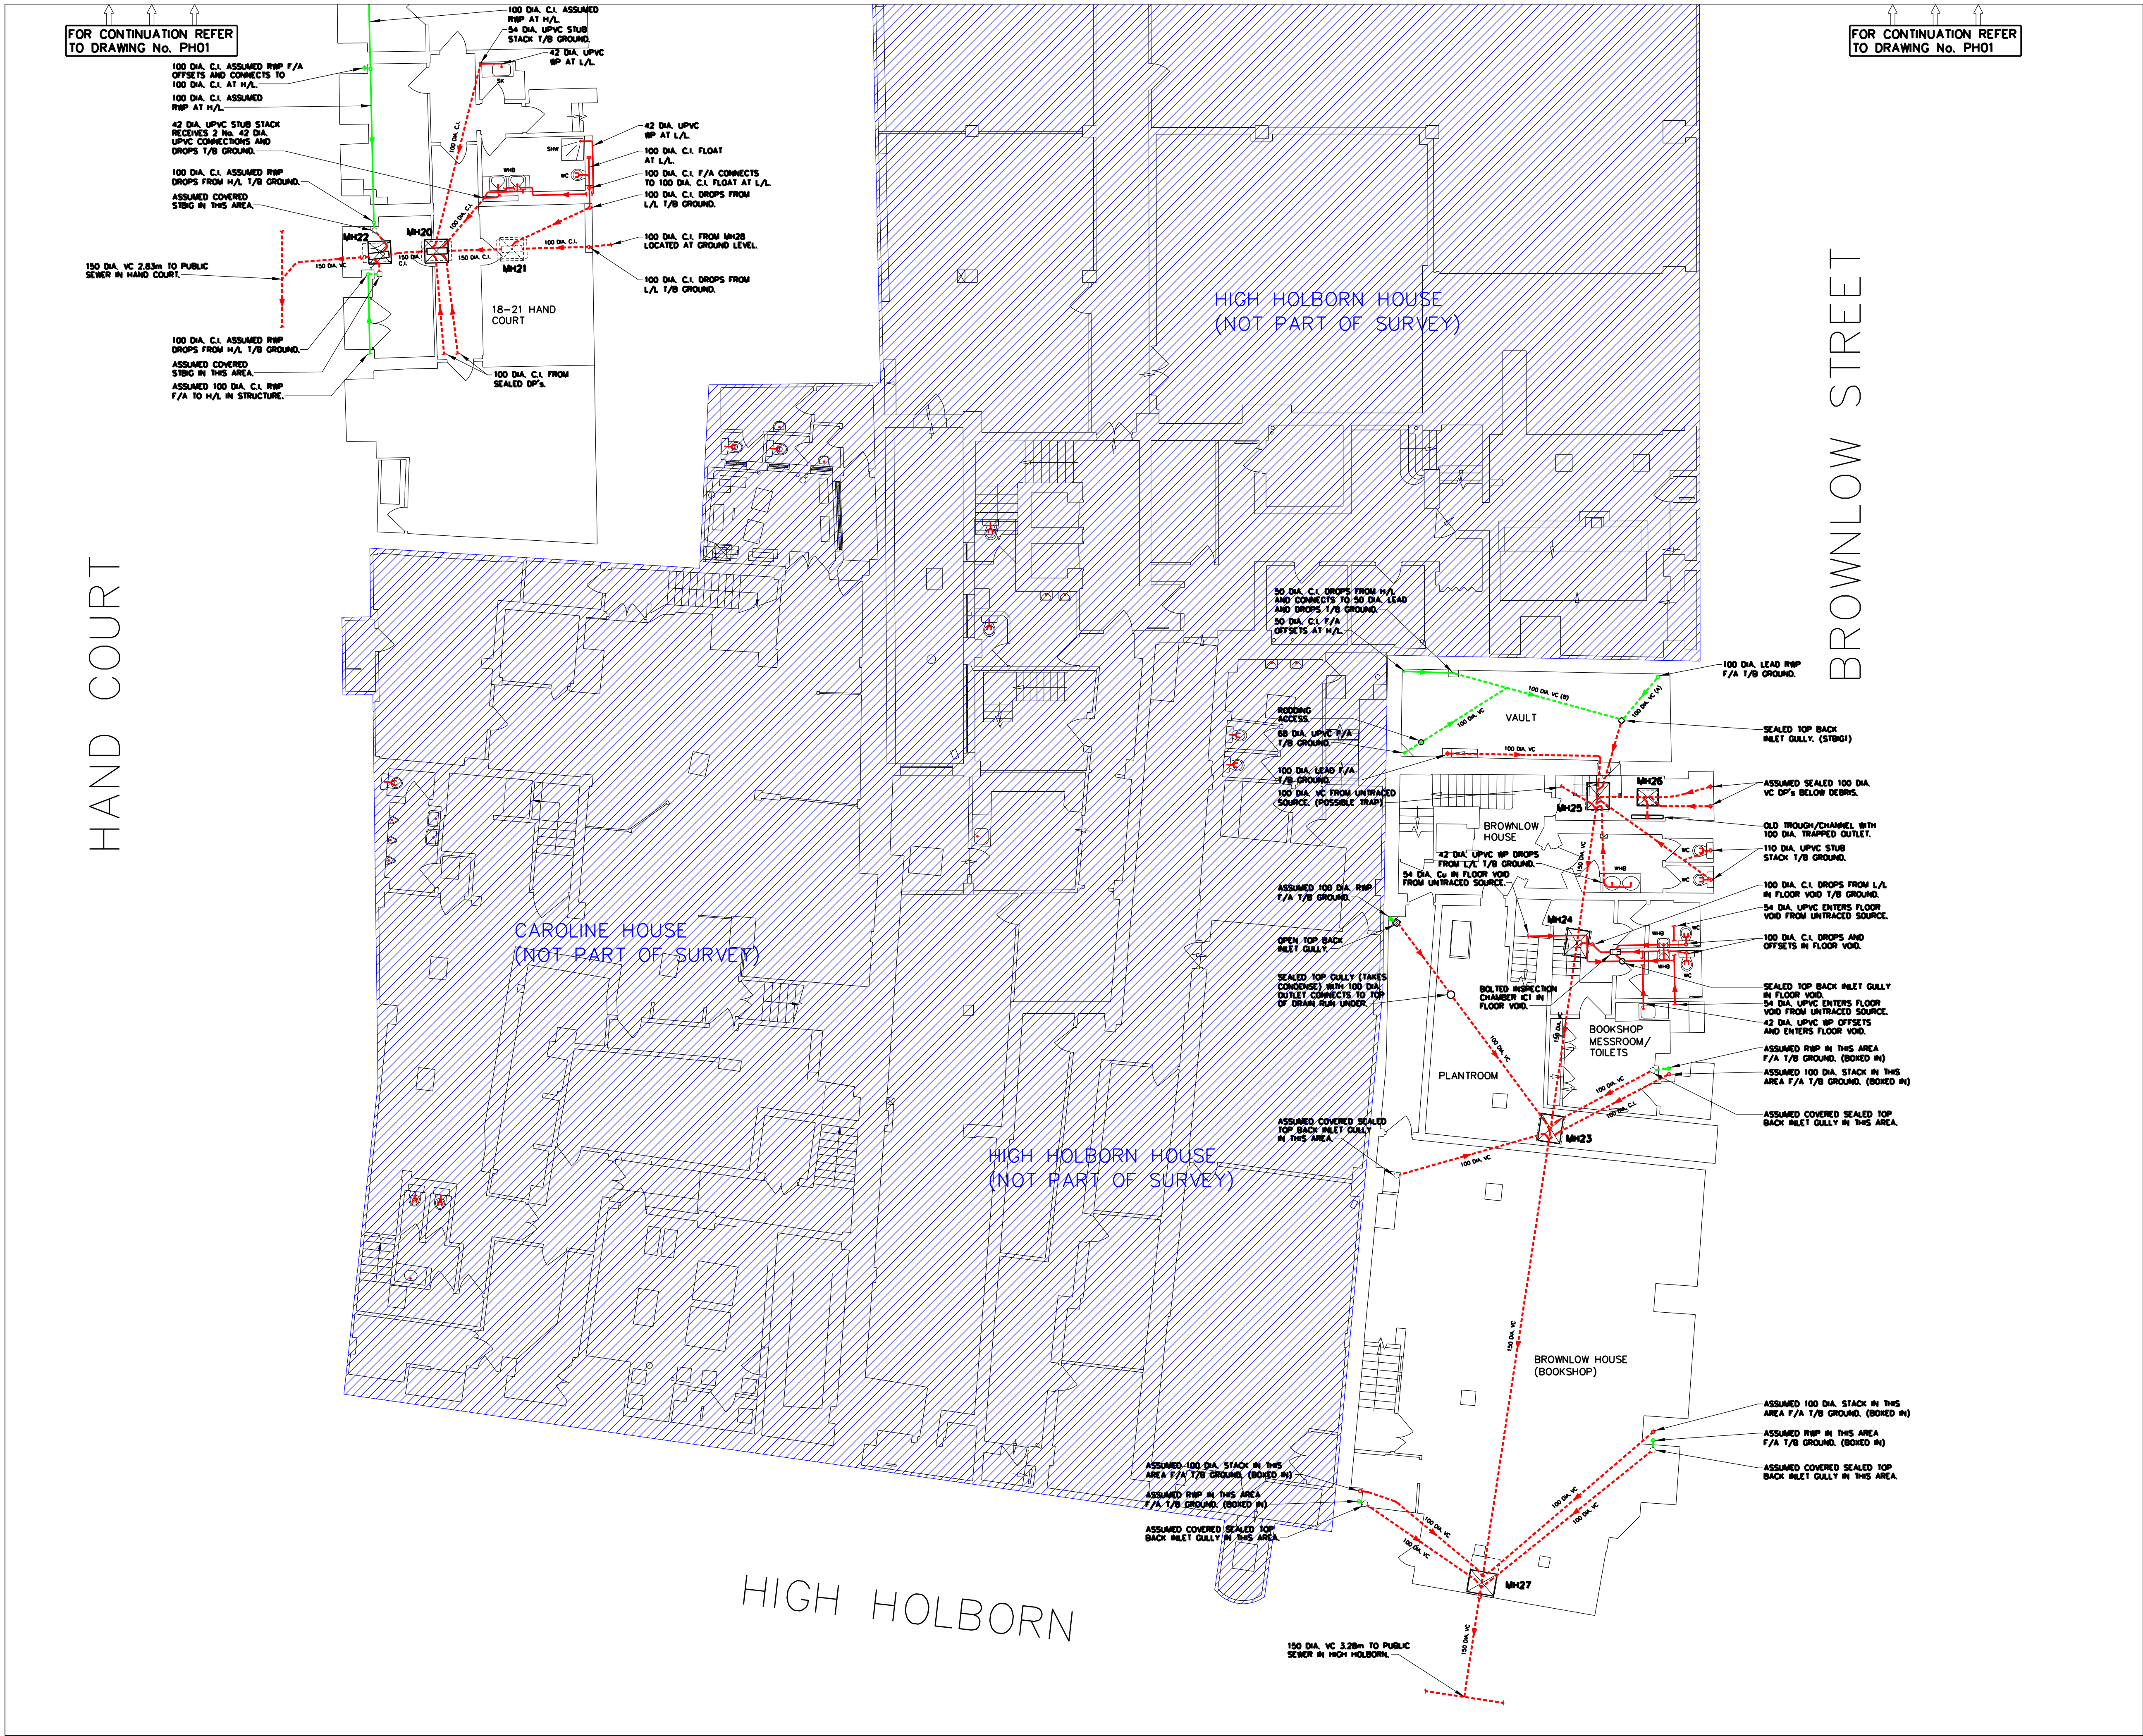
1. THIS DRAWING SHOULD BE READ IN CONJUNCTION WITH DRAWING No. PH01, PH04 & PH05 AND THE SPAFLOW LTD REPORT DATED MARCH 2017.
