Status: -
Date: 15/12/2017
Revision: A
Job no: 1843
Prepared by: Siun O’Brien
Approved by: Mark Tillett

1. Introduction

Heyne Tillett Steel Limited has been appointed by Channing Junior School to consider the construction aspects and impact of the proposed subterranean development, in support of a planning application to the London Borough of Camden (LBC). The proposed development includes the construction of a standalone single storey basement to provide changing rooms and ancillary spaces in the southern end of the site and a further single storey basement which extends beneath the existing building to provide additional classrooms and a drama studio.

This Basement Impact Assessment (BIA) has been prepared by Heyne Tillett Steel in conjunction with GEA and in line with the Camden Planning Guidance CPG4 – Basement and Lightwells, along with section DP27 – Basement and Lightwells of Camden’s Development Policies 2015 and supplementary reference documentation within these documents. This report provides specific details of each stage of the basement impact process as well as information on excavation, temporary works and construction techniques, including details of the potential

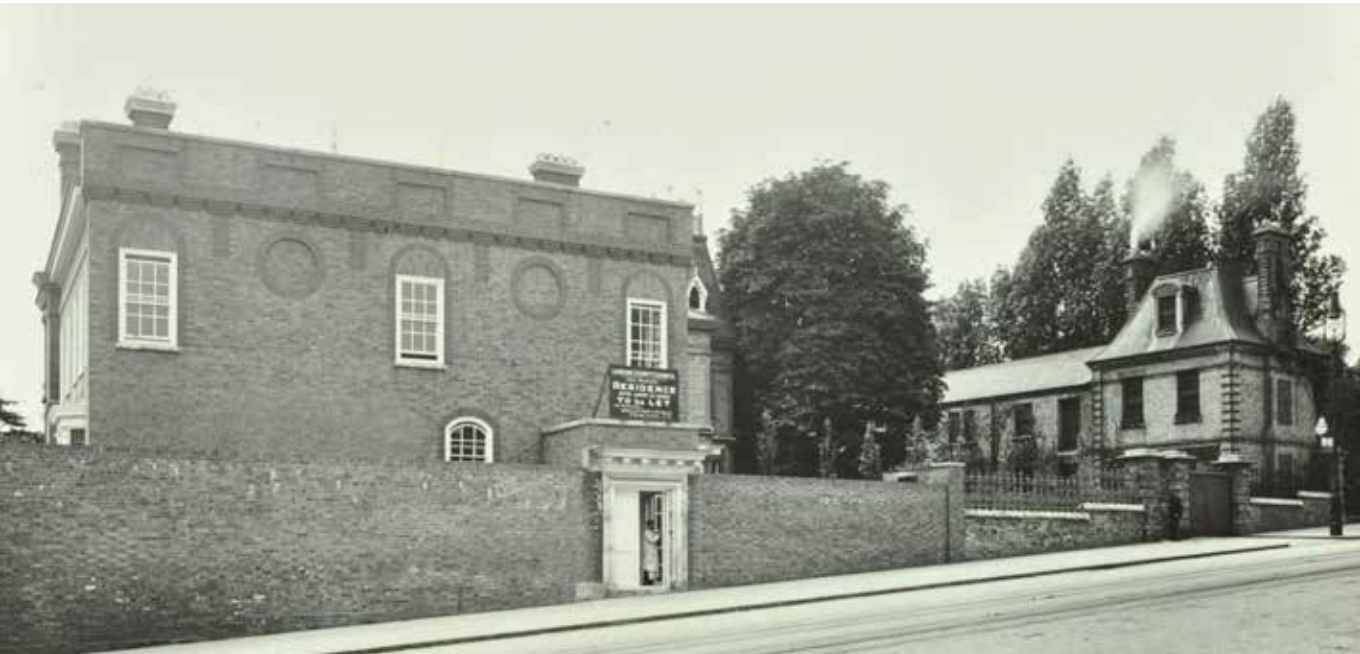
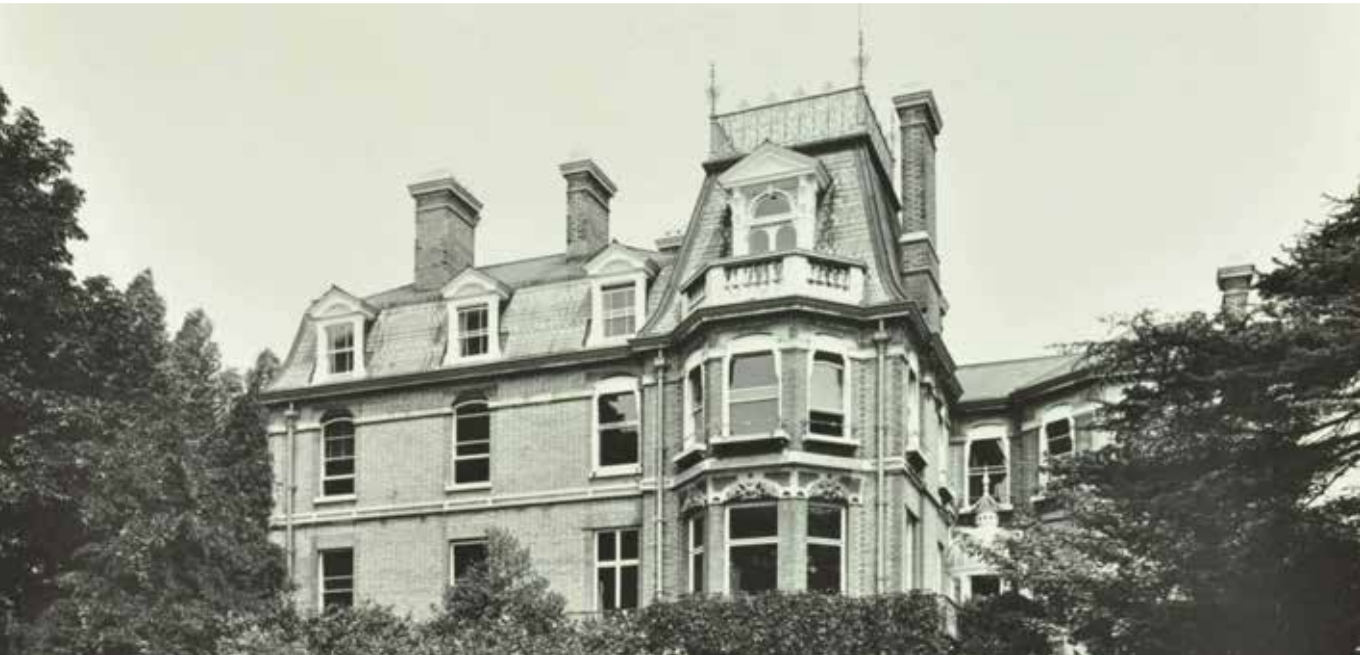
Archive Photographs – Fairseat House, North East and South West Elevations c.1911

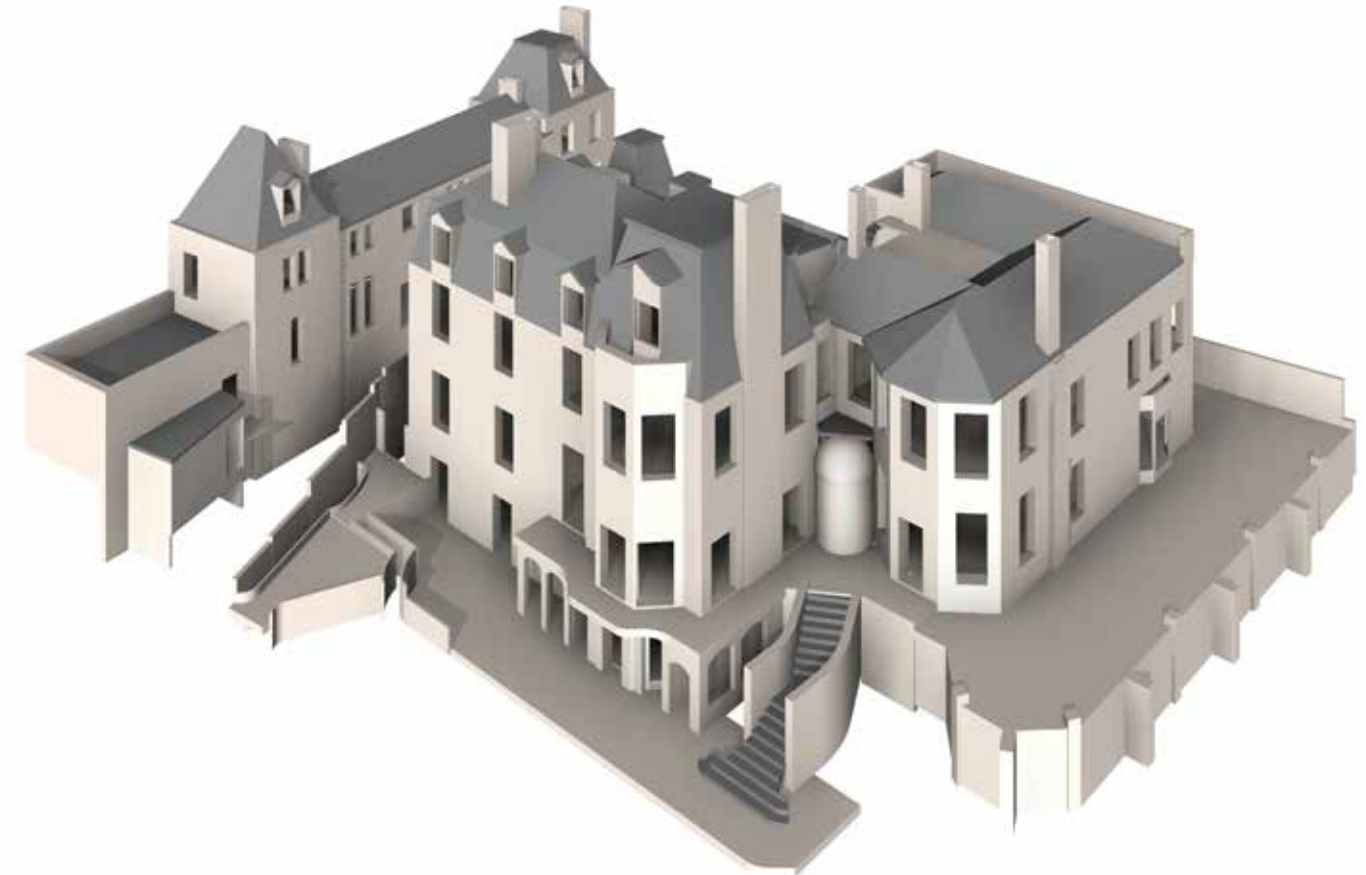
Isometric View of Existing Structure looking North

The existing structure comprises a series of loadbearing solid masonry walls supporting timber joists with lath and plaster ceilings typically. Ground floor slabs appear to be of ground bearing concrete construction or suspended timber joists spanning between solid masonry sleeper walls. The existing structure appears to be in reasonable condition where inspected.

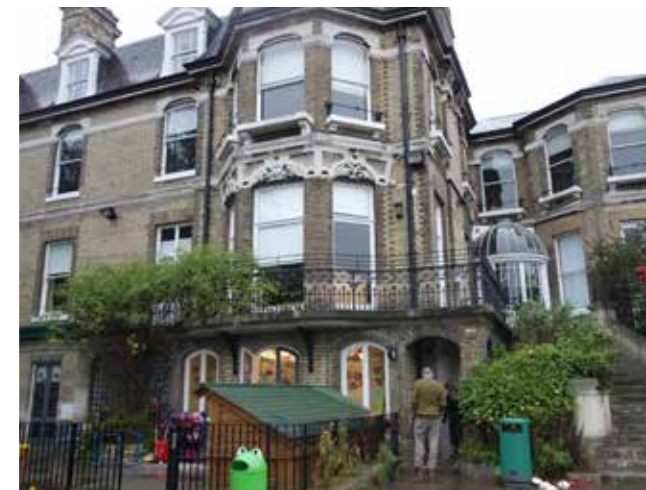
View of South West Elevation and Feature Stair

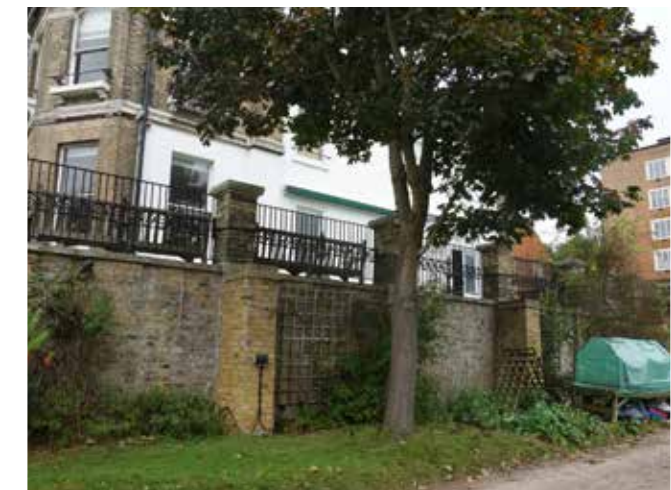
View of Existing Masonry Retaining Wall, East Elevation

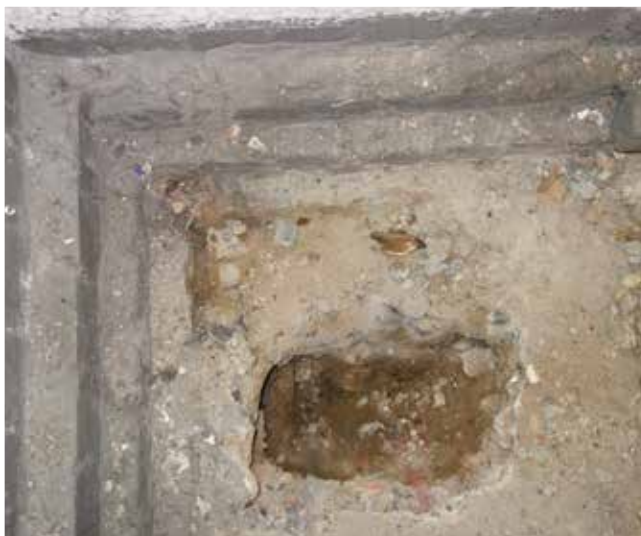
Site Photographs - Trial Pits, Main School Building

A series of trial pits were also undertaken at lower ground and ground floors respectively to establish the construction details of existing footings and their founding levels.

Existing loadbearing masonry walls appear to be founded on corbelled footings overlying concrete strip footings of varying depths. The concrete strip footings bear onto the firm silty sandy Bagshot Formation layer of the ground strata typically.

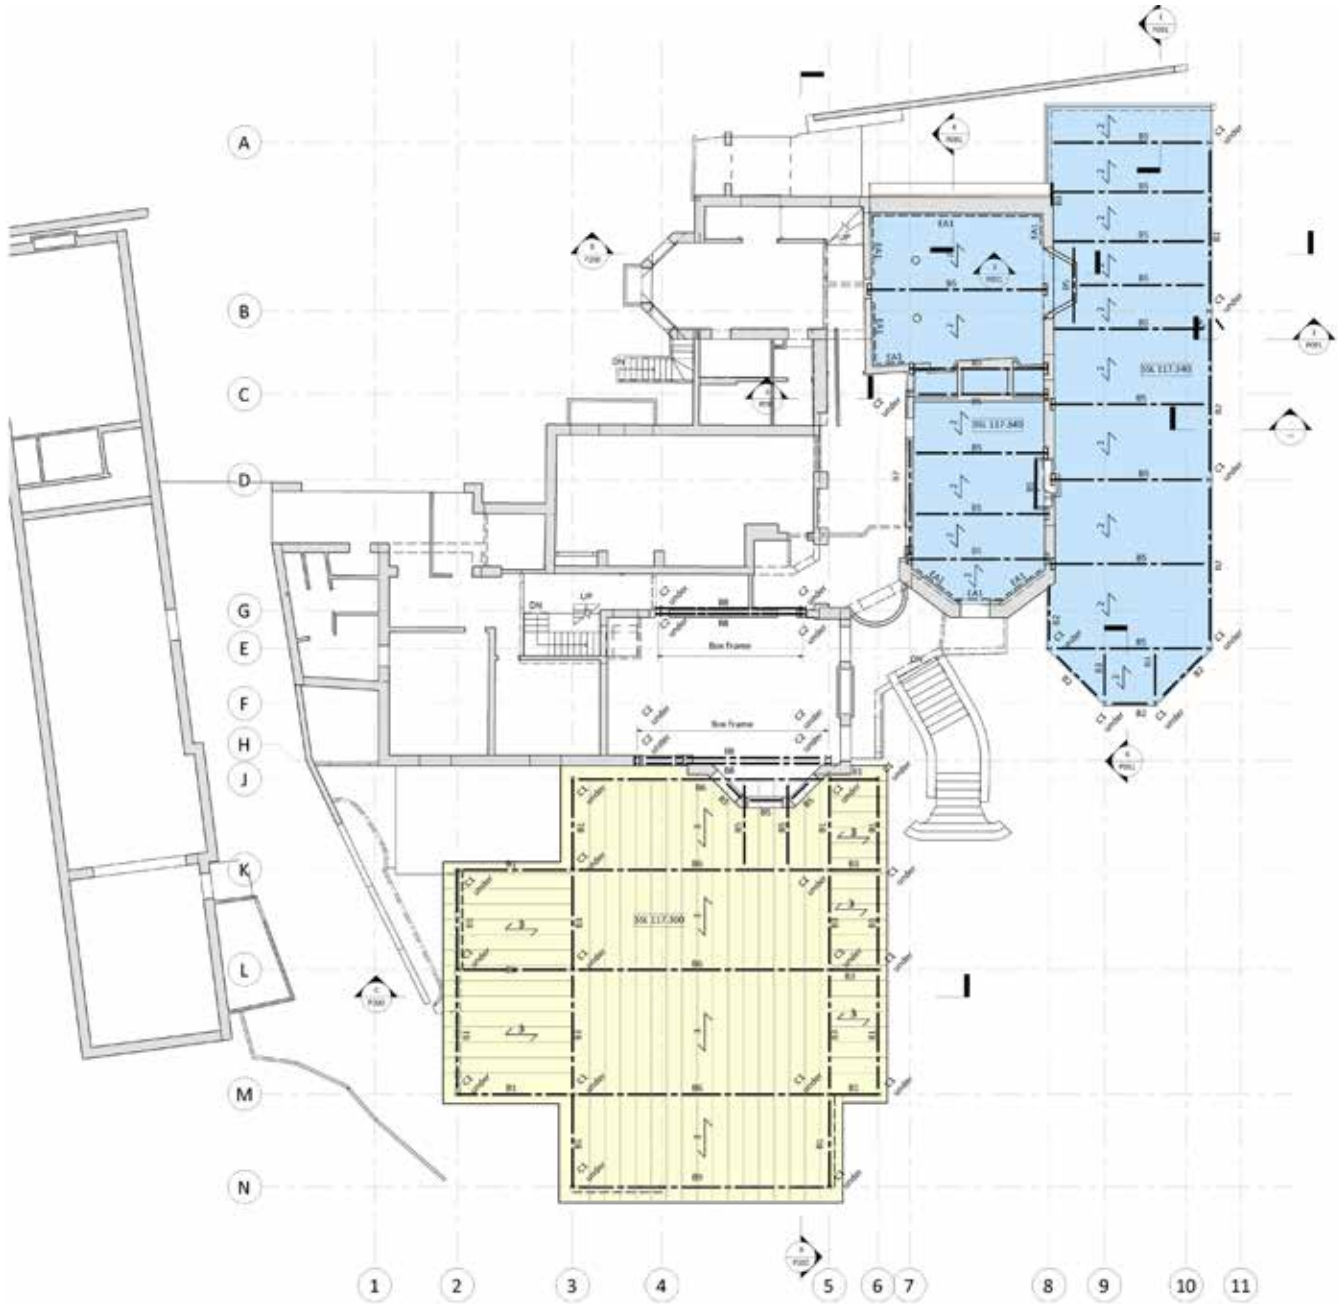
Proposed Structural GA - Ground Floor, East Extension and Hall / Dining Room

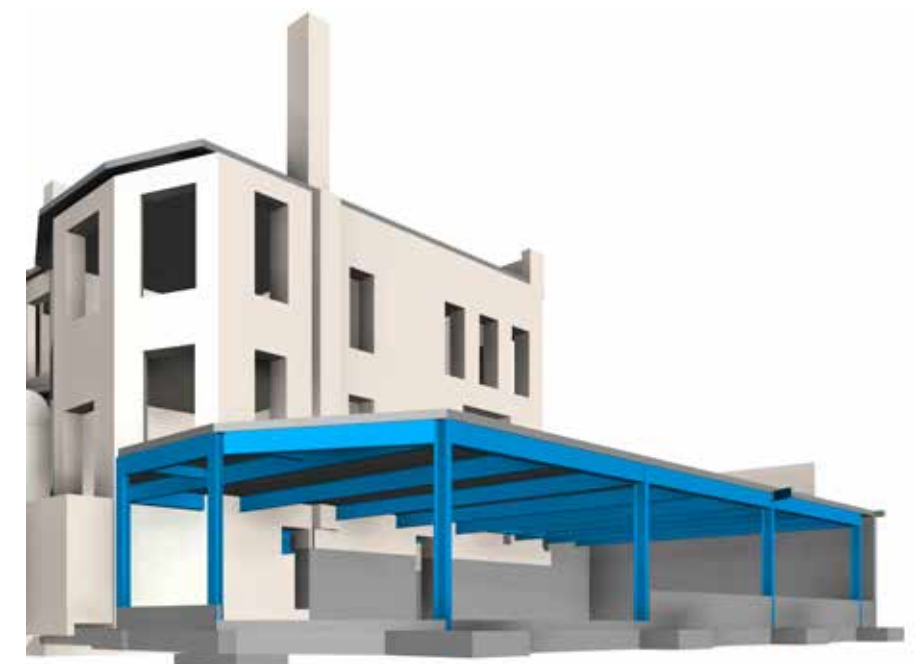
Construction of Pad Foundations / RC Slab

5.3.8 Construction of Pad Foundations / RC Slab

- Cast RC pad foundations to all remaining steel columns
- Cast RC ground bearing slab to entire footprint of extension, dowelling into existing RC underpins and retaining walls as required

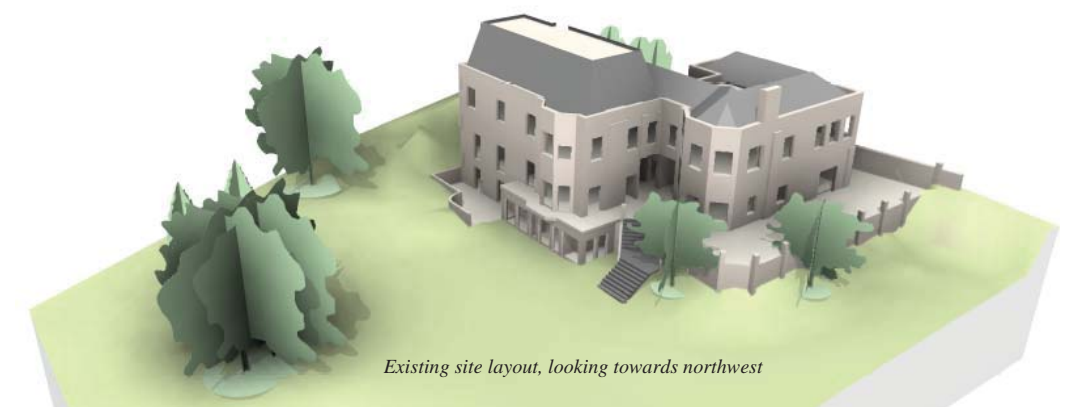
A walkover of the site was carried out during the fieldwork and selected photographs are included overleaf. The local topography slopes down in both easterly and southerly directions and the site is essentially on three levels ranging from about 118 m OD to 111 m OD. The ground floor level of the school is located at approximately 117 m OD, the lower ground floor and playground levels are at roughly 114.27 m OD to 113.59 m OD and the tennis courts are located on the lowest level at about 110.40 m OD. The site slopes generally from north to south over a distance of about 106 m, with an overall slope angle of 10°, and from west to east also at about 10° over a distance of about 110 m.

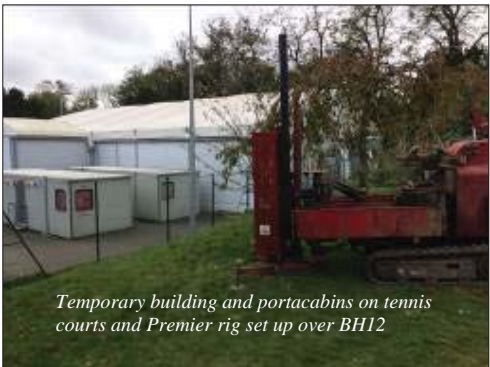
Temporary building and portacabins on tennis courts and Premier rig set up over BH12
