## ARBORICULTURAL ASSESSMENT REPORT

<b>For:</b>	<b>Client:</b>	Oriel Services Limited
	<b>Insurer:</b>	Zurich - UK Commercial
<b>Site:</b>	<b>Policyholder:</b>	Ivydown Limited
	<b>Risk Address:</b>	18-18A Rona Road, 18-18A Rona Road, London, NW3 2JA
<b>Refs:</b>	<b>OCA Ref:</b>	70860
	<b>Client Ref:</b>	6657691
	<b>Insurer Ref:</b>	20-50-170171

- 1.1 OCA Insurance Ltd has been instructed by Oriel Services Limited on behalf of the building insurers of 18-18A Rona Road. We have been advised that the insured property has suffered differential movement and damage that is considered to have been caused by trees growing adjacent to the property influencing soils beneath its foundations.

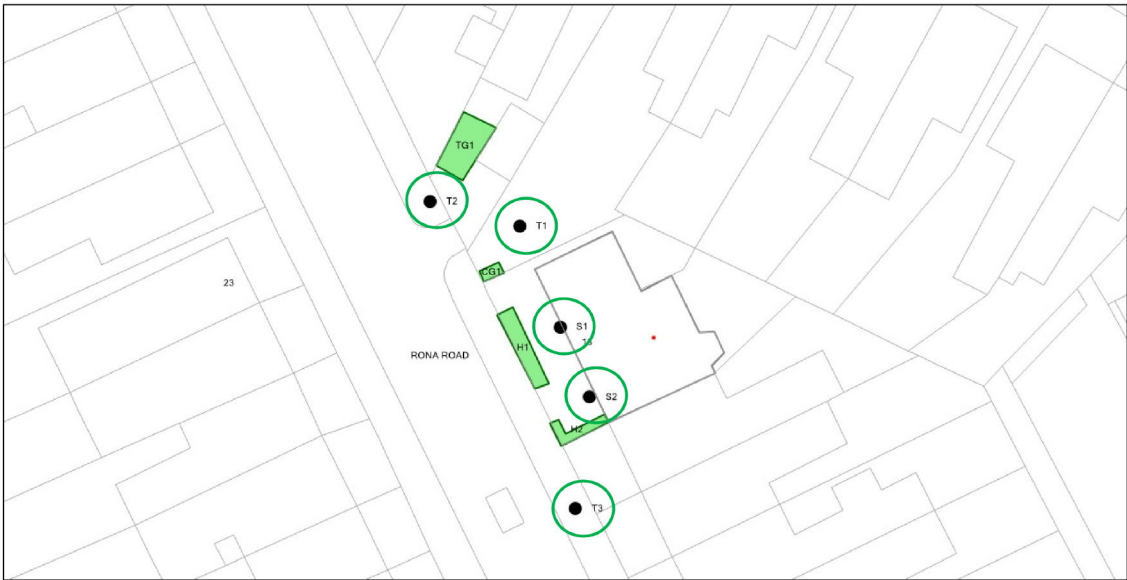
## 8.0 APPENDIX 2: SITE PLAN

Location:	18-18A Rona Road, 18-18A Rona Road, London, NW3 2JA
Job Ref:	70860
Survey Date:	20.03.18 - NTS
By OCA Insurance Limited Crown copyright 2016. License number 100043594
