PLANNING & LISTED BUILDING APPLICATION FOR

**113 ALBERT STREET**  
NW1 7NB

Ben Smith Architecture have been appointed by the owners of 113 Albert Street to prepare an application to carry out remedial damp-proofing works to the house including dry lining the vaults at the front of the property, improve the habitability and levels of the rear bedroom at lower ground floor level, and improve accessibility into the building.

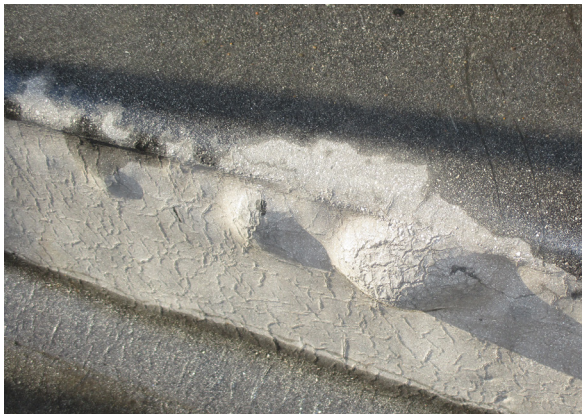
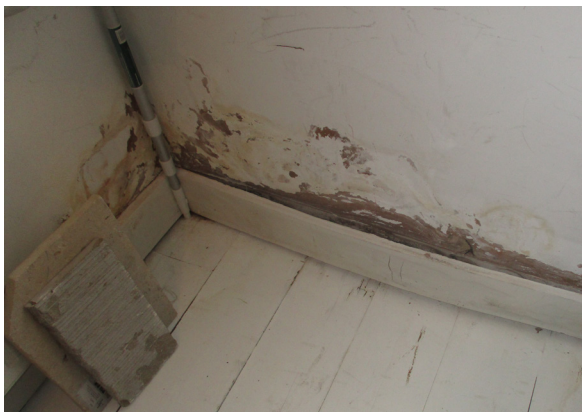
Mains access with blistered asphalted steps (above)  
Interior damp damage (below)

- Water ingress in the rear elevation, around the existing lightwells, which have caused water to flow into the masonry at GF level, and through the structure into the lower ground floor. As a result, the interior plaster and decorative finishes are stained and damaged.
- The external ground level at the rear drains insufficiently, causing rainwater to pond by the rear elevation and damp conditions at the base of the wall resulting in decaying timber internally.

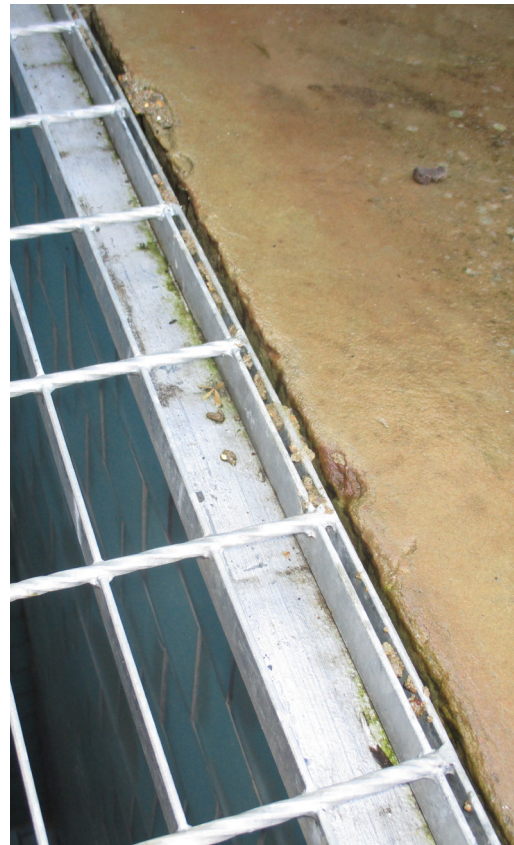
Weak waterproofing point around metal grille over rear lightwell

- As part of the works to connect both lightwells, the damp-proofing at the base of the rear elevation and around the lightwell would be improved, by installing cementitious waterproofing slurry to the walls below ground (retaining and façade) under sand-cement render.

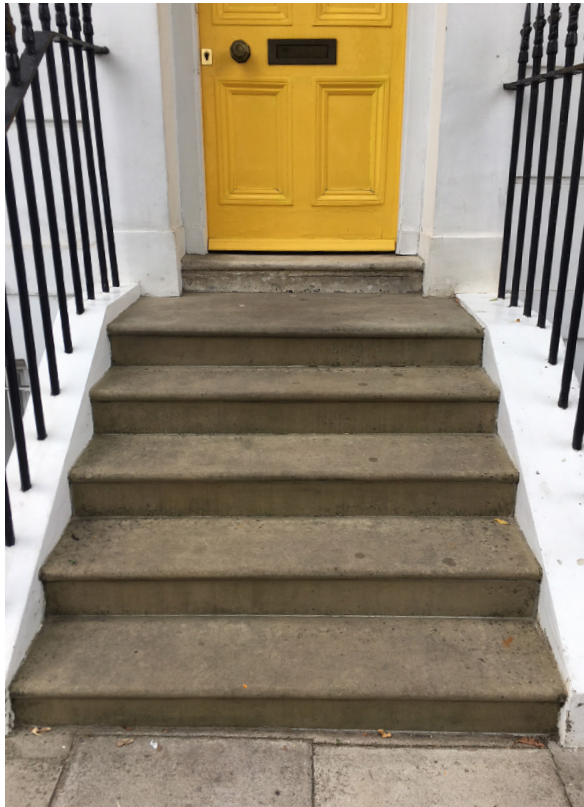
New proposed steps to raised ground floor to be clad in Portland stone to match neighbouring properties

The main access into the (raised) ground floor is via a series of steps up from street level. This arrangement is repeated along the terrace group of buildings, although the finish and treatment of these differs amongst the properties. In the case of 113 Albert Street, the steps are coated in a bituminous treatment that, as can be seen in the appended damp investigation report, show signs of damp damage. As part of the works we proposed to strip back the existing damaged asphalt and clad the treads and risers in Portland stone, with bull-nosed edges to the treads, to match neighbouring properties, such as no. 115. This would help enhance the overall appearance of the main access, and the terrace group in general.

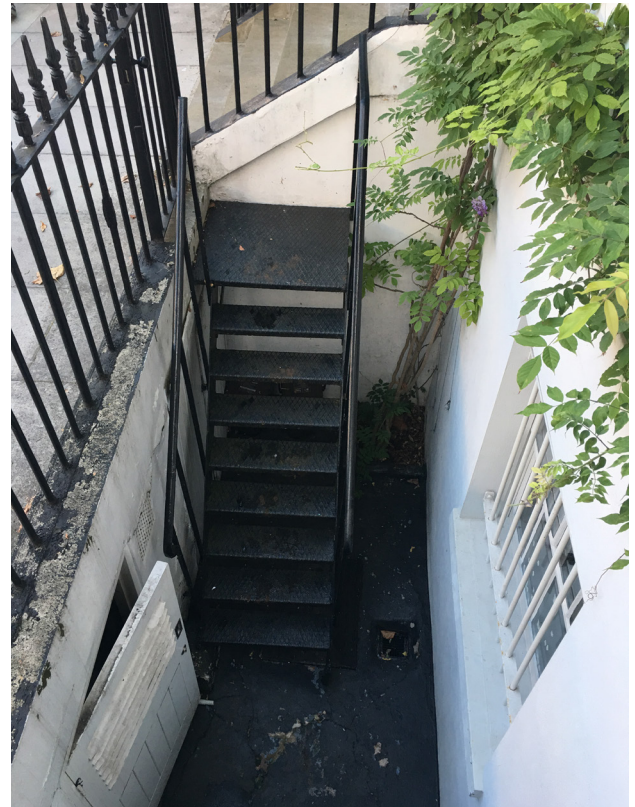
Existing steep, slippery and narrow stairs leading to front lightwell

The gate itself is only approximately 650mm wide, and the stair is not only steep but also slippery due to water collecting on the treads. The rubbish and recycling is stored in the front lightwell, away from clear view from the street, and the narrow steps therefore serve as the only route for the waste disposal removal. The current configuration with narrow, steep, slippery steps, and a narrow gate onto the street, makes maneuvering even the smallest of the council's recycling bins up to street level a hazardous activity.

To remedy this we propose to widen the existing (non-original) gate by a single finial to achieve a more comfortable (approx.) 700mm wide opening. We would then also replace the current impractical stair with a new cast iron one, in the style of the existing, but with a consistent, more gentle pitch and perforated treads (to avoid stagnating water) for ease of use. We have been liaising with a specialist metalworker to ensure we can achieve a finish for both railings/gate and stair that respect the history and fabric of the building to preserve the consistent style of the building and rest of the terrace group.
