Basement Impact Assessment

**190 Goldhurst Terrace,
London, NW6 3HN**

Ref: 16550/R3

April 2018

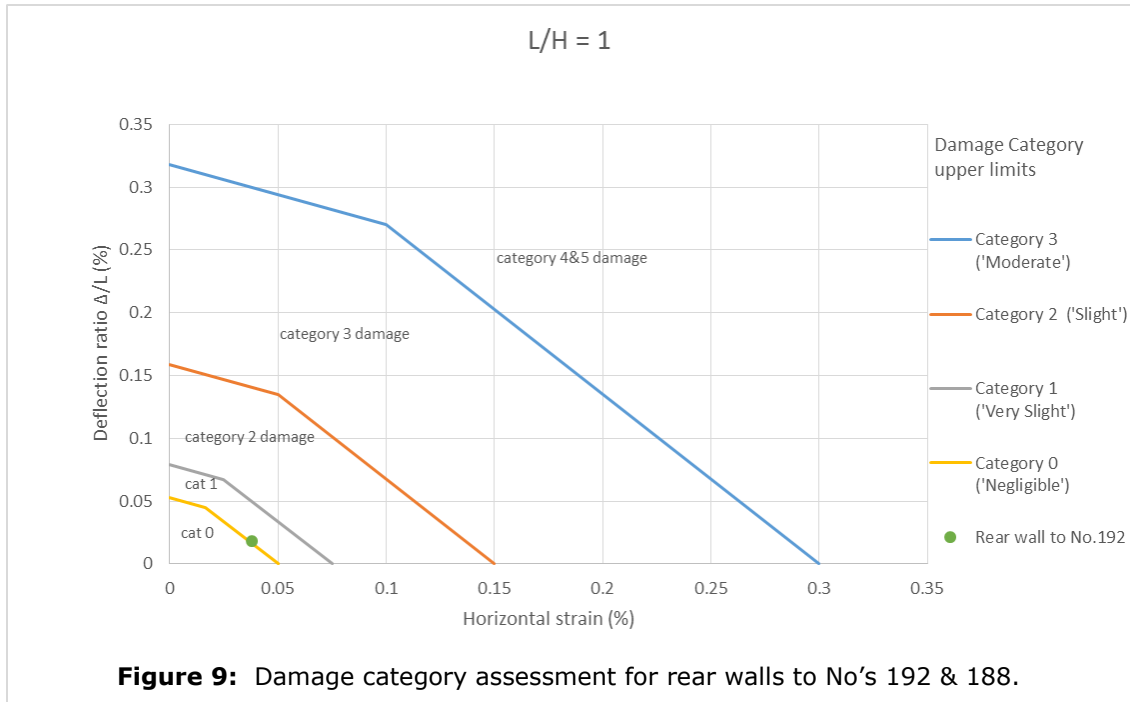
10.6.8 The maximum settlement predicted by the PDISP analysis alongside the rear walls to No's 192 & 188, in Stage 1 was 0mm (see Figure D3 in Appendix D), thus this can be ignored. The typical settlement caused by relaxation of the ground alongside the basement in response to excavation of the underpins, was therefore estimated using only the convex settlement profile for a worst case (low stiffness) support system presented in Figure 2.11(b) in CIRIA Report C580. This settlement profile gives a maximum deflection, $\Delta = 0.07\%$ of the excavation depth, occurring at a distance greater than the depth of excavation from the excavation. The maximum $\Delta = 2.28\text{mm}$, which represents a deflection ratio, $\Delta/L = 1.75 \times 10^{-4}$ (0.018%).

10.6.9 Using the graphs for $L/H = 1.0$, these deformations represent a damage category of 'very slight' (Burland Category 1, $\epsilon_{lim} = 0.05-0.075\%$), on the boundary with Burland Category 0, 'negligible', as given in CIRIA SP200, Table 3.1, and illustrated in Figure 9 below.
