IoE Number:	47854
Location:	COTTAGES TO THE REAR OF THE FIRE STATION, WEST END LANE (west off)
	HAMPSTEAD, CAMDEN, GREATER LONDON
Photographer:	Mr Anthony Rau
Date Photographed:	04 December 2006
Date listed:	21 May 1990
Date of last amendment:	21 May 1990
Grade	II

CAMDEN TQ2585SW WEST END LANE 798-1/35/1706 (West side (off)) 21/05/90
Cottages to the rear of the Fire Station GV II 4 terraced firemen's cottages. c1901. By the London County Council Architect's Department; job architect WA Scott. Rendered brick; ground floor originally exposed brick. Westmorland slate roofs with deadlights; tall brick stacks at centre and on gable ends. Each cottage 2 rooms deep. 2 storeys. 1 window each at ground floor level; 1st floor continuous strip at eaves level to each pair. Paired panelled and part-glazed entrance doors with overlights (except left hand being C20); wooden bracketed plain hoods. Entrances flanked by 3-light casements (all windows originally with small panes). 1st floors with centrally positioned 6-light casement strips to each pair. Rear with C20 single storey bathroom extensions. INTERIORS: have stairs between party walls and sitting rooms with panelled airing cupboards at 1st

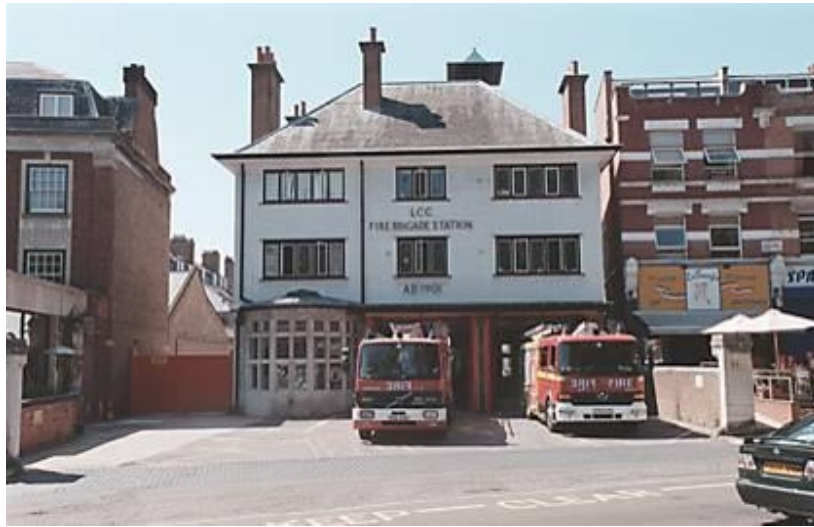
IoE Number: 478544
 Location: FIRE STATION, 325 WEST END LANE (west side)
 HAMPSTEAD, CAMDEN, GREATER LONDON
 Photographer: Mr Steve Kirkland
 Date Photographed: 05 August 2007
 Date listed: 14 May 1974
 Date of last amendment: 14 May 1974
 Grade II

CAMDEN TQ2585SW WEST END LANE 798-1/35/1705 (West side) 14/05/74 No.325 Fire Station GV II Fire station. c1901. By the London County Council Architect's Department, job architect WA Scott. Roughcast walls; glazed brick to part of rear elevation. Hipped Westmorland slated roof with projecting eaves, moulded eaves cornice and tall brick chimney-stacks; double pitched to rear wing having in the angle a tall roughcast former water tower rising from ground floor level to appear above the roof; wooden belvedere with copper pyramidal roof. EXTERIOR: main front with 2 bays of part-glazed engine shed doors to right and to left a polygonal bow window of stone with transom and mullion casements having small leaded panes. 1st and 2nd floor with bands of 5-light casements to outer bays flanking central 3-light bands; all with small leaded panes. Left hand return with similar windows plus a brick 6-light bay window with stone mullions and slated penthouse roof. Rear with cast-iron railings to 1st floor balcony above engine shed. Double gabled wing has similar polygonal bow window to front on right hand bay and 3-light casements to each floor. INTERIOR: mess room has half-height panelling and large segmental arches to window alcoves; segmental-arched panelled door to rear. Similarly panelled fireplace with bracketed mantle. The fire station forms a complex with the firemen's cottages (qv) in the rear yard.
